**REPORT ON A SECOND BAT AND BARN OWL SURVEY
AT WALKERS BARN, MILES KNOLL,
NR WATERHOUSES, STAFFORDSHIRE**

December 2013

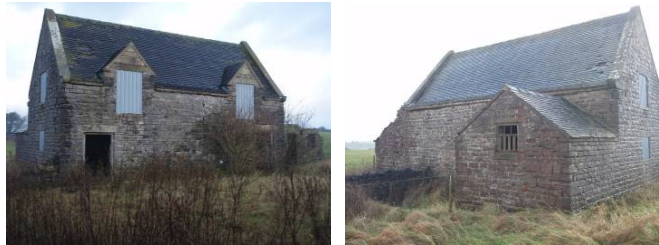
- 1.7 The barn lies close to the A523 Leek to Ashbourne Road at the grid reference SK 10460 48810.
- 1.8 The site is a stone built two-storey field barn with a tile roof.

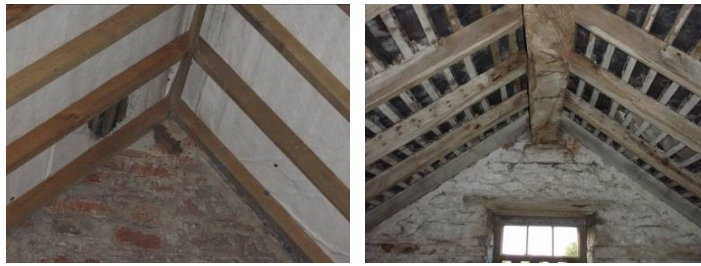
- 1.9 The roof has two dormers which were put in place about 13 years ago when the barn was re-roofed.

- 1.10 The two-storey area has its roof lined with breathable roofing felt, but the small single storey area at the rear as no roof lining.

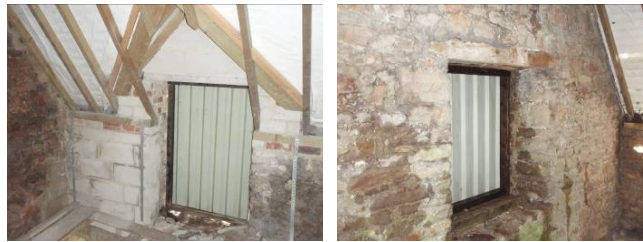
- 1.14 Most of the windows are 'boarded' over with corrugated metal sheets. There is no glass in the windows.

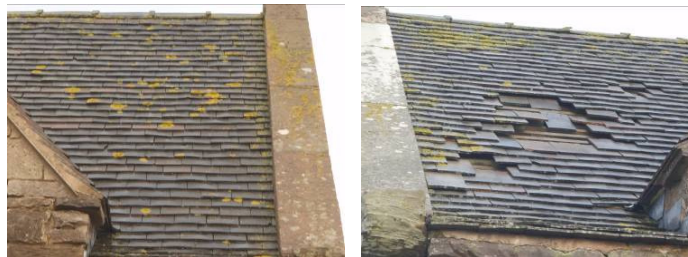
- 1.16 The gables of the roof have parapets and there are some tiles missing on one area of the roof.

- 11.3 Should a roost be subsequently found then the situation will change and a licence required.
- 11.4 As a precaution, if roof tiles and ridges are to be removed this should be done carefully by hand always mindful that there may be a bat underneath. In the unlikely event that bats are found during building operations, work must cease immediately in that area, the bats left alone and a bat consultant contacted for advice.

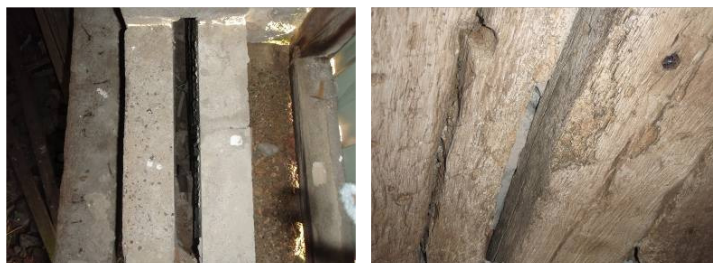
- 1.19 The 'dormer' areas and roof generally have relatively new timbers (13 years old) and there are no cavities, shrunken mortise joints, slots, peg holes etc in the internal roof timber work.

- 1.20 There are gaps, however, in all the lintels including the newer ones above the 'dormers', windows, doorways etc.

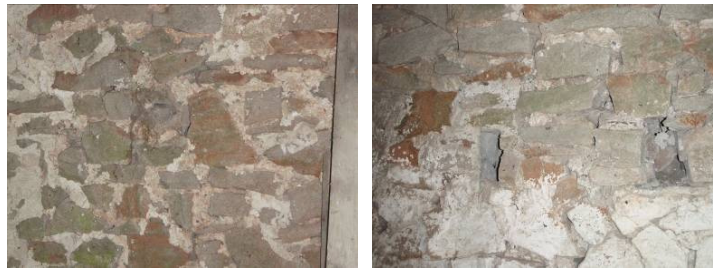
- 1.21 The old solid stone internal walls have an abundance of deep cracks and crevices.

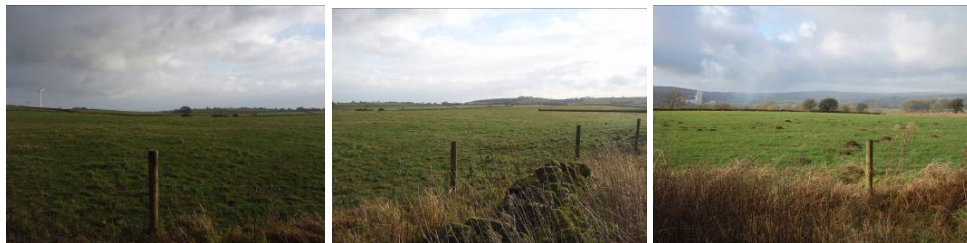
- 1.22 The barn lies around 900ft above sea level.
- 1.23 The building stands alone in a field surrounded by high pasture used for stock grazing. There are few hedgerows and dry stone walls and wire fences mark field boundaries in the main.

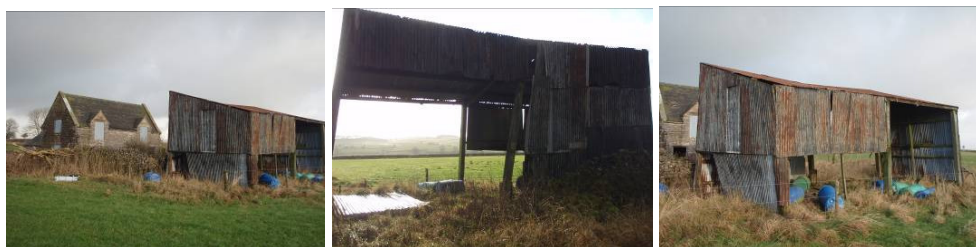
- 1.24 The site has a very open aspect taking the full brunt of any wind and rain as it stands unsheltered high on a hill. It is considered sub optimal habitat for bats. There is an adjacent metal clad barn in a poor state of repair.

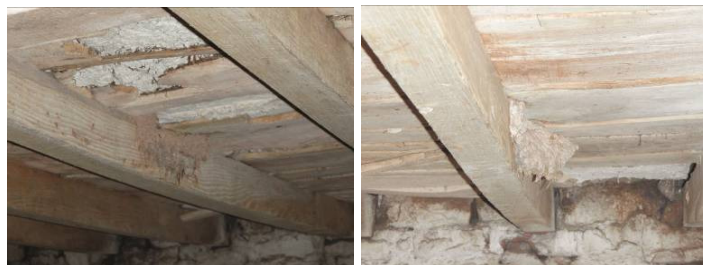
- 9.1 No evidence of bat or barn owl usage was found anywhere in the barn.
- 9.2 For bats, special emphasis was placed on searching cracks and holes in walls, in lintels, around window and doors, behind woodwork. These are common sites to find hibernating bats. No bats were seen in these places though the stone walls were thick and 'rubble' filled making it difficult to check all deep cavities even with an endoscope.
- 9.3 No evidence of barn owl usage was found in the barn and this is often much easier to locate if present.
- 9.4 There was evidence of significant use of the barn in summer by nesting barn swallows (*Hirundo rustica*). A number of pairs had obviously nested throughout the barn during the 2012 season and in previous years.

- 11.9 The loss of breeding sites for this species are therefore of conservation concern.
- 11.10 Barn swallows are summer visitors (mainly April – October) to Britain.
- 11.11 Nesting on beams in barns is common. Egg laying is usually in early or mid May. Incubation lasts 11 – 19 days and the fledging period is 18 – 23 days. Two broods are normal, three occasionally. Young may still be in the nest in September. Where possible, building works should be arranged to avoid disturbance to swallows when nest building and rearing their young.
