IVY COTTAGE.

BAT SURVEY.

Ref No:- 160934.

Date: 21st September 2016.

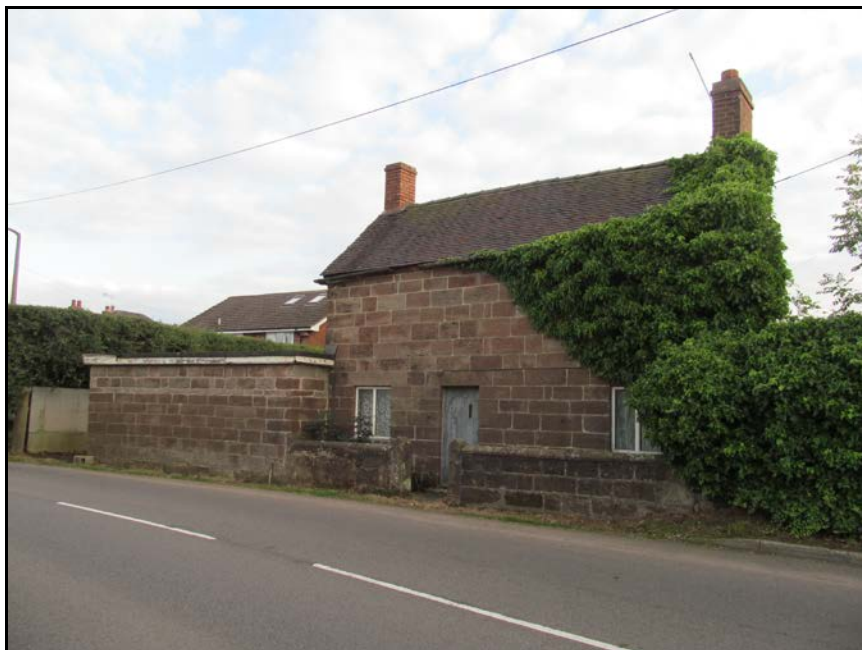
3.3.1.1. Building A is a stone built cottage constructed with large, solid blocks of coursed stone. Western end of the building is covered with a dense area of ivy

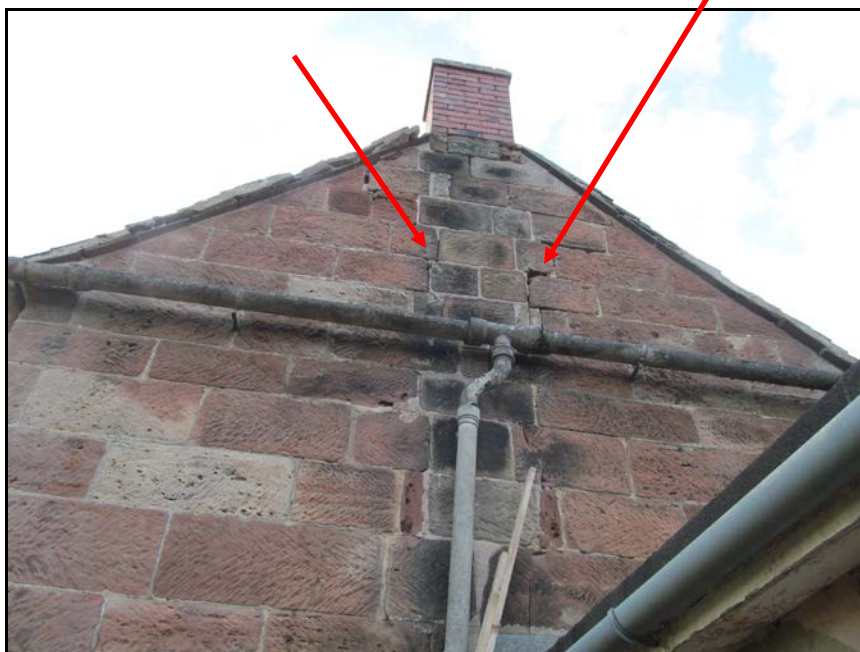
3.3.1.2. The remainder of the walls are good and solid with the exception of a small number of cracks and crevices on the eastern gable end wall. These have the potential for roosting bats although close examination with a pole mounted camera identified no signs of use by bats.

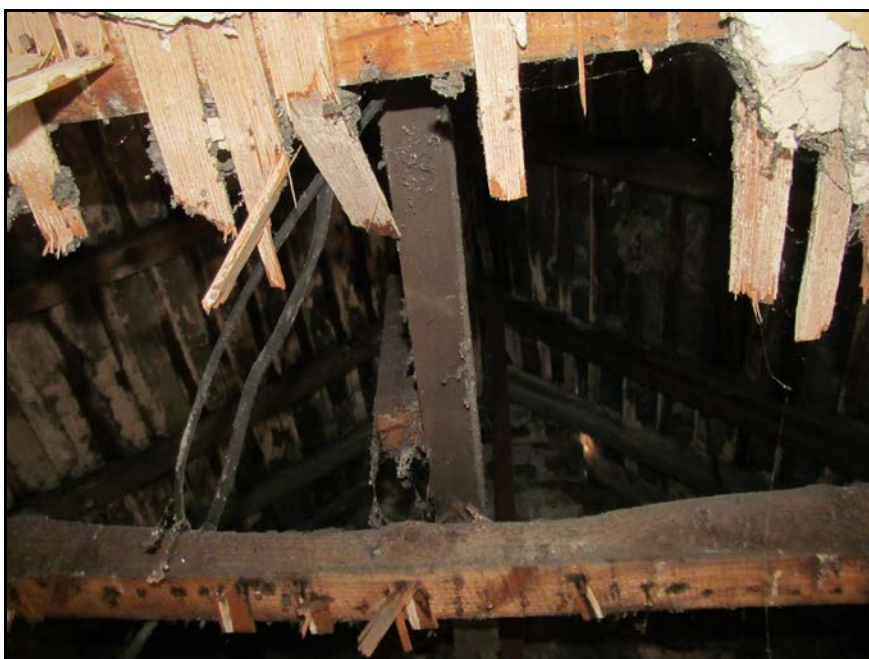
3.3.1.3. The roof is generally in fair condition but there are slipped and displaced tiles, particularly down the southern side of the eastern gable end that provide access for bats to the loft space. There are also some small gaps beneath the ridge tiles.

3.3.1.4. The loft space is quite low because the top floor rooms extend into the loft. However, the majority of the ceilings are down opening the loft space into the two bedrooms.

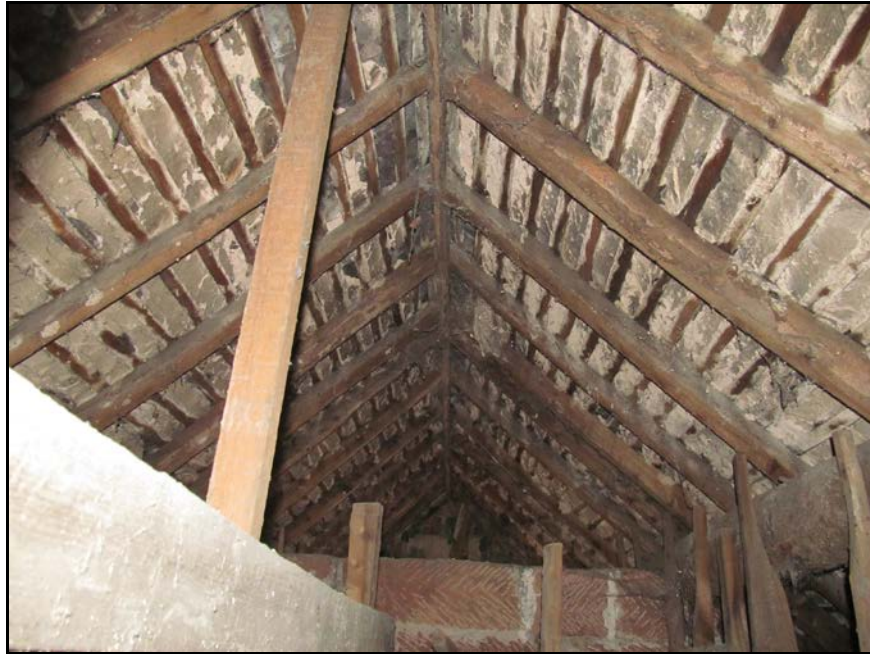
3.3.1.5. There is no felt beneath the roof tiles and therefore the slate laths and torching are exposed as shown below. There are areas where the torching has deteriorated and this has exposed various gaps. There are also gaps leading up beneath the ridge tiles and occasional gaps to the outside of the roof, particularly around the chimney at the eastern end of the roof.

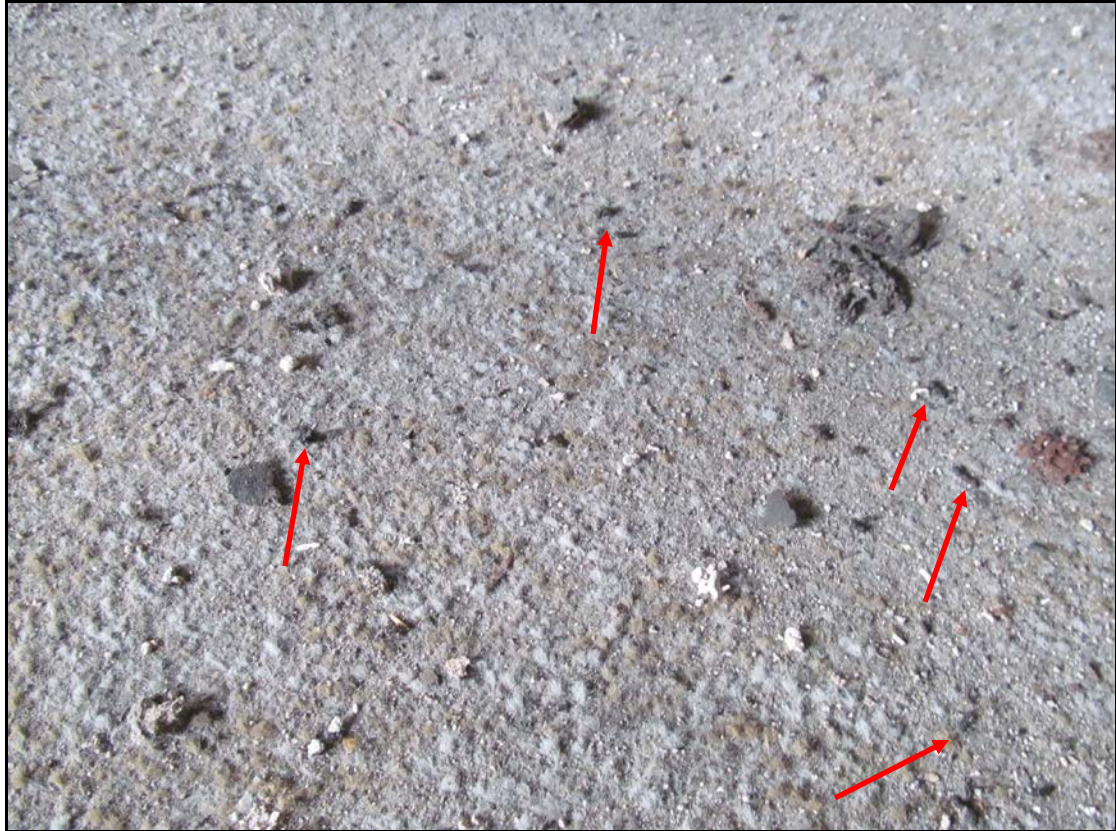
3.3.1.6. A small group of approximately 20 to 30 bat droppings were found on the carpet in the western room beneath the ridge. These were all quite small and were assessed to be fairly fresh, black but drying, as shown in the photograph below. A sample of these was collected and compared to library samples. They were assessed to be Pipistrelle droppings.

4.3. The day time inspection identified a small number, approximately twenty, of small bat droppings on the carpet beneath the ridge in the western of the two bedrooms. These were of varying age although none were very old so it is assessed these are from this current 2016 season.

5.2. Because there is a roost in the building it will be necessary to prepare a mitigation strategy to accompany this report when submitted to the Local Authority. This will be a simple statement and will cover timing of works that will impact on the existing roost, generally between October and March when bats are in hibernation and will cover the provision of mitigation and compensation measures. This would generally be to provide a number of bat bricks in the new buildings to be constructed on the site.

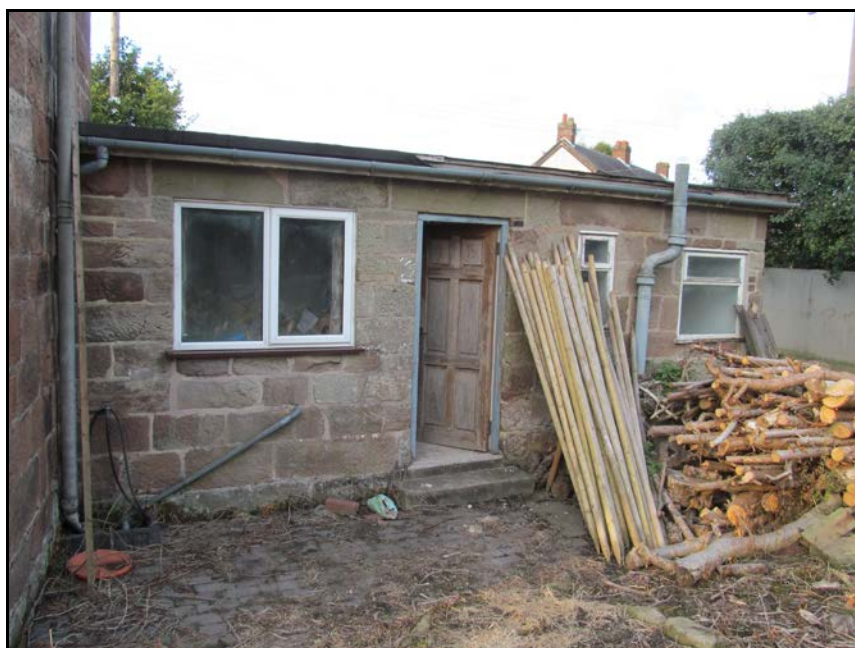
3.3.2.1. Building B is a stone built single storey extension on the eastern end of Building A. Like the cottage, it is constructed with large, solid blocks of coursed stone with a flat roof.

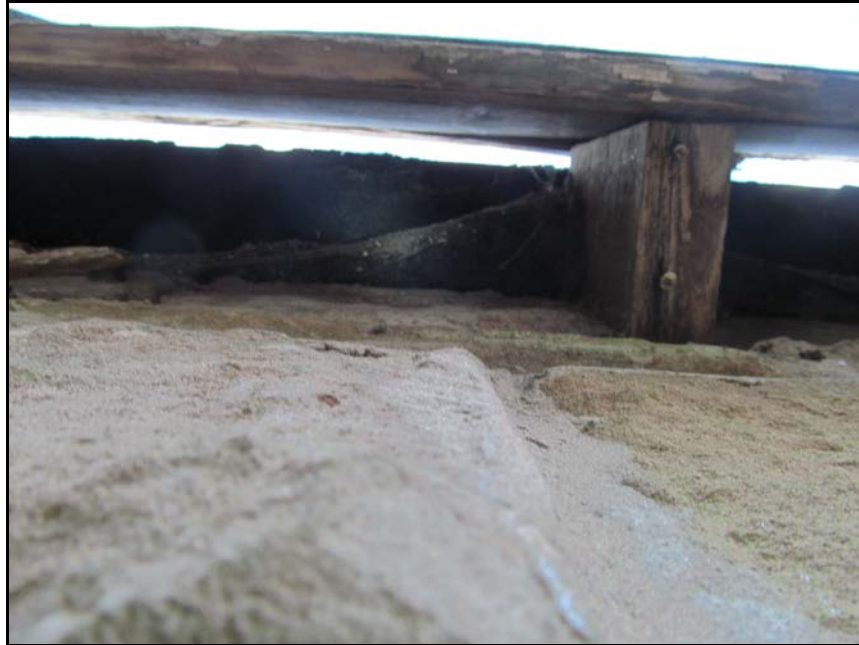
3.3.2.2. The walls are in good condition with no visible cracks and crevices but the fascia and soffit boards are rotten and in a poor state with gaps around. However, these were low down and easy to visually inspect. There were a number of cobwebs present but no signs of use by bats.

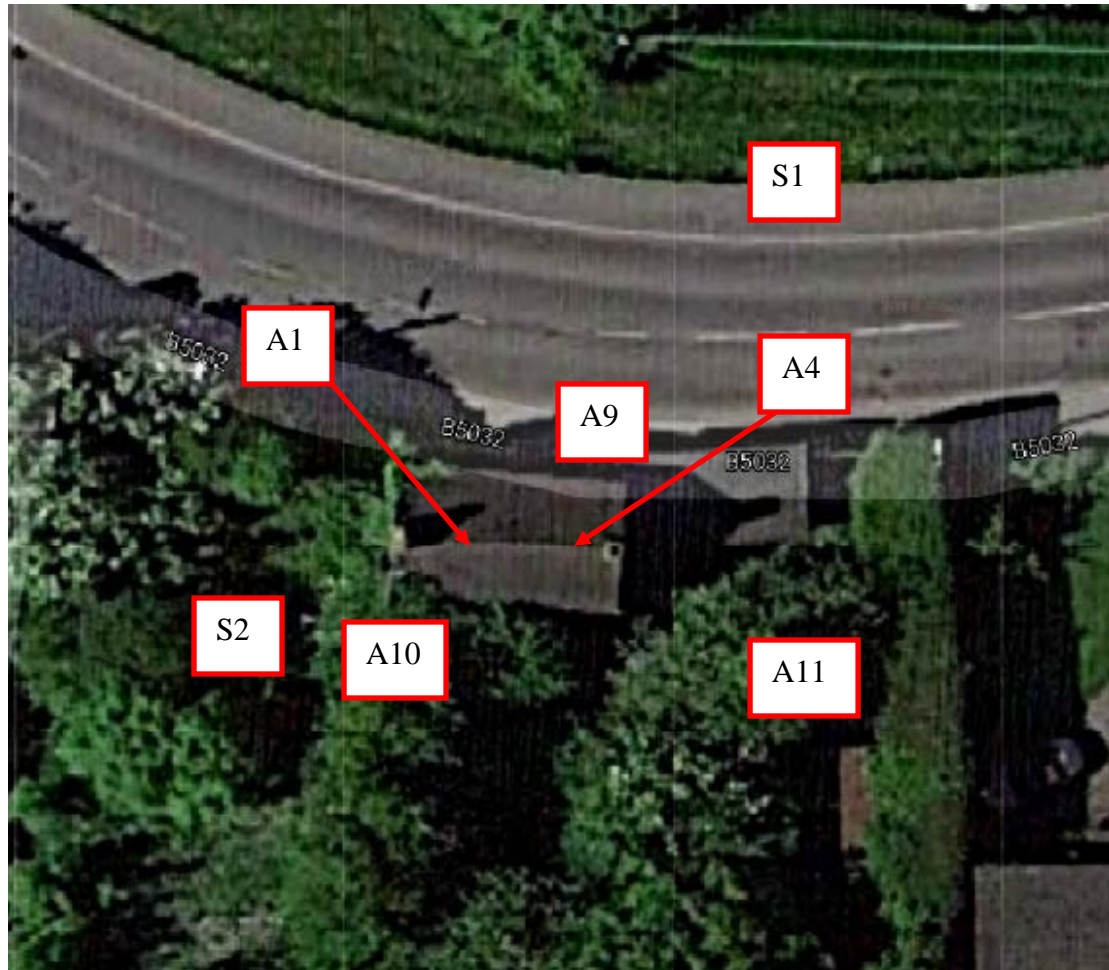
3.4.4. The surveyors were deployed to view all sides of the property simultaneously and the Anabat recorded were similarly deployed to record bat activity inside and

outside the buildings. The aerial photograph below shows the positions of the surveyors (S) and Anabats (A). Anabats 1 and 4 were placed inside the upper floor of the building to record bat activity in the loft space.
