**Preliminary Roost Assessment for Bats & Birds**

**Location: Land by Leekbrook house**

**Basford Lane**

**October 2017**

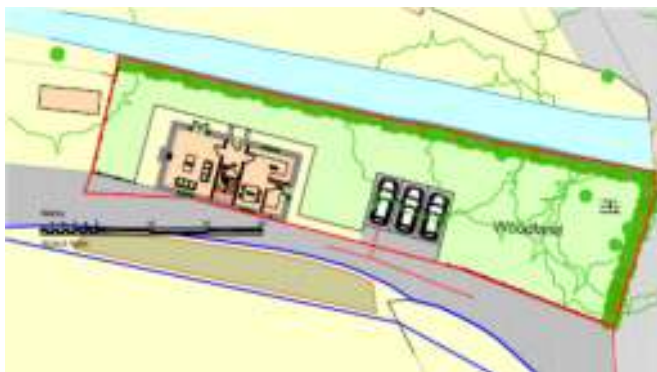
It is proposed that the existing garage will be demolished to make way for residential accommodation and parking. **Figure 2 below showing layout of new development.**

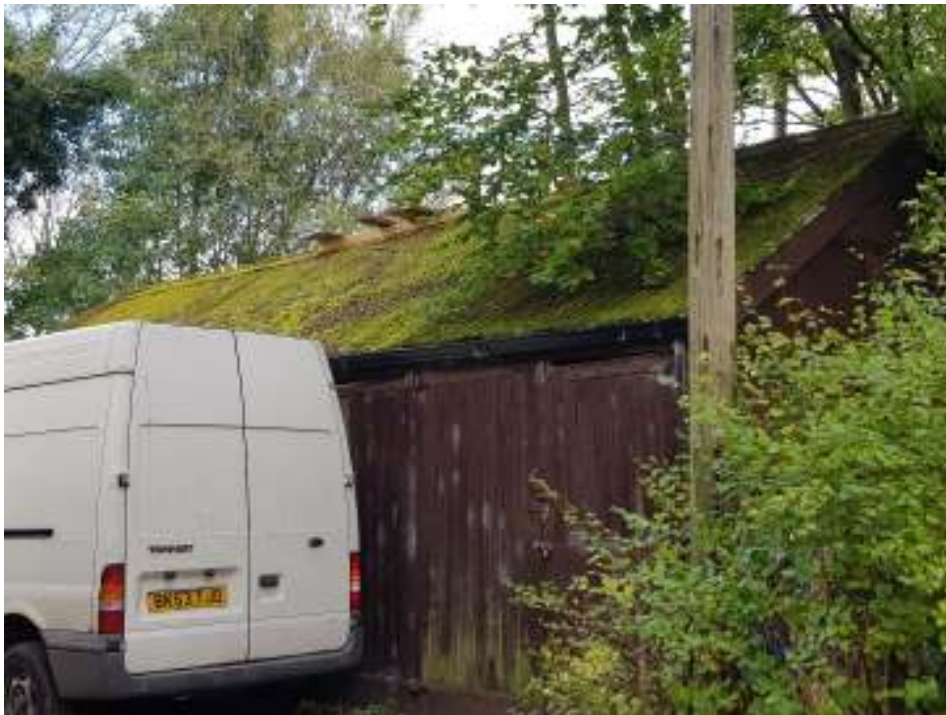
Building	Description	Evidence found or potential for bats
B1 External	No access constraints were encountered during the site survey. The garage will go under planning consideration. The building is a single storey, wooden construction with two gable ends aligned east to west. The overall length of the building is 12m x 5m and it appears to be structurally sound. The structure of the building, showed little cracks and crevices. What crevices and gaps were evident were inspected with an endoscope this was used to inspect the identified crevices but no bat evidence was recorded. The roof is pitched and is of fibre material and heavily mossed, and would appear to have no egress points this was evident on inspection from ground level. During the inspection, noticeable the doors were intact preventing access for bats and birds. During the inspection of the building no evidence of bats were made, though evidence can be removed from external weather and more so during the season when bats are least to be present	No evidence of bats found, the building is assessed to have <b>Negligible potential</b> for roosting bats

Plate 1: Showing garage, with dominating moss located on the roof.

The building was thoroughly inspected throughout and there were no constraints up on the survey inspection, during the inspection we found that there were no signs of Bats or their droppings therefore it is recommended that no further surveys on the garage is need to be conducted, in accordance with the Bat Conservation Trust guidelines (BCT, 2016) 3rd addition.

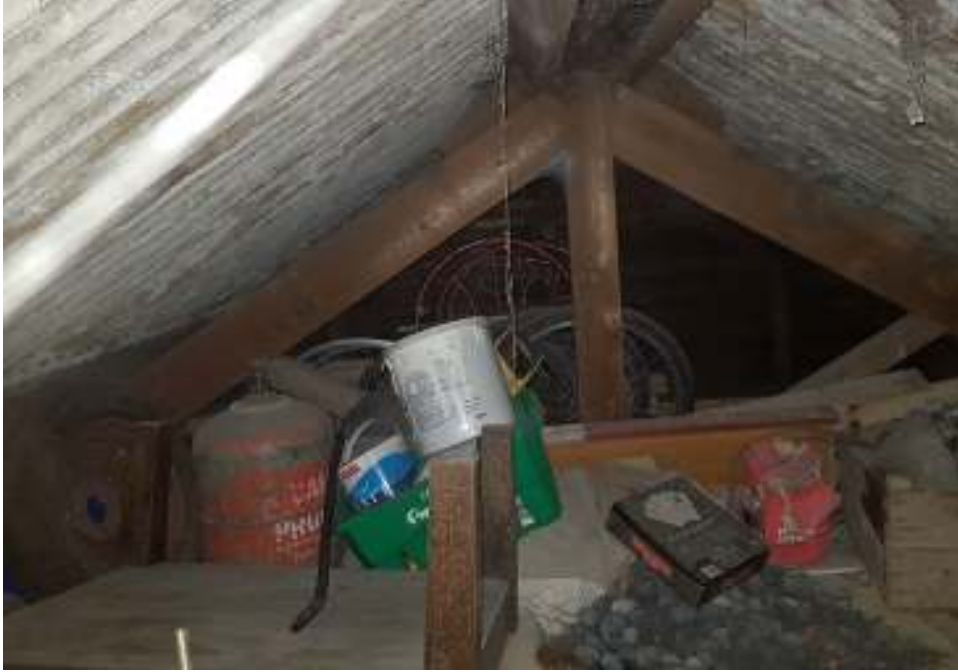
Internal	The internal inspection of the building identified the building to be divided up into two rooms currently used as storage. The inspection found that the building area was relatively dry with areas which were dark which most bats prefer, the inspection concentrated on the single layered timber structure, which	The buildings were easy to inspect as there were no roof felting or crevices which we could not inspected fully, and the floors and walls had not been cleaned for some time. The inspection found no evidence of droppings or bats.

<p>was in good condition providing little in the way of crevices what crevices that were identified were found to be shallow therefore confidently inspected. The roofing of the building is made of fiber material roofing visible (No roofing felt or other constraints), the ridge of the roof was relatively clear with some areas of cob webs. All the floors and walls were inspected also showing no evidence of bats or birds. The internal of the building has not been regularly cleaned this was evident from cobwebs present and areas of dust &amp; debris. The building itself was fully inspected with confidence and no constraints preventing inspection</p>	
--	---	--

Plate 2: Showing the internal of the garage which provided limiting roosting potential
