# **Protected Species Survey for Bats**

**Lot 2 Beehive Farm, Harvey's Lane**

**Kingsley Moor, Stoke-on-Trent**

**October 2017**

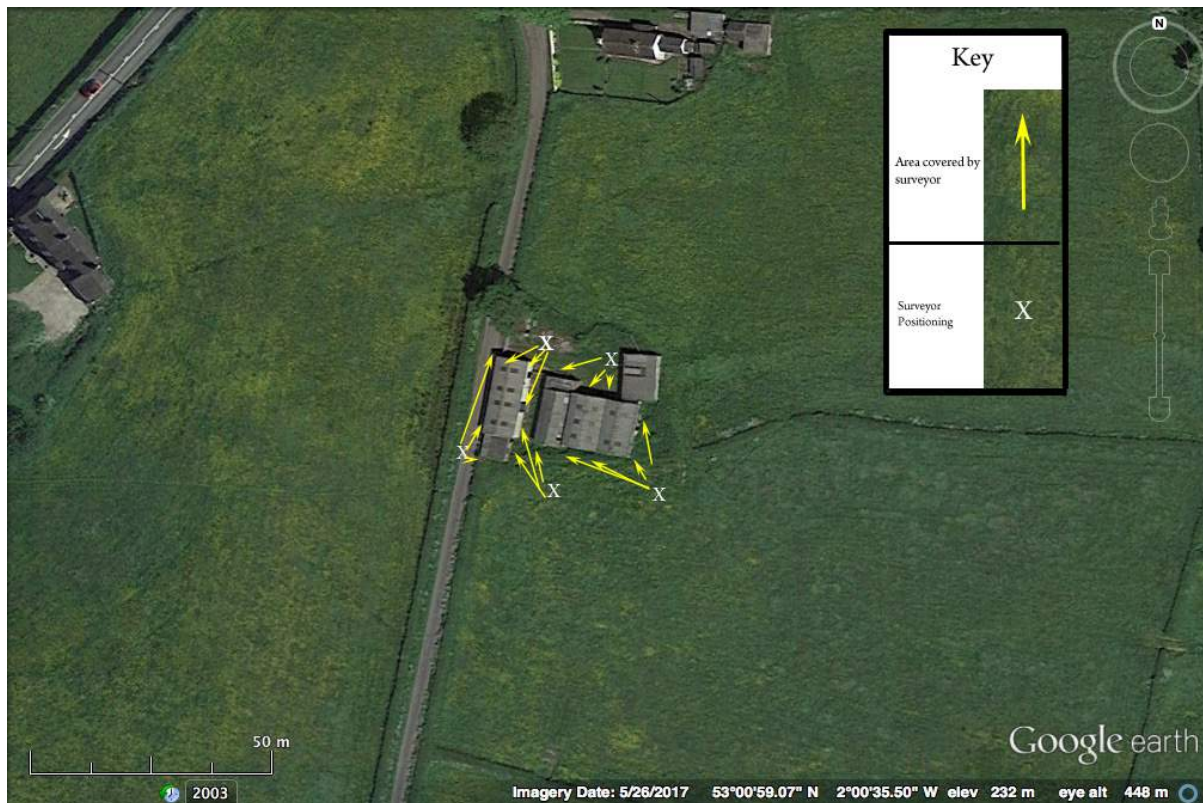
Figure 3: shows positioning of surveyors during nocturnal surveys. White 'X' symbols show position, yellow arrows show areas covered  
 (Image taken from Google Earth Pro: ©2017).

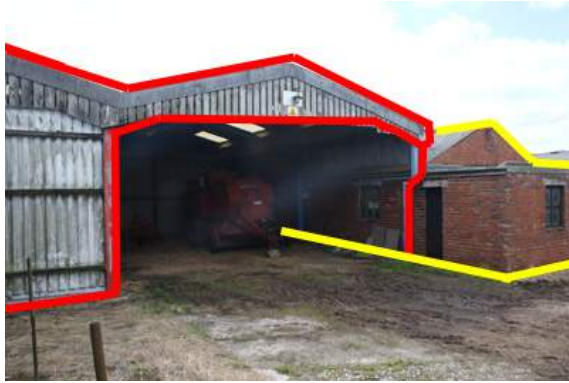
*Image 1: Red lines highlight Building 1, yellow lines highlight Building 2.*

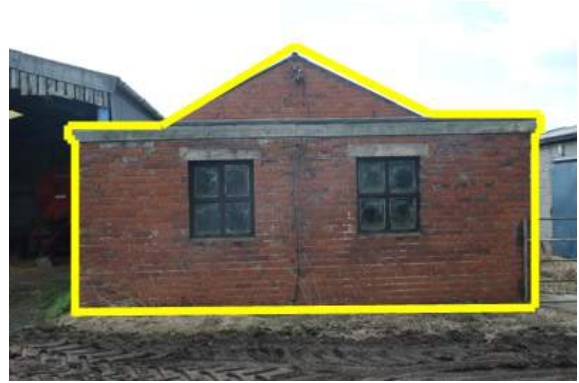
- 1.1.9 This building is a single storey brick-built barn with a steel-framed pitched roof that is covered with corrugated asbestos sheeting. A small utility room with a flat roof covered with felt adjoins the north-east facing aspect. This building was formally used to house cattle.

*Image 2: Yellow lines highlight north-eastern facing elevation of Building 2.*

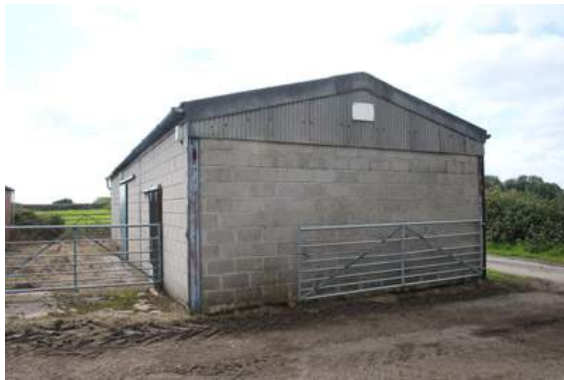
- 3.1.10 During the survey, gaps were noted between the doors, guttering, fascia and steel cladding, which could be suitable for use by crevice-dwelling bats. Internally, void-dwelling bats could utilise the steel roof structure for perch-feeding. This building is not suitable for a maternity bat roost.

*Image 3: Is representative of Building 3.*

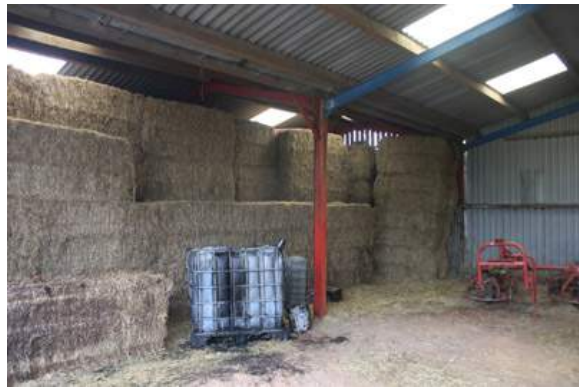
- 3.1.8 This structure is open-fronted, offering unrestricted access. Gaps between the corrugated metal roof sheeting and timber cladding are large enough for crevice-dwelling bats to enter, however given the barn's draughty conditions coupled with likely inconsistent temperature fluctuations, there is little chance that any bat species will utilise the structure for daytime, breeding or hibernation roosting. The steel and timber roof structure offers suitable perch-feeding opportunity (night roosting) for void-dwelling species such as brown long-eared *Plecotus auritus* and Natterer's, *Myotis nattereri* bats.

*Image 4: Shows steel framework construction of Building 1 and stacked hay bales.*

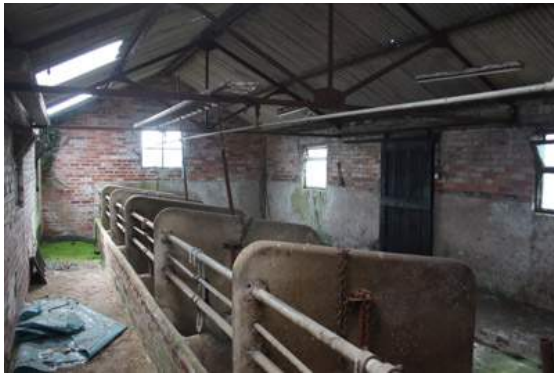
- 3.1.9 Access could be gained via open windows located along the north-west and south-east elevations. Furthermore, there are gaps along the ridge, between the corrugated metal roof sheeting and under the fascia. The external brickwork is in good condition and well-appointed, offering little in the way of roosting opportunity for bats. Internally, daylight could be seen shining through the roof and between the doors. Void-dwelling bat species could potentially use the steel framework for perch-feeding purposes. This building is not suitable for a maternity bat roost.

*Image 5: Shows internal aspects of Building 2. Note the steel framework and corrugated asbestos roof cover.*

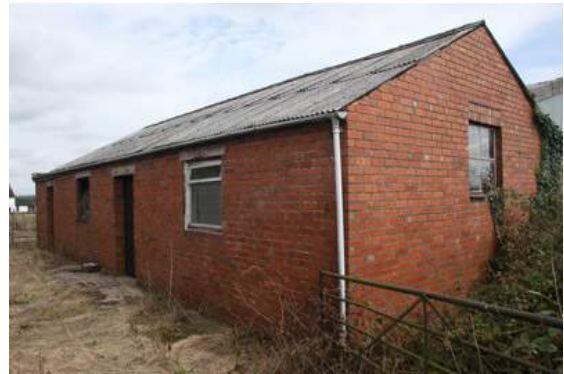
*Image 6: Shows the north-west and south-west facing elevations of Building 2.*
