## VALIDATION REPORT

MOSS FEEDS LIMITED DILHORNE

Report No: 13239/3 Date: November 2017

C AND C BUILDING SOLUTIONS LIMITED

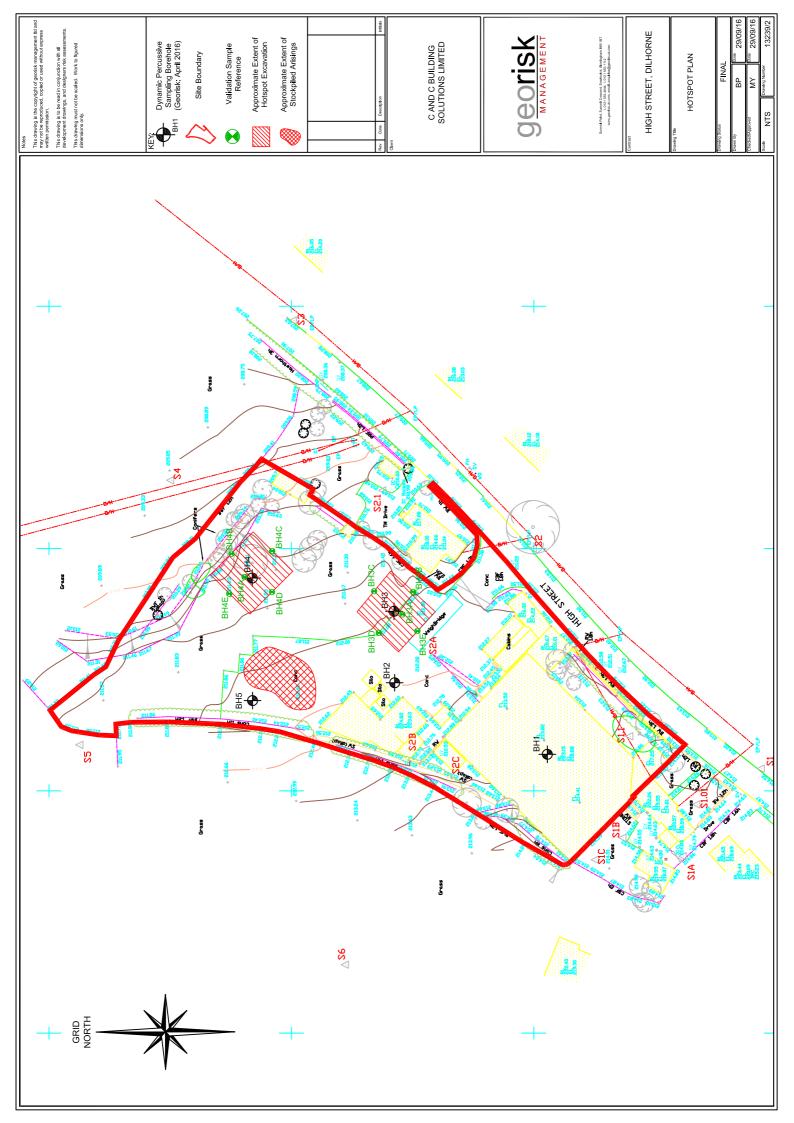
4.1.1 The ground investigation identified two hotspots of hydrocarbon impact in BH3 and BH4. Following site clearance, Georisk attended site to inspect the removal of the impacted material and to obtain samples from the sides and bases of the excavation. The extent of the excavations together with the sampling locations is shown on Drawing No. 13239/2 in Appendix A. Trial pit logs and photographic records are included in Appendix B.

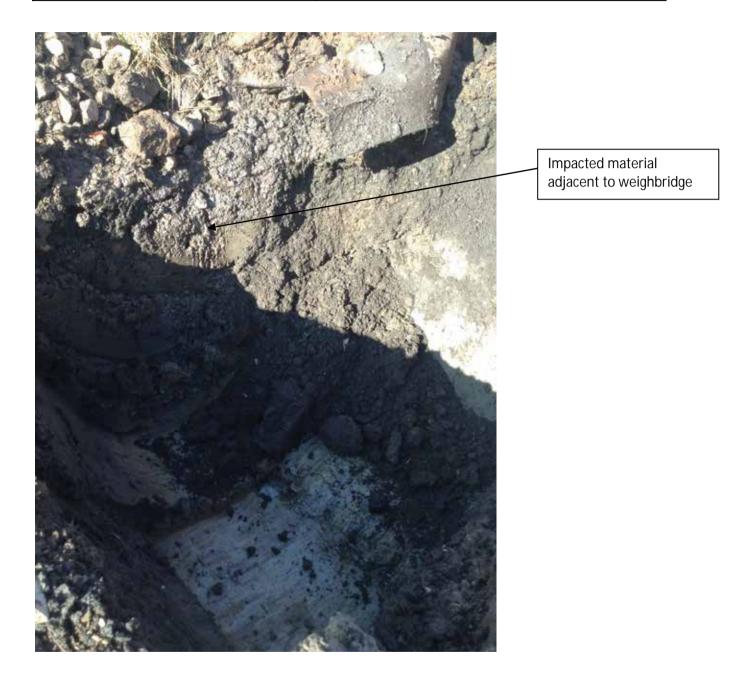
- 4.1.2 The excavation extended along the northern corner of the weighbridge in the centre of the site and extended down to a maximum depth of 2.3 m below existing ground level (begl). Visual evidence of impacted soils together with hydrocarbon odours was identified during this process in the Made Ground and the upper layer of the underlying natural clay. The impacted soil was removed from the excavation and stockpiled on a remnant concrete slab for subsequent removal off-site to a suitably licenced tip. Samples (reference BH3A-BH3E) were obtained from the sides and base of the excavation and sent to an accredited laboratory for testing.

Date: 28 September 2017 Site: Moss Feeds Limited, Dilhorne Hotspot BH3 Impacted material adjacent to weighbridge

- 4.1.5 The majority of test results are below the laboratory limit of detection and all results are below the relevant S4ULs for a proposed residential with plant uptake end use.
- 4.1.6 Following excavation and removal of hydrocarbon impacted material, the excavation was backfilled with site-won arisings.

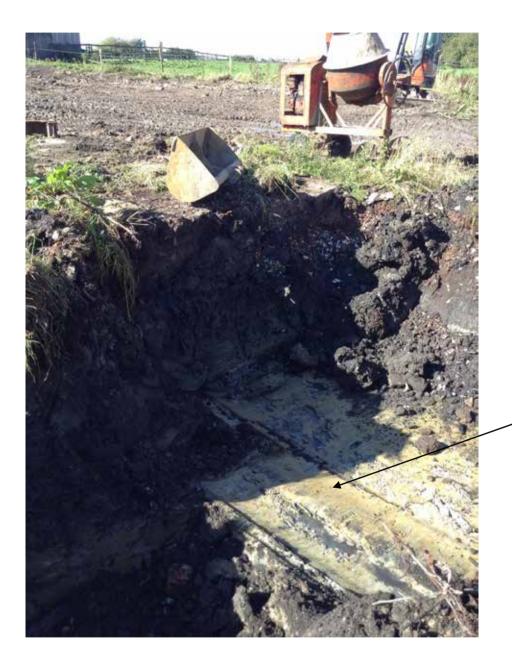
Date: 28 September 2017	Site: Moss Feeds Limited, Dilhorne Hotspot BH3	
-------------------------	---	--

No visual or olfactory evidence of contamination below 1.5 m begl.

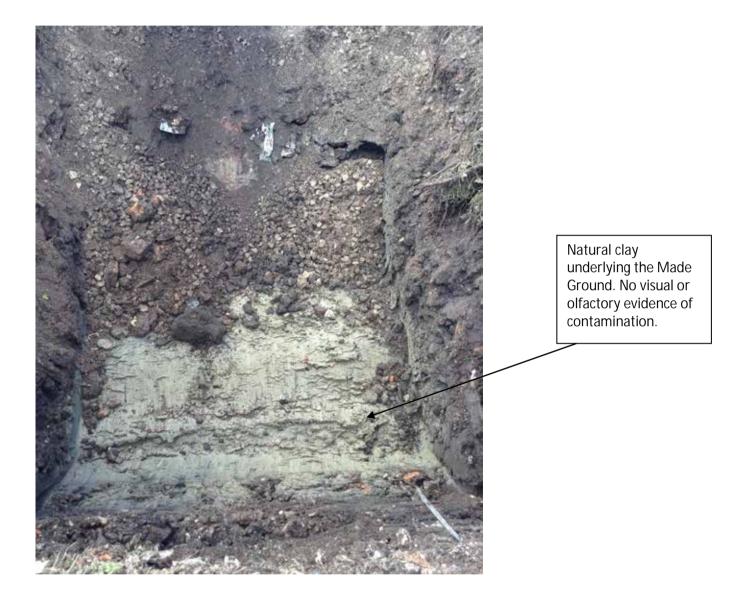
Date: 28 September 2017	Site: Moss Feeds Limited, Dilhorne
	Hotspot BH4

- 4.1.7 The excavation was carried out in the north-eastern part of the site and extended down to a maximum depth of 3.0 m below existing ground level (begl). No visual or olfactory evidence of impacted soils were identified during this process. Samples (reference BH4A-BH4E) were obtained from the sides and base of the excavation and sent to an accredited laboratory for testing.
- 4.1.8 The results of the soil testing from the vicinity of BH4 is summarised below and compared with assessment criteria for a proposed "residential with plant uptake" end-use assuming a 1 % soil organic matter content.
- 4.1.9 The results of the confirmatory testing provided by the laboratory are included as Appendix C to this letter report.

- 4.1.10 All test results are below the laboratory limit of detection and below the relevant S4ULs for a proposed residential with plant uptake end use.
- 4.1.11 Following excavation, the excavation was backfilled with site-won arisings.

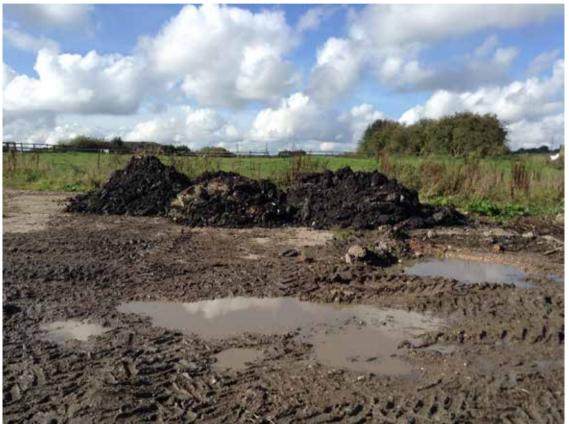
Site: Moss Feeds Limited, Dilhorne Stockpiled impacted strata

Impacted material stockpiled on concrete slab for off-site disposal

- 6.1 The field observations made by Georisk, supported by validation testing carried out, confirms that the pre-construction remedial works have been satisfactorily carried out in accordance with the Outline Remedial Action Plan. Gross hydrocarbon impacted soils have been excavated to stockpile for subsequent off-site disposal.
- 6.2 As per the requirements of the Outline Remedial Action Plan, construction phase remedial works will be required (as discussed in Section 5).

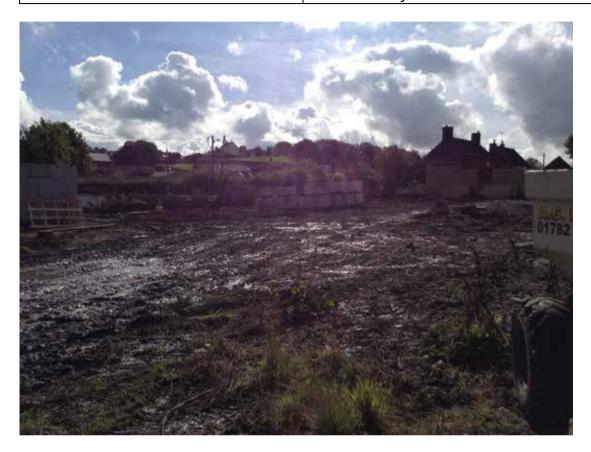
Site: Moss Feeds Limited, Dilhorne Current Site Layout

- 2.4 Stockpiled scrap materials, including an old fuel tank, vehicle, engine parts, building materials, tyres, car batteries and oil drums together with demolition rubble, were present at various locations in May 2016. These had been removed by the time of the pre-construction remediation works in September 2017 as shown on the photographic records in Appendix B.
