Barn/Outbuilding,  
The Hollins,  
Horton,  
Leek.

On behalf of Mr Barnacle.

Report number: IA-003

**Bat Report**

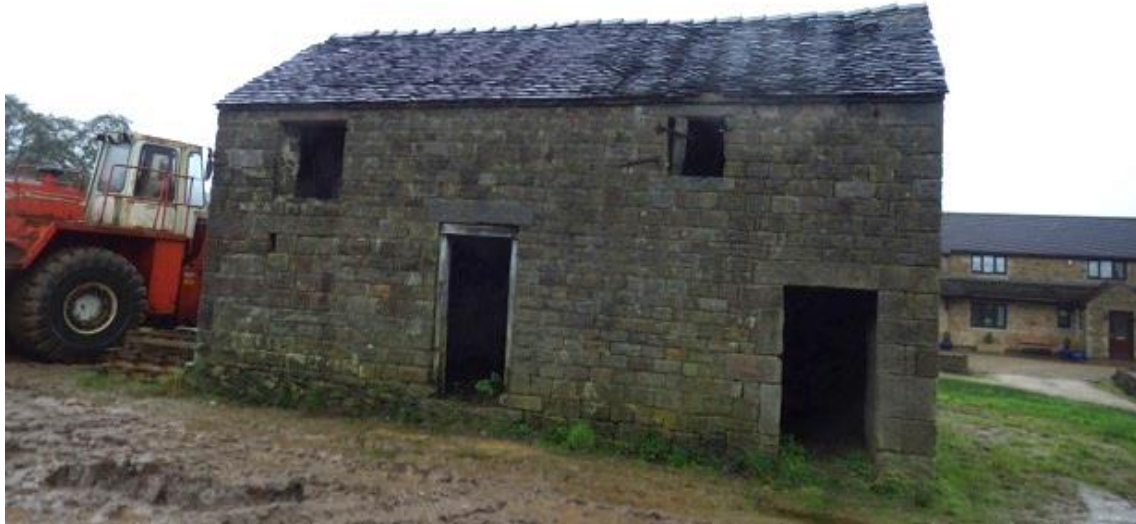
Plate 1. The barn building set in a farmyard/commercial environment, the building is isolated, with no bat foraging or commuting habitat adjacent to the barn.

Externally the target building demonstrated poor bat roost potential (see plates 1,2 and 3).

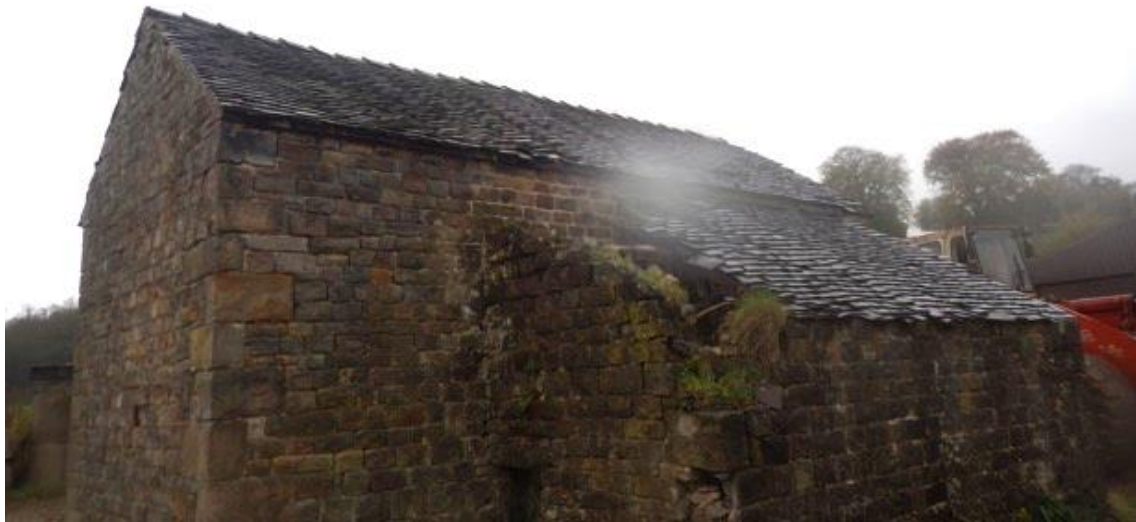
Plate 2. The single storey piggery leads from the rear wall of the barn, it is in a state of disrepair, with large holes occurring in the roof and walls, allowing wind and rain to enter the area.

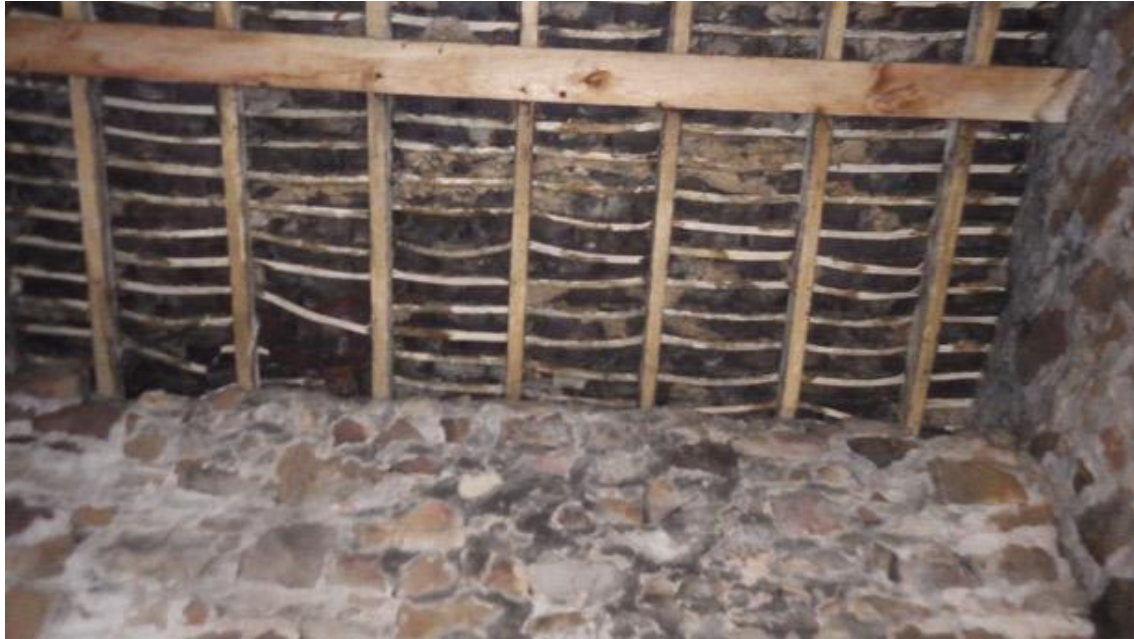
Plate 3. The underside of the roof is open and visible for inspection.

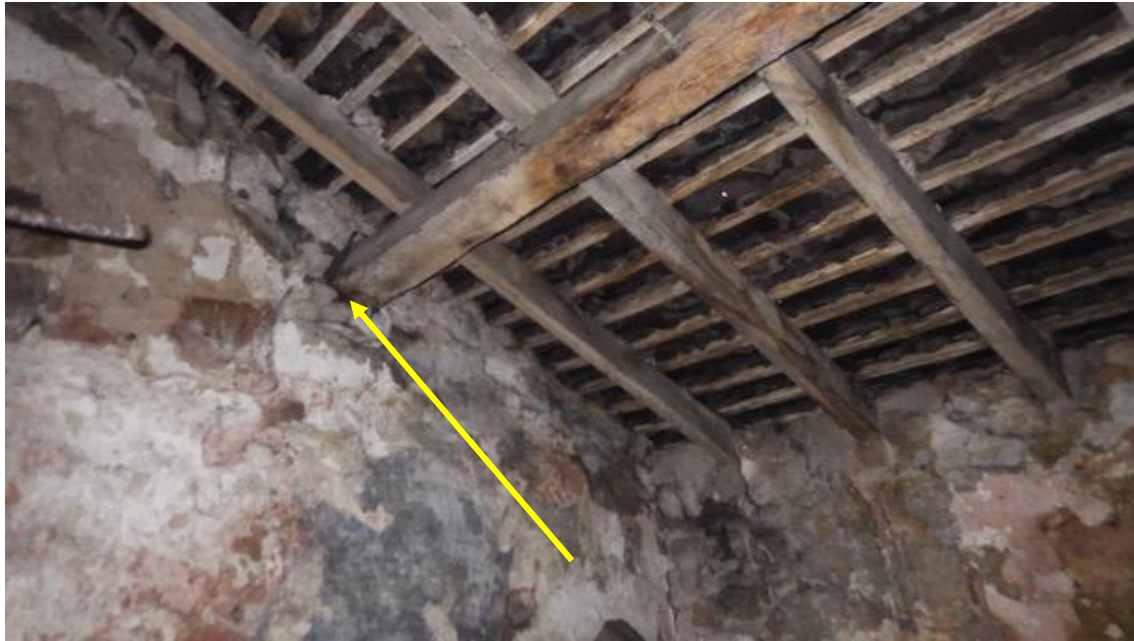
Plate 4. The underside of the roof which is supported by a beam and lath structure is open for inspection, the main beams are tightly fitted to the walls, some small gaps were checked using an endoscope, no signs of bats were found.

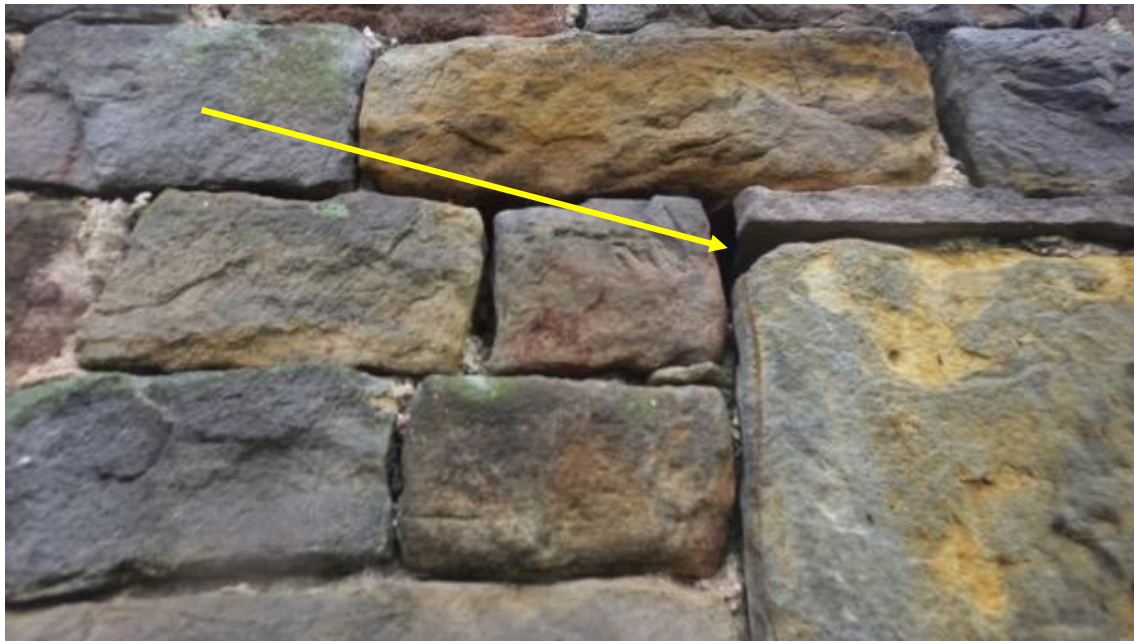
Plate 5 The external walls were mainly well pointed which sealed the gaps, however some gaps did occur, as above, these were examined closely with an endoscope which allows close observation. No signs of bat presence or usage were found.

However, some cracks and crevices were located within the building and external walls, these may be used in an infrequent basis as a temporary roost during foraging activity. Therefore it is suggested that prior to the works commencing, the construction operatives are given a bat safeguard toolbox talk as provided in appendix 1 of this document.

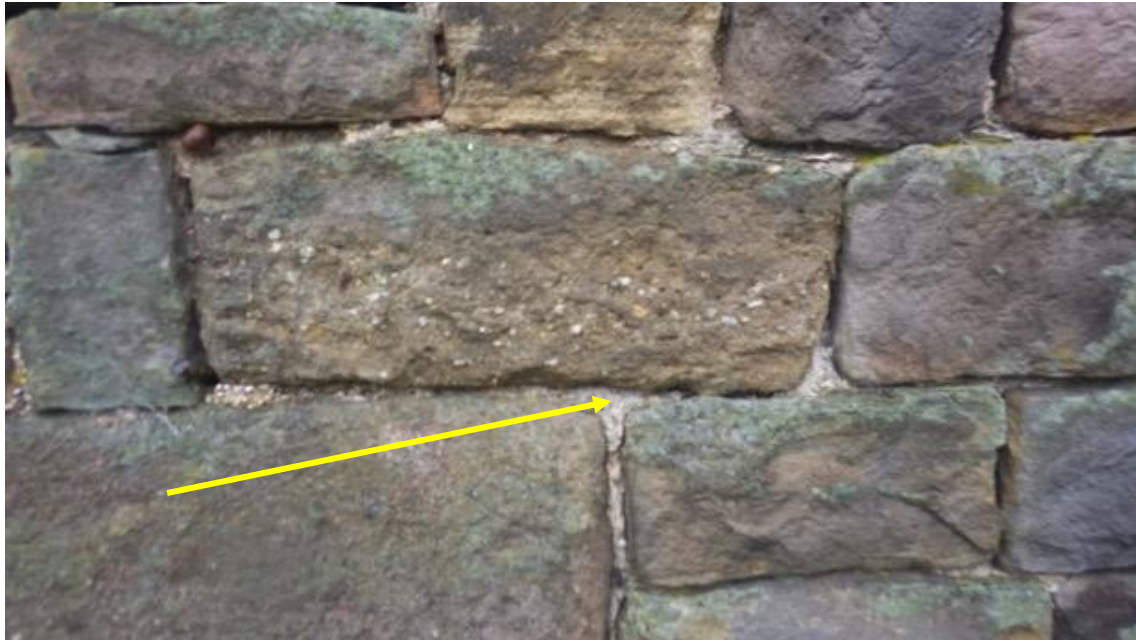
Plate 6 As mentioned in plate 5 the vast majority of the external brickwork was pointed, with cement mortar which creates shallow joins, which doesn't provide a sheltered roost habitat.

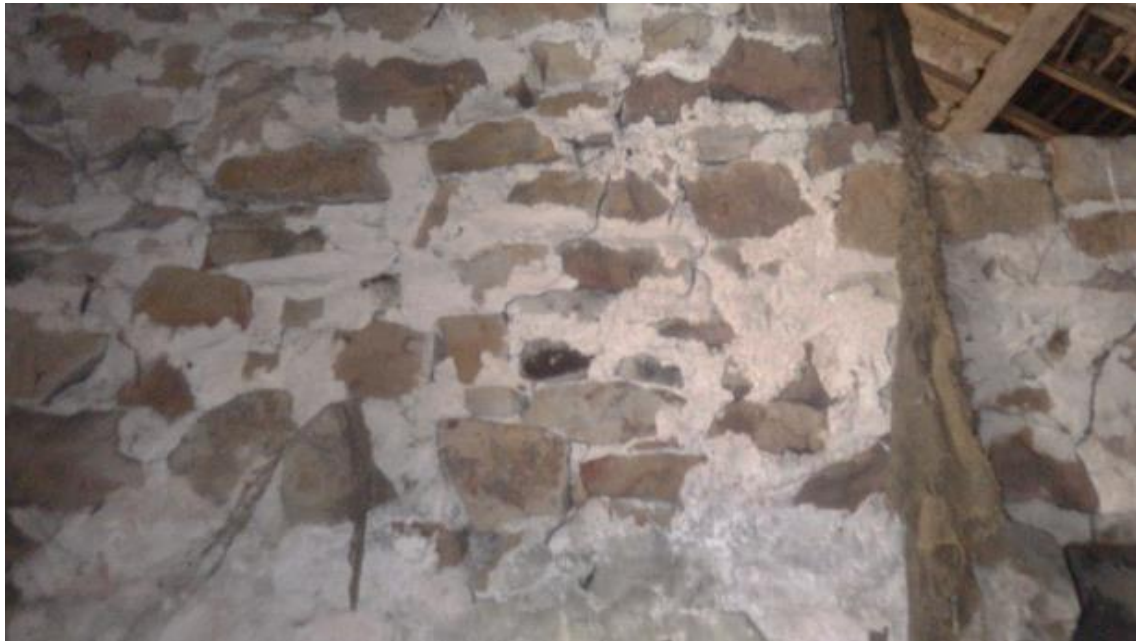
Plate 7 The internal walls are well sealed with cement mortar providing little in the way of bat roost habitat.

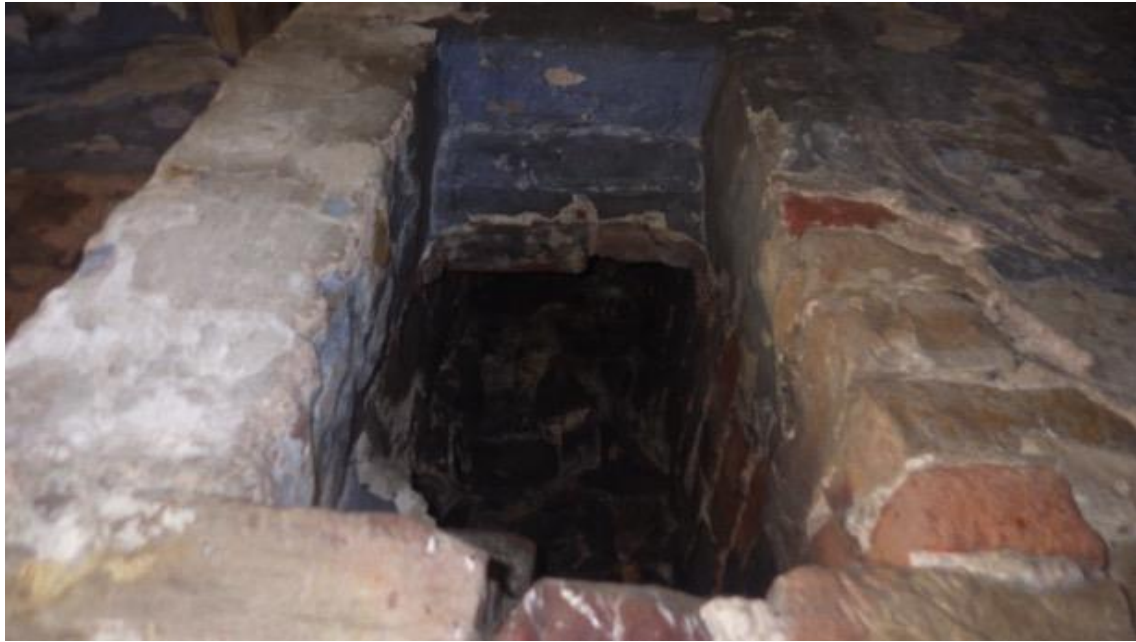
Plate 8 The building internally had a fireplace, and chimney, the area was checked via endoscope, up to the 2m reach of the probe.

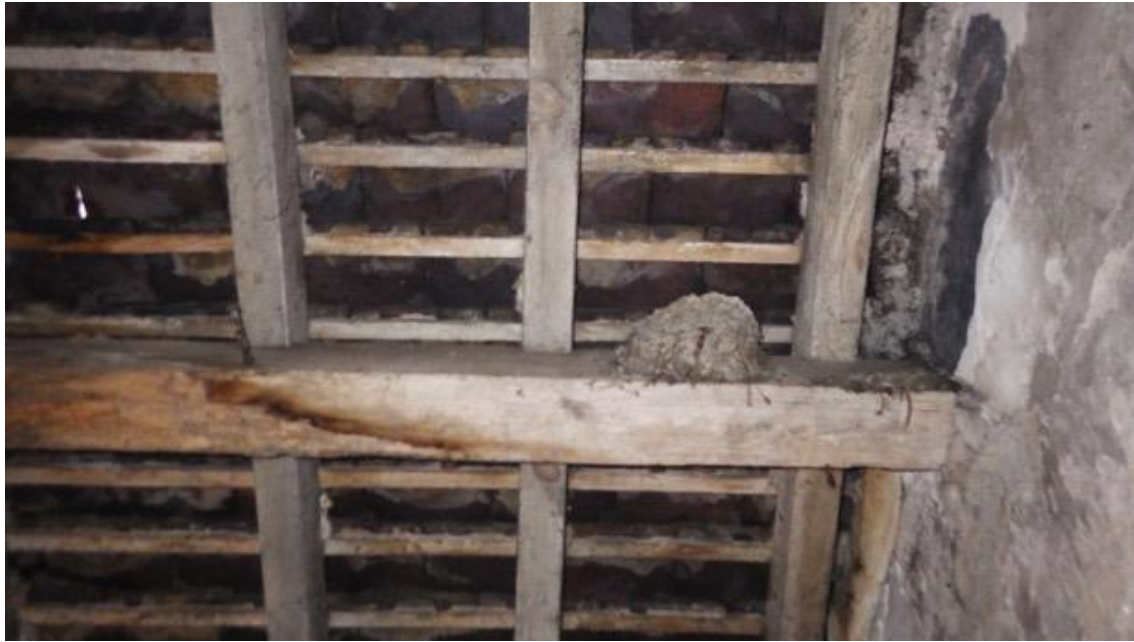
Plate 10 A barn swallow nest was recorded on a roof beam in a building, this looked to have been used during the last breeding season given the level and state of droppings.

Given that barn swallow nesting activity (nest and droppings) was located within the barn it is suggested that a number (3 suggested) species specific nest boxes, as shown below, are erected on the wider site, in a location that allows free access for the birds.

Additionally, if works are being undertaken within the bird-nesting season (April-End August), given the dynamic nature of bird colonisation, a bird nest check should be undertaken by a suitably experienced ecologist prior to the commencement of works.
