**PRELIMINARY ROOST ASSESSMENT
& DUSK EMERGENCE BAT SURVEY**

**SMITHY POOL,
CONSALL, STAFFORDSHIRE**

AUGUST 2017

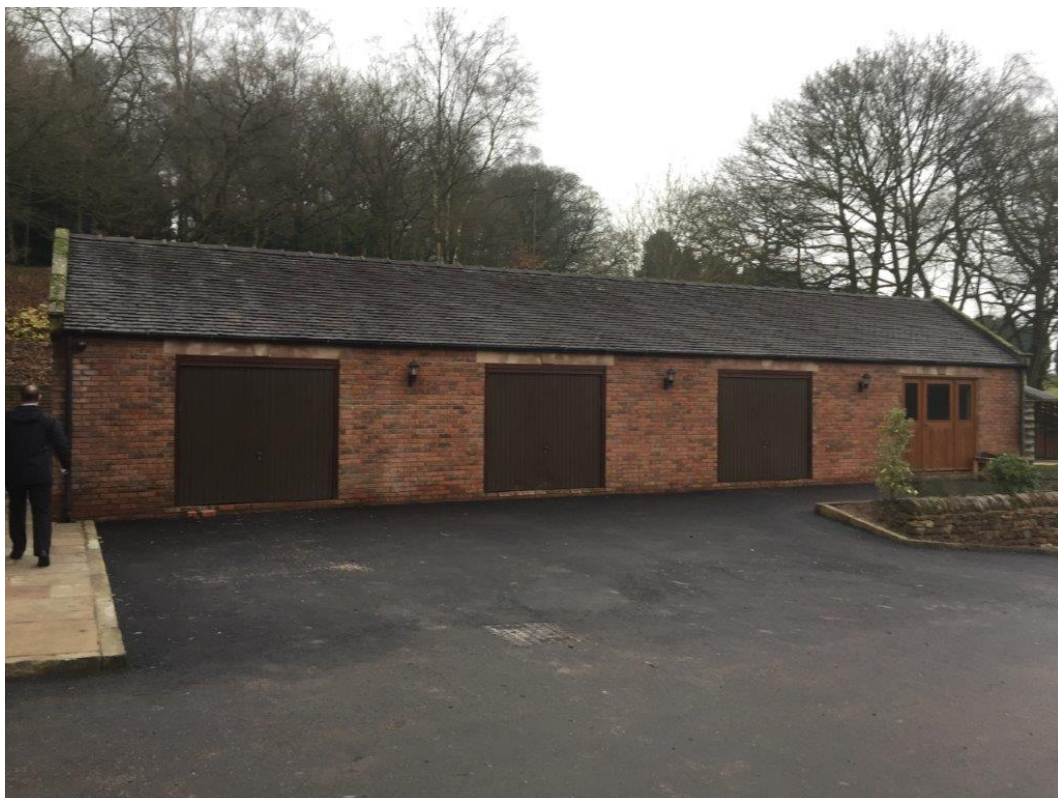
The building was a modern single-storey building which was constructed from block and brickwork with sandstone lintels above the doors and windows (Plate 1). The pitched roof comprised clay tiles with a felted flat top design (i.e. no ridge or apex).

Plate 1: Eastern (front) side of the outbuilding at Smithy Pool, Consall, Staffordshire.

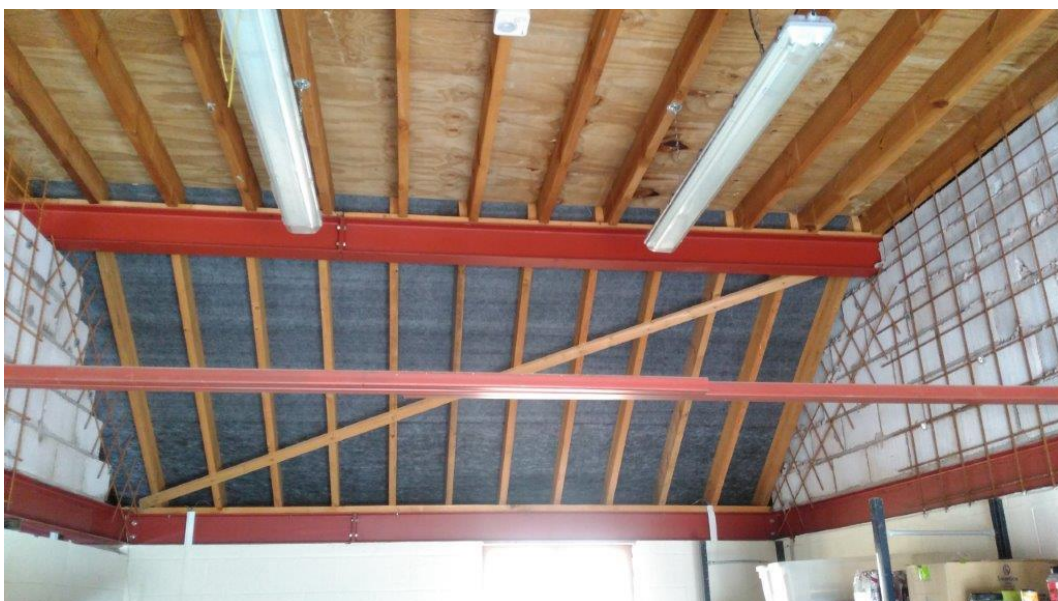
The building was divided into three store rooms (one of which had a walk-in refrigerator), toilet facilities and a reception room (Appendix 1). The reception room had plastered walls and ceiling which followed the roof line. The store rooms were open to the roof which was lined with breathable membrane (Plate 2). The only roof space present was a small accessible open roof void above the toilet room.

The building was regularly used inside and was well maintained. The roof membrane appeared in good condition with no obvious access gaps or tears which would allow bats to access the inside of the building.

Plate 2: Internal structure of the roof with metal and wooden beams, lined with boards / breathable membrane.

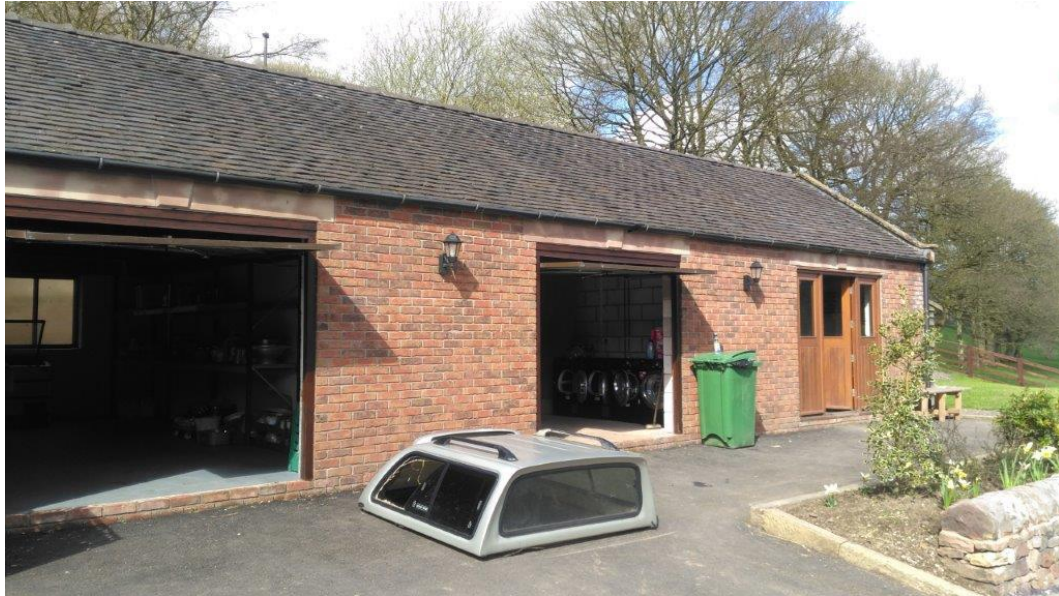
Externally, the roof was covered with clay tiles which were in generally good condition. The central part of the roof was flat and covered in felt. The building had partial 'ridge' tiles along the top of the eastern side of the roof (Plate 3). Where the flat roof joined the western pitch of the roof (Plate 4 & 5), there was lead flashing which had several large gaps along the length of the building (Plate 6). There were numerous gaps under the 'ridge' tiles along the top of the eastern pitch of the roof, in addition to gaps under lifted and missing tiles on both the eastern and western sides. There were no soffits, eaves or bargeboards present on the building.

Plate 3: The roof of the outbuilding with 'ridge' tiles and clay roofing tiles (eastern aspect).

Although it is considered unlikely for roosting bats to be present, it is recommended that a standard precautionary approach is undertaken during removal of tiled sections of roof. Roof tiles, ridge tiles and flashing should be lifted carefully by hand, and checked underneath for any evidence of roosting bats.

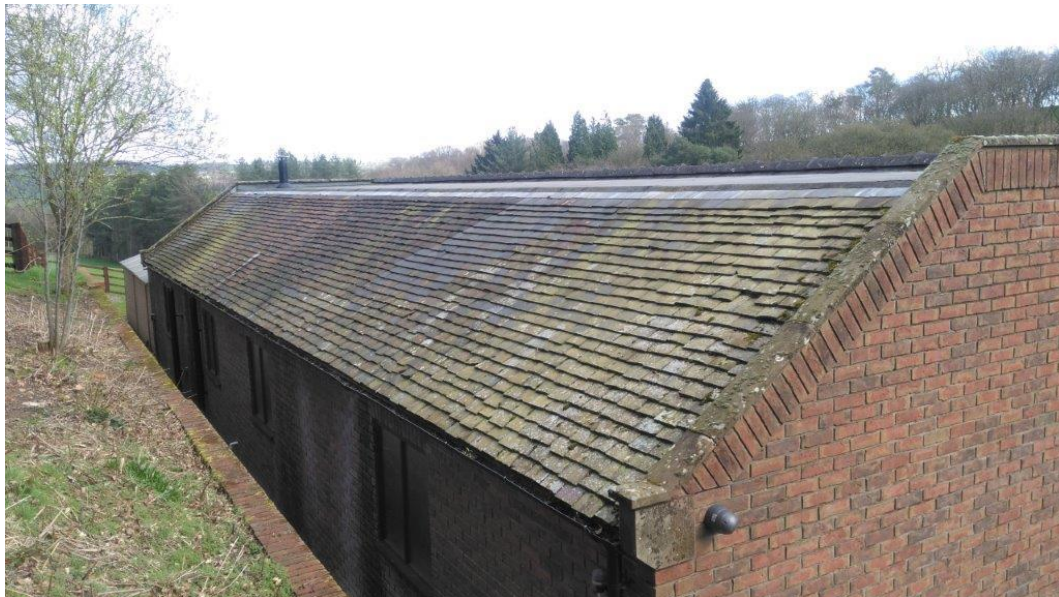
Plate 4: The western side of the roof with lead flashing and clay roofing tiles.

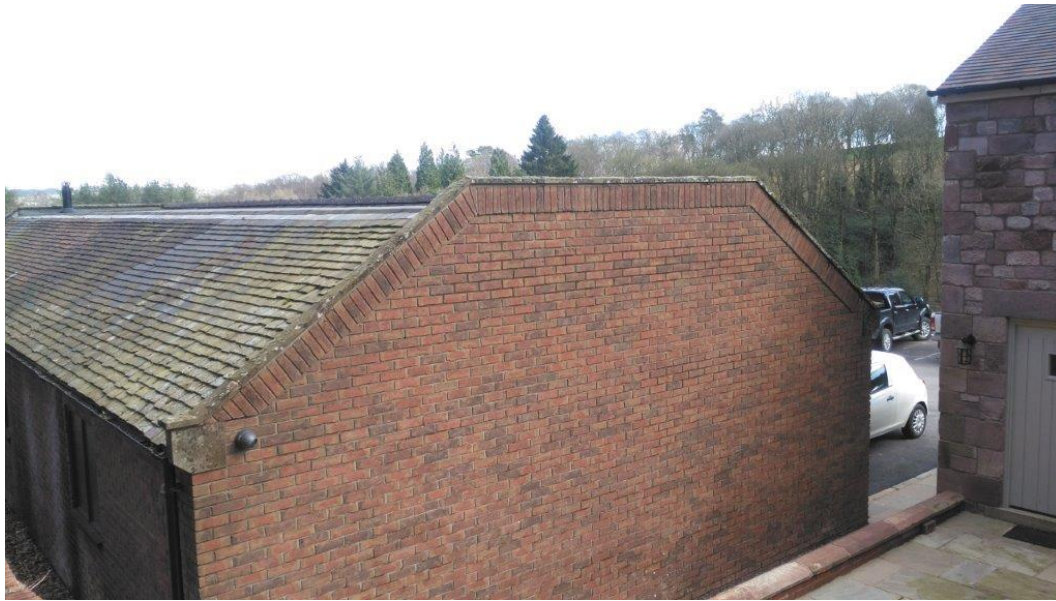
Plate 5: Northern side of the building showing the design of roof, with the central flat felt roof and the absence of soffits, eaves or bargeboards.

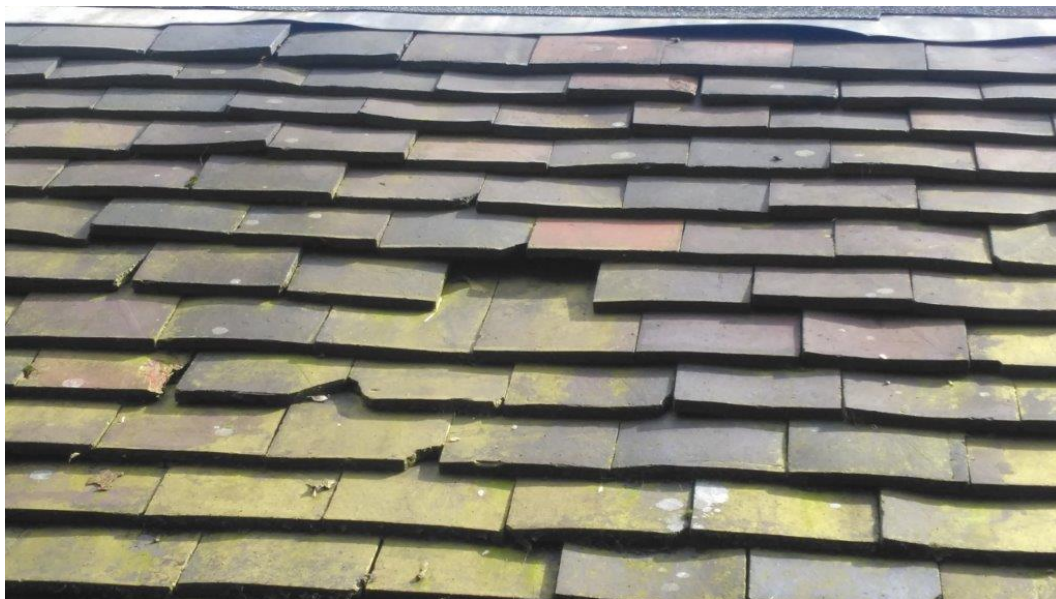
No evidence of bats was found internally or externally in any section of the building. However, the presence of gaps both under the 'ridge' tiles and roofing tiles provide potential opportunities for roosting bats.

Plate 6: Example of missing tile and gaps under the lead flashing which could be used bats to access a roost between the tiles and membrane (western side).

If any evidence of bats (including bat droppings which are of similar size to mouse droppings, but crumble when pressed) is found or suspected during the work, work must stop immediately and further advice sought from a licenced bat ecologist. In this case, a licence may be required before work can legally proceed.
