Bat and Barn Owl Survey and Report

STONE BUILDING, CHATSWORTH FARM, LASK EDGE

Jonathan Ayres CEnv MCIEEM FLS | 29/06/2017

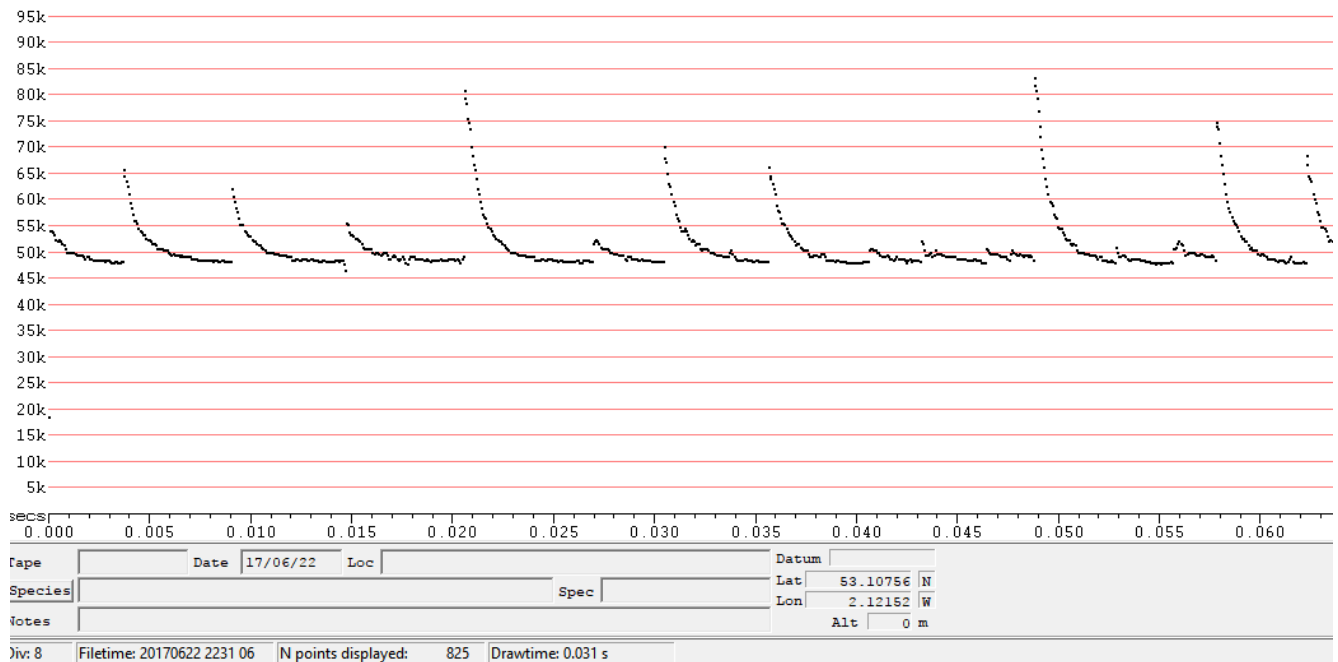
Figure 2 – Common pipistrelle and soprano pipistrelle calls, showing a number of social calls.
