**PRELIMINARY ROOST ASSESSMENT  
& BAT ACTIVITY SURVEYS**

**BARN AT IVY HOUSE FARM,  
ROWNALL, WETLEY ROCKS, STAFFORDSHIRE**

**AUGUST 2017**

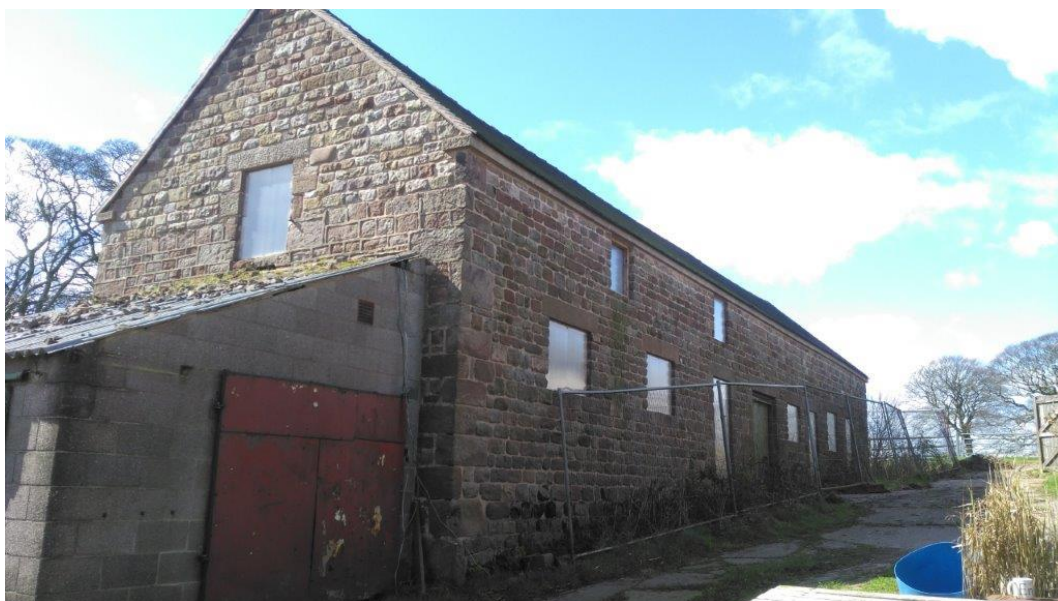
Plate 1: North side and east gable of the stone barn at Ivy House Farm

The barn was a large single-storey building which was constructed from stone and dated between the 18<sup>th</sup> and 19<sup>th</sup> century (Plate 1 & 2).

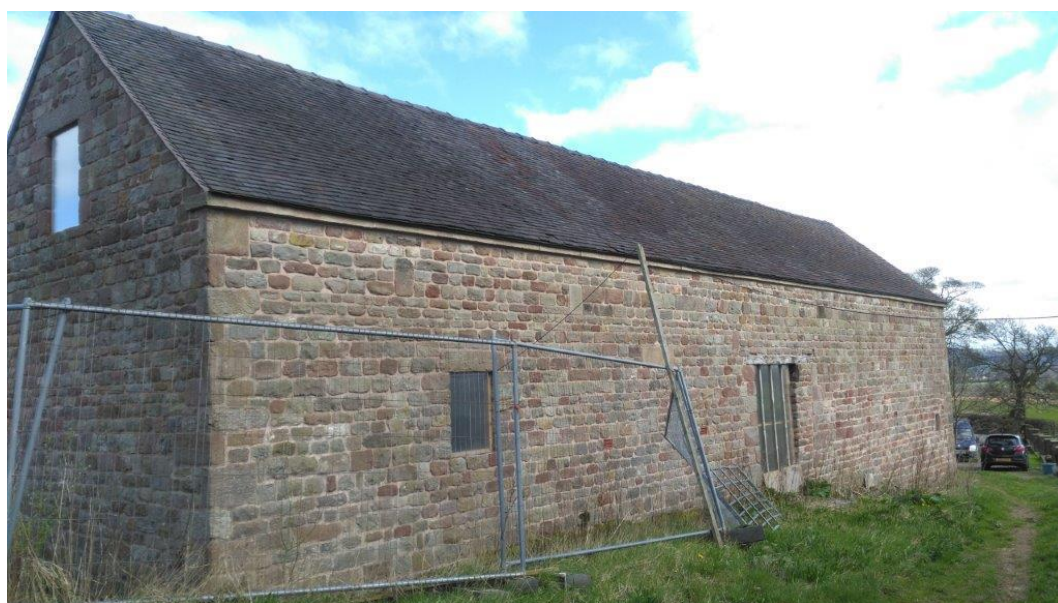
Plate 2: Southern side and west gable of the stone barn at Ivy House Farm

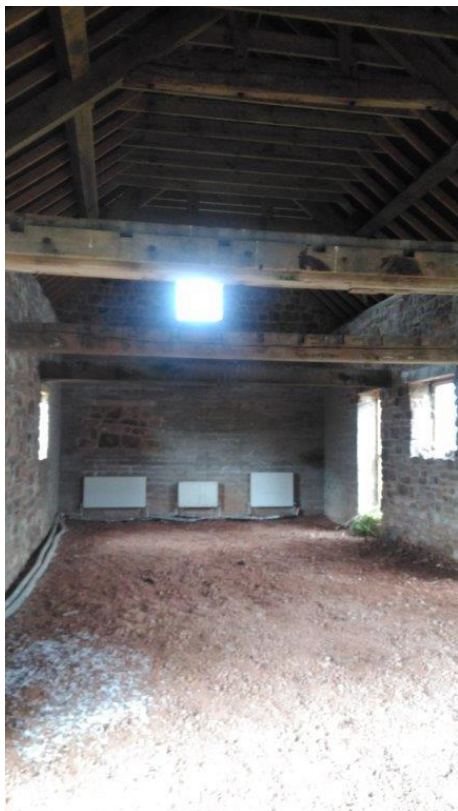
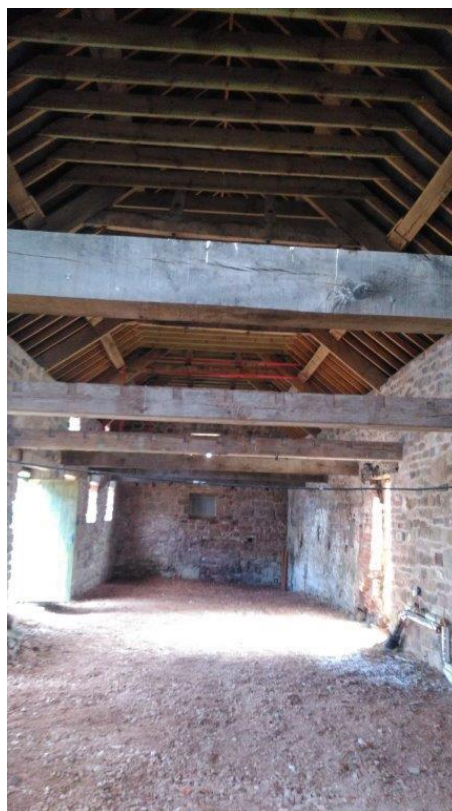
Plate 3: Internal views of the barn showing radiators (left)

The barn was open to the roof inside (i.e. no roof space present), with a large internal void of approximately 20m in length x 6m in width (Plate 3). The building was not used for storage or any other purpose at the time of survey but it was noted that there were radiators running to keep the building dry; this may also have the effect of raising the internal temperatures slightly.

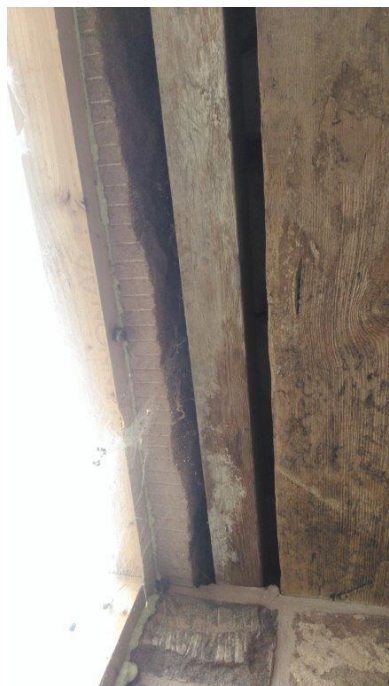
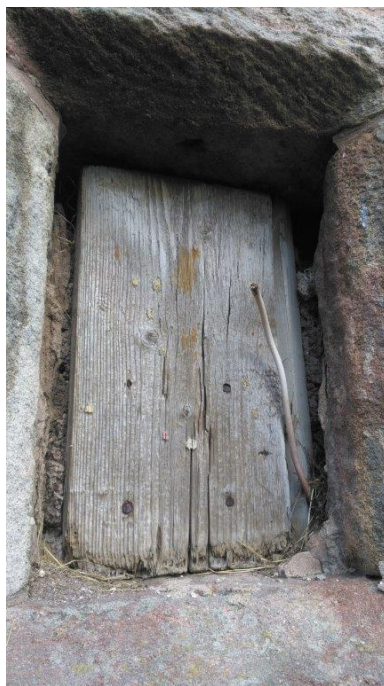
Plate 4: Gaps potentially suitable for roosting bats between wooden lintel inside the windows of the barn (left) and in wall cavity on external wall of barn (right).

All the windows and doors were covered with translucent Perspex boards, which made the barn quite light and draught-free inside. The lintels above the doors and windows were constructed from either sandstone or wood. Above some of the wooden window lintels there were gaps (approximately 40mm) between the timbers (Plate 4) which have potential to be used by roosting bats.

There were some crevices in the stonework and above lintels, mostly inside the building, which will be lost during the conversion work. Whilst there was no obvious evidence of bats using these crevices, there is a small risk that bats could roost in such crevices at other times of year. It is therefore recommended that as a precaution, a licensed bat worker undertakes an endoscope inspection inside the crevices immediately prior to re-pointing. If any evidence of bats is found during this pre-works check, a licence would be required before the crevice is re-pointed.

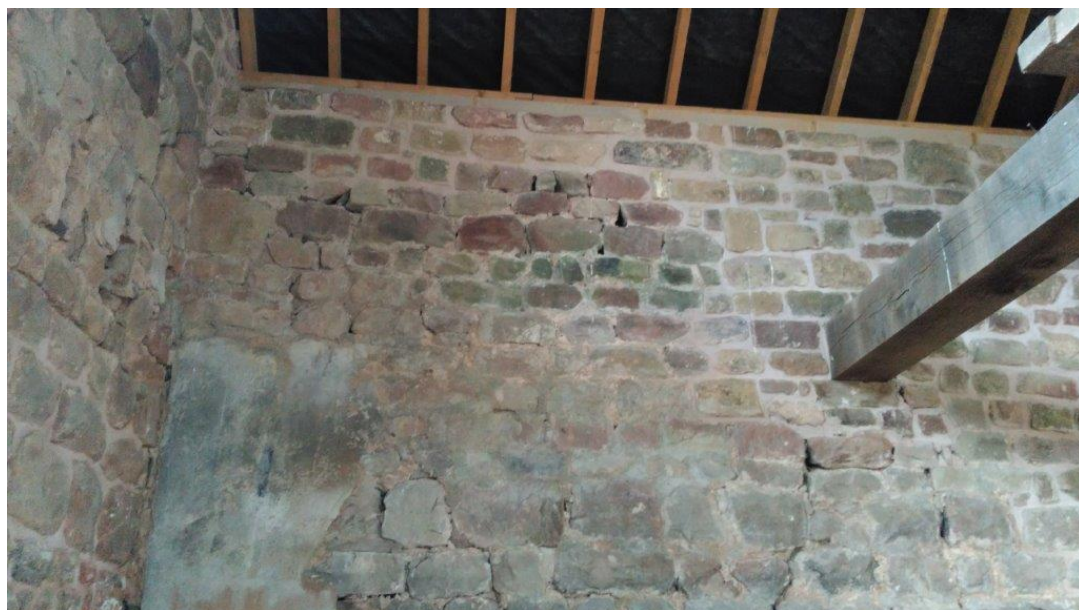
The roof was lined with a breathable membrane, and appeared to have been re-roofed within the last 15 years. There had been some fairly recent structural work to the barn, with re-pointing of some of the internal walls and new roof beams. Despite this, there were still crevices present within the internal stone walls of the barn, at a range of heights (Plate 5), which could be used by roosting bats.

Plate 5: Crevices within the internal stonework of the barn that could be used by roosting bats.

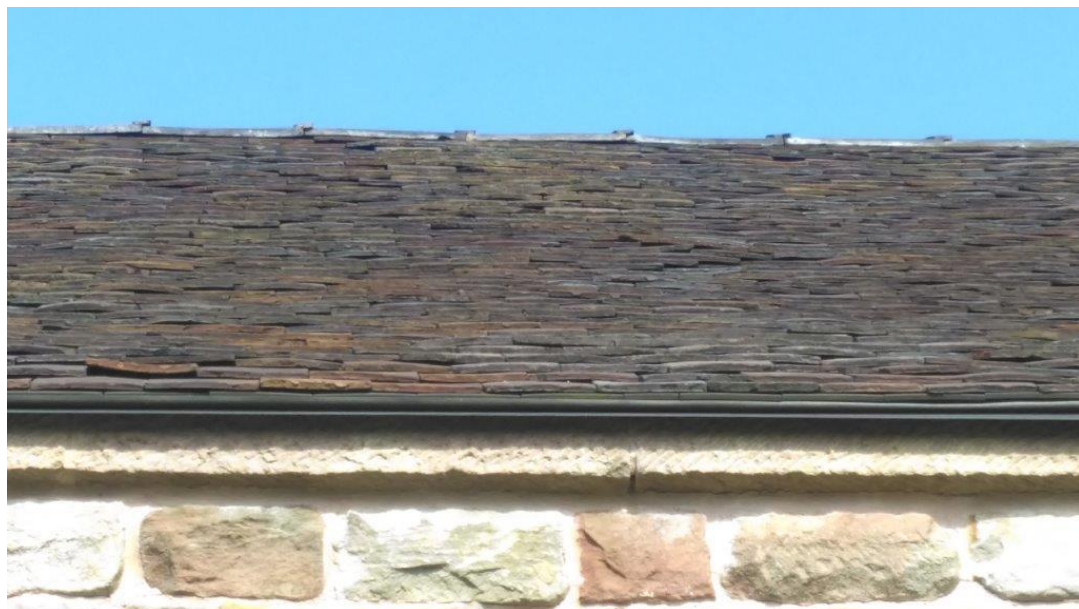
Externally, the barn had a single-pitched roof which was covered with clay tiles. Overall, the roof appeared to be well maintained although there were numerous gaps under lifted and missing tiles that were large enough to potentially be used by bats. There were several gaps under the ridge tiles on both the north and south sides of the building (Plate 6), as well as gaps under the end tiles on the gable ends which could allow birds and bats access to the wall tops and potentially into the internal space. The external walls were in good condition, appearing to have been re-pointed in recent years.

Plate 6: Gaps under ridge tiles and roof tiles of the barn (southern aspect) which could be used by roosting bats.

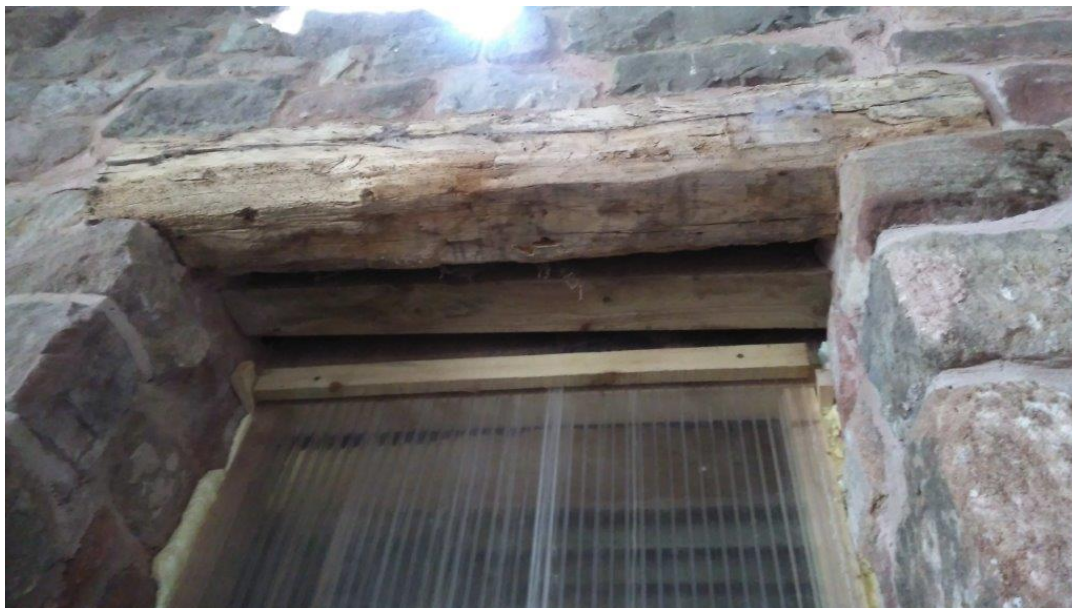
Several house sparrows *Passer domesticus* were seen flying inside the barn with at least two active nests above a wooden window lintel (Plate 7) and within a wall cavity inside the building.

Plate 7: Active house sparrow nest above the wooden window lintel inside the barn.

As there are active house sparrow nests present, any works undertaken which may affect the nesting sites should be programmed between October and February to avoid harming active nests. It is recommended that a check for nesting birds is undertaken by an ecologist prior to any works on the building, to ensure 'out of season' breeding birds are not present.

As house sparrows are a 'red list' species which have suffered serious decline, partly due to loss of available nest sites in buildings, it is recommended that at least two sparrow terrace nest boxes (32mm entrance hole) are fixed to the external walls to provide nest sites for sparrows in future. The boxes should be installed on the north and east walls to avoid strong sunlight and high winds, and placed at 2-4m in height. 'Woodcrete' sparrow terrace boxes may be preferable to timber as this material is longer lasting. An example may be found at the following link: <http://www.nhbs.com/title/174850/1sp-schwegler-sparrow-terrace>

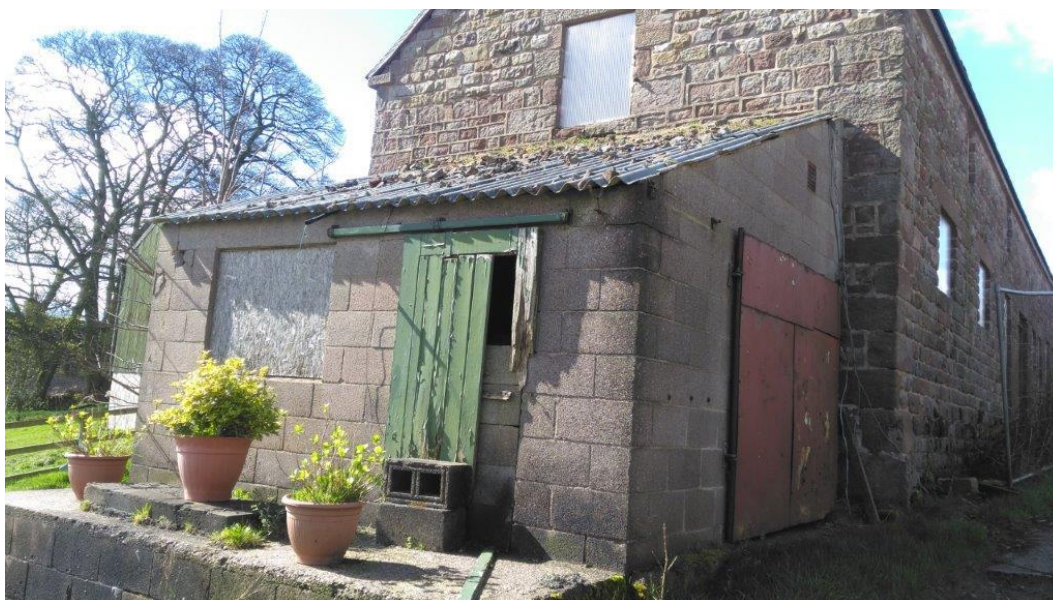
An attached single-storey lean-to shed was present at the eastern gable end of the barn, which was constructed of concrete blocks and had a corrugated asbestos roof (Plate 8). There was a single window which was boarded up, and a wooden door which had two wooden planks missing, potentially allowing bat or bird access inside. Although access was not possible at the time of the

survey, due to the structure of the lean-to, it is expected that bat roosting potential inside the lean-to is limited. No evidence of bats was found externally.

Plate 8: The single-storey lean-to which was attached to the eastern gable end of the barn could not be accessed for internal inspection.

The proposals involve the conversion of the barn into a two-storey dwelling. The inside of the barn will become living space. The single storey lean-to on the east side of the barn will be demolished.

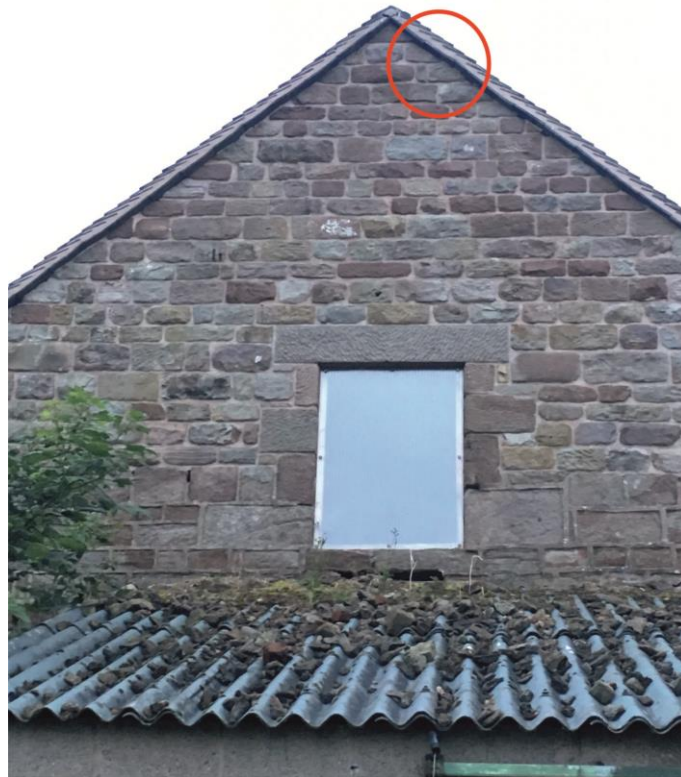
A dawn re-entry survey of the barn was undertaken on 2 August 2017 and found one common pipistrelle returning to roost in the east gable end at 46 minutes before sunrise, in a similar location to the bat which had emerged during the July survey. The bat appeared to enter a crevice near the apex (Plate 9 for approximate location). It appears likely the access point would allow the bat to roost on top of the gable wall near to the apex.

Plate 9: The area on the east gable wall where the bat emerged and returned during the dusk and dawn surveys. Likely roost site on top of gable wall (beneath tiles).

The dusk emergence and dawn re-entry surveys found that the east-facing gable of the barn supports a non-breeding day roost for an individual common pipistrelle bat.

It is recommended that the bat roost in the east gable wall is retained in-situ. The roost is currently being used by an individual common pipistrelle, and whilst it is of low conservation significance, it is legally protected even when the bat is not present.

As re-roofing has been undertaken in recent years, and the gable wall is in good condition, it is assumed that there is no need to disturb the roost as long as re-pointing is avoided in this area, and there is not due to be any external lighting on this end of the building.

A licence from Natural England **would** be required if there is any unavoidable work to the east gable end, which has potential to:
