MR M MELLOR

STAR BANK, OAKAMOOD

BAT EMERGENCE / RE-ENTRY SURVEY

July 2017

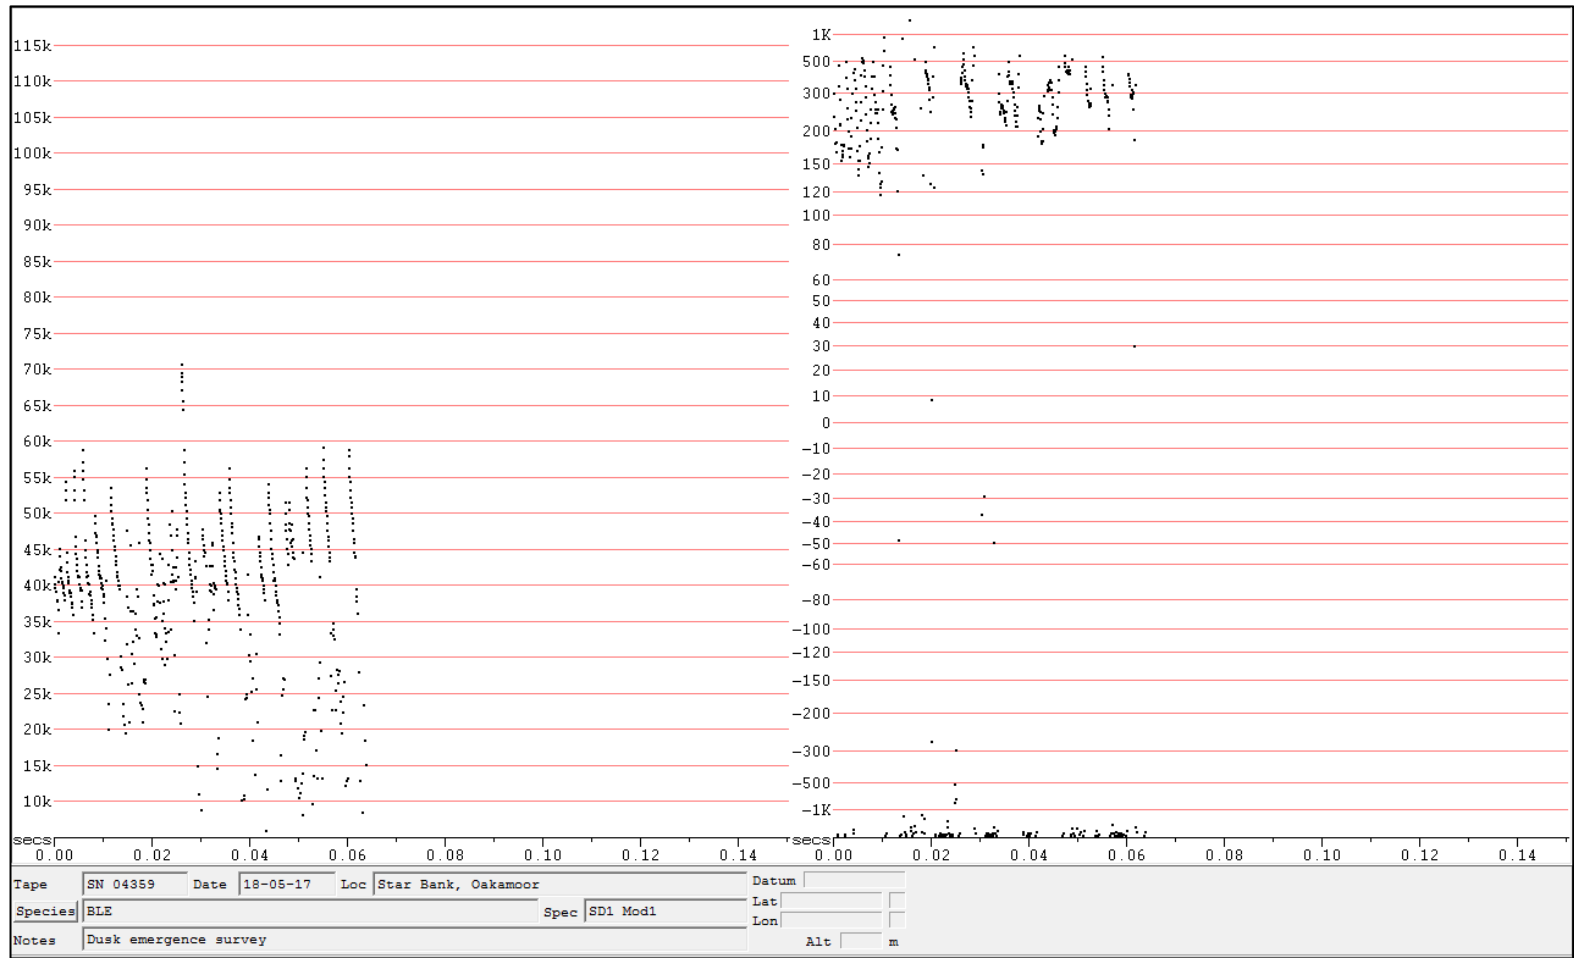
Sonogram 1: Echolocation calls of brown long-eared bats found roosting in the barns.  
Recorded by Anabat SD1 and analysed using Analook (view: F7 compressed, frequency & slope).

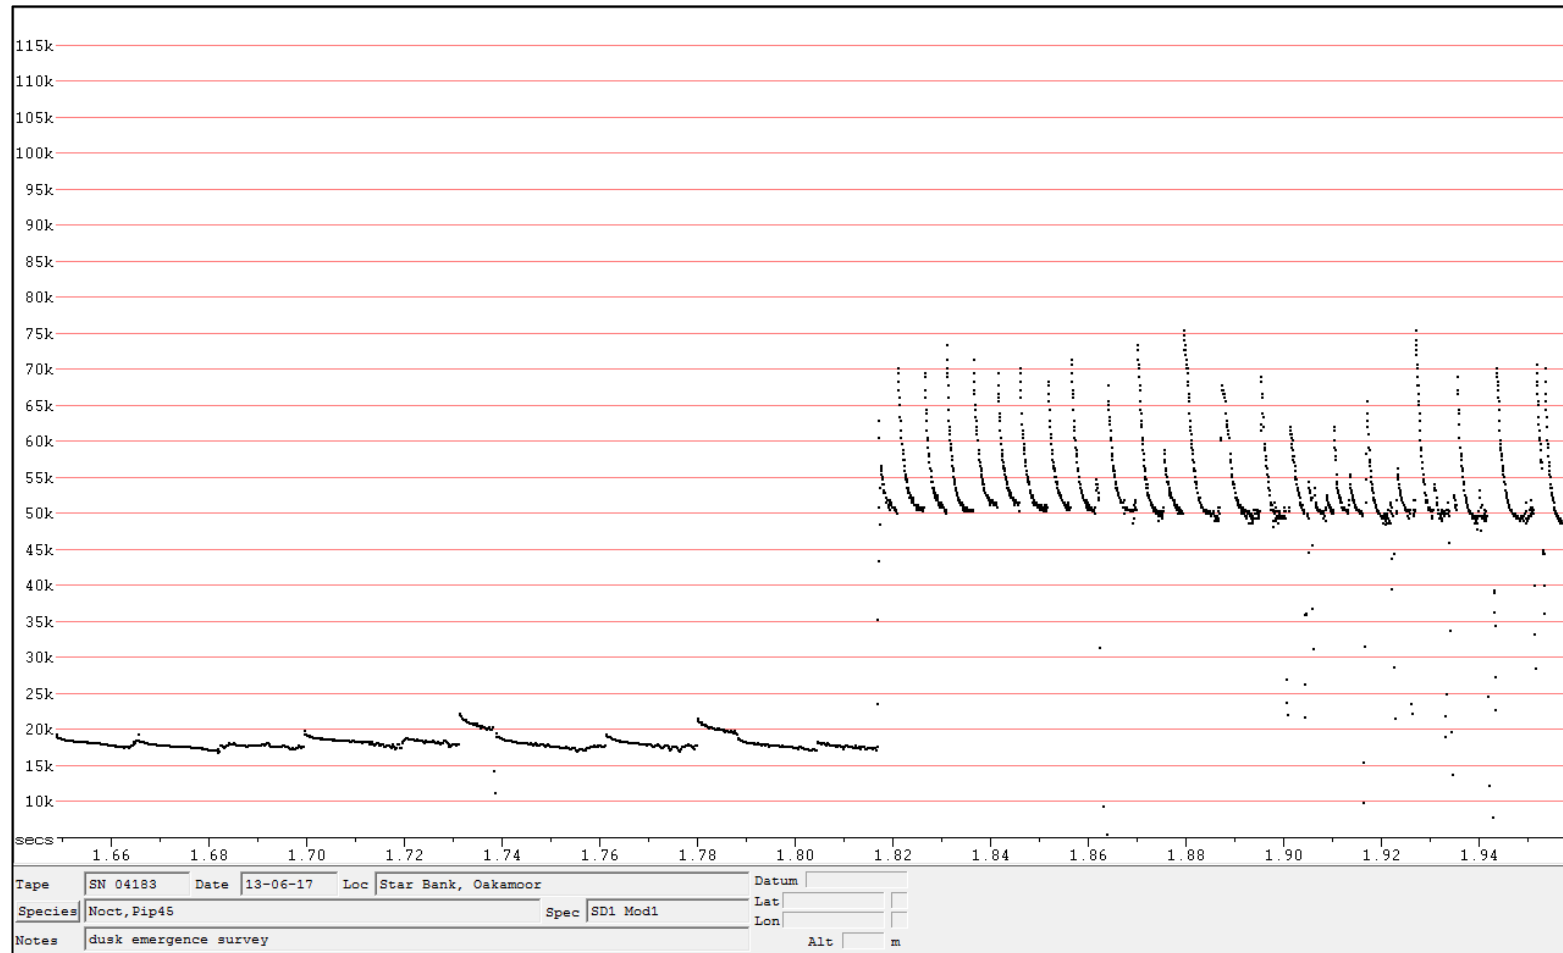
Sonogram 2: Echolocation calls of noctule and common pipistrelle bats also detected foraging at the site, but not roosting in the barns.  
Recorded by Anabat SD1 and analysed using Analook (view: F7 compressed, frequency only).

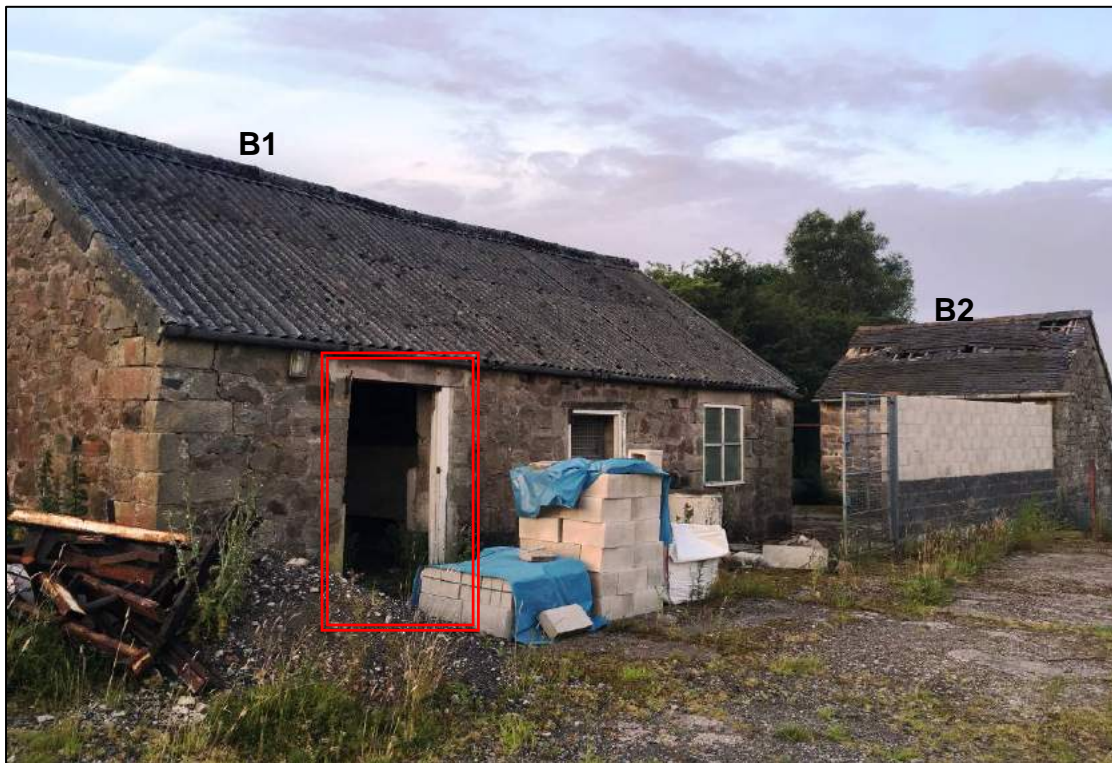
**Plate 1**

and a few minutes later a bat was seen to fly in through the open doorway on the north-western elevation (see Plate 1, Appendix 2). No bats were seen to leave the building after this time and no calls were detected to indicate individuals flying inside the building.

Building B1 - day roost for brown long-eared bats. Roost entrances via open doorways on north-western elevation and south-western gable end.

- 4.6 With the proposals being to convert the two small barns for residential use, there will not be scope to retain the existing roost entrances on B1, as bats are using the open doorways and windows that will need to be sealed to make the building weather-tight, as well as a crevice on a wall that will be enclosed within the accommodation. However, there may be scope to retain or replicate the existing crevice features used on B2, as these are on the external surface only.

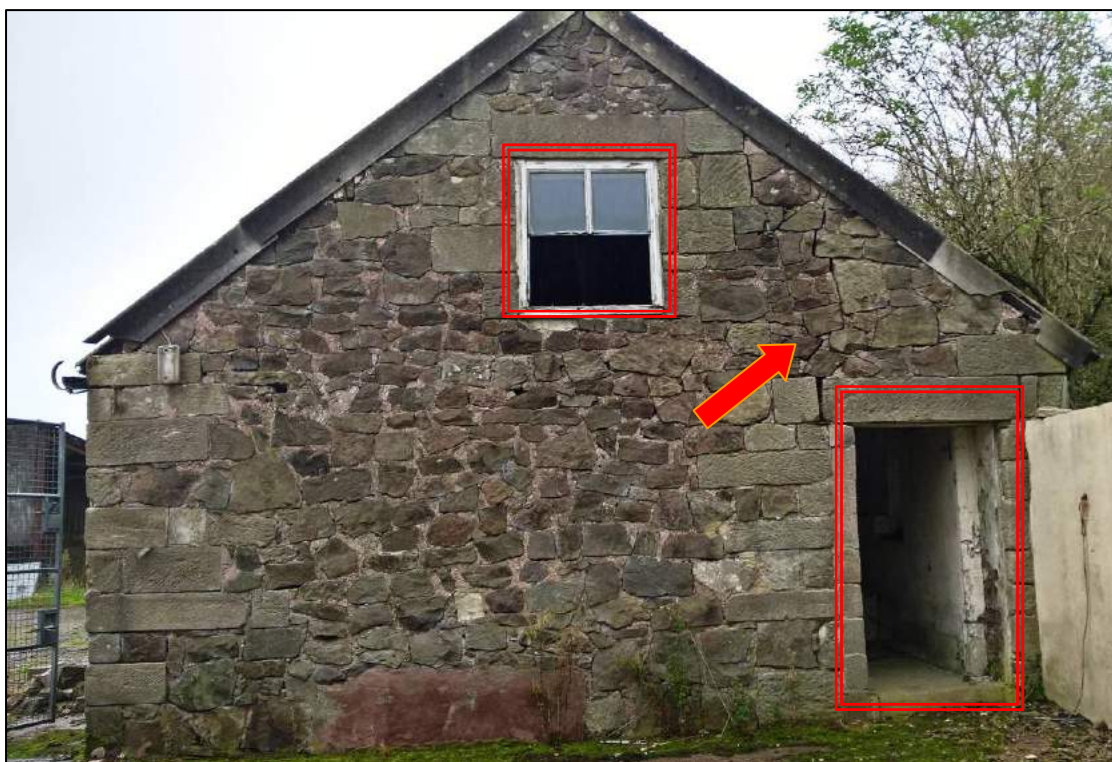
**Plate 2**

Building B1 - roost entrances on south-western elevation and also a crevice feature in the external stonework.

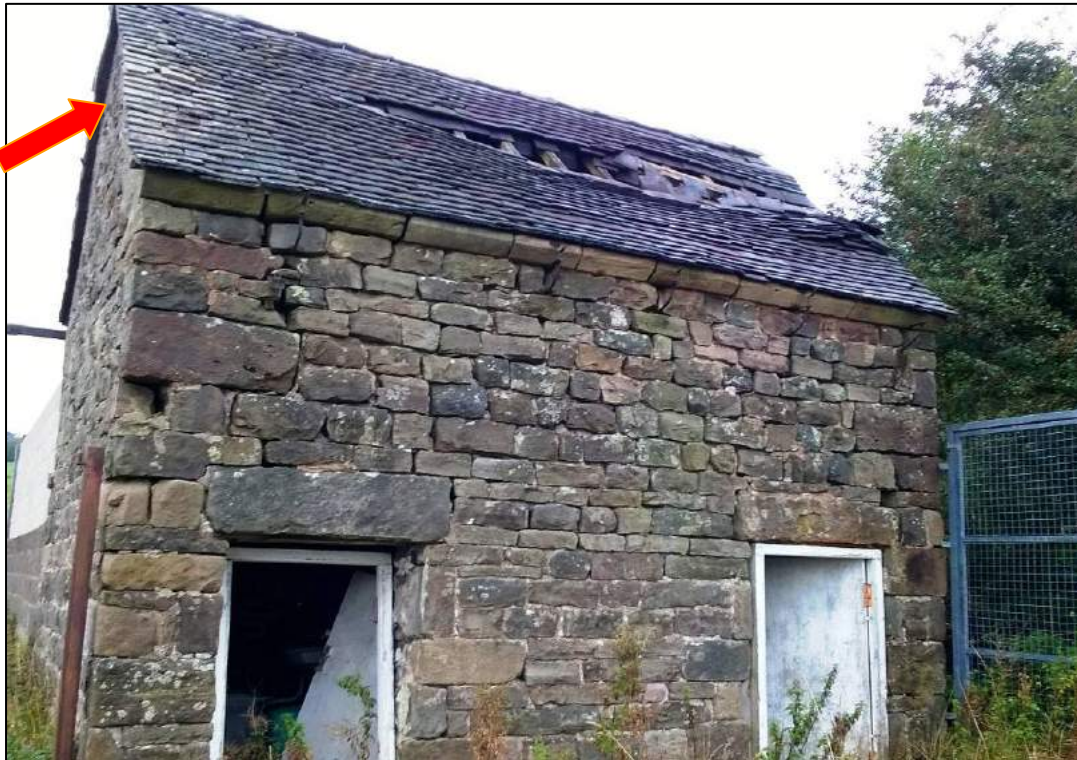
**Plate 3**

- 3.14 At approximately one hour before sunrise a single brown long-eared bat was seen flying around the smaller of the two barns (B2) before entering a roost in a crevice at the edge of roof tiles on the north-western gable end (See plates 2 and 3, Appendix 2).

Building B2 – day roost for brown long-eared bats with roost features on NW gable end.

- Retaining crevice features in locations close to the existing roost sites on the north-western gable end of B2 by leaving small gaps between the stonework when the building is re-pointed; and
- Creating new access points for bats at the ridge of B1 using raised ridge tiles or leaving a small gap in the mortar at the apex on a gable end to provide access to the ridge beam.

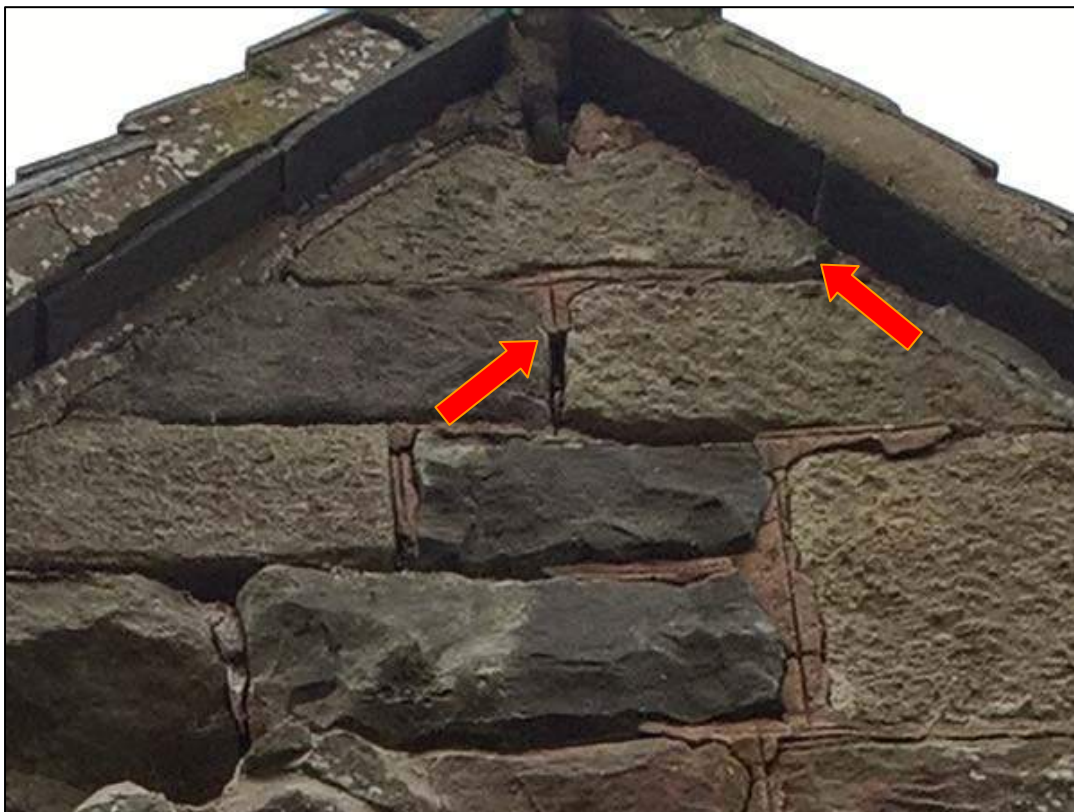
**Plate 4**

- 4.3 The roost features on B2 were discrete crevice features in the external stonework that did not provide access to the internal room of the barn. There was no evidence of the bats using the internal areas of B2 as part of their roost space. In addition to a small crevice on the external stonework that was used on a single occasion, the open doorways and window on the north-west and south-west elevations of B1 were the access points consistently used for this building. However, the precise resting place inside the structure could not be confirmed. Although bats were seen entering and exiting the barn on each of the survey visits at times that would indicate the presence of a roost, surveyors did not observe any sustained flying activity inside the barn, suggesting that the bats were flying straight to or from their resting place.

Roost features – crevices between stones on NW facing gable end.  
(Discrete crevice features only, neither providing access to interior of barn.)
