**Internal /External Bat Survey**

**Former Fole Dairy, Uttoxeter**

**Report to C B Collier F.D. Ltd.**

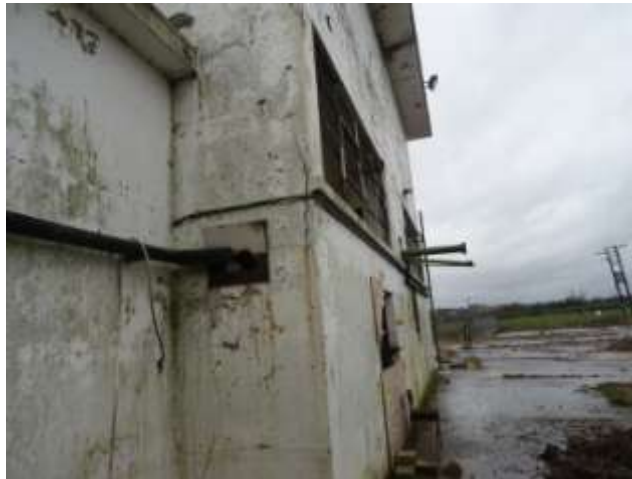
*Pump House*

The pump house is a disused, two-storey structure and is entirely brick built. This is located within the western extent of the site and is detached from the main complex of buildings. The pump house supports a flat roof and has several broken windows. Signs of disrepair were also noted along the rendering, but no suitable bat roosting features (e.g. cracks) were noted. The windows offer potential access and egress points for bats but, equally, has allowed the internal fabric of the building to become draughty / exposed and generally unsuitable for roosting. Internal inspection revealed no signs of bats and no suitable features.

**This building was therefore assessed as having negligible BRP.**

Building / Structure	Bat Roosting Potential	Further surveys required
Pump House	<b>Negligible</b>	Should potentially intrusive works be required to the pump house (e.g. refurbishment / dismantling / demolition). <b>No further survey</b>
Cold Storage Building	<b>Negligible</b>	There are no further recommendations concerning any works proposed to the Cold Storage Building
Bottling Plant -	<b>Negligible</b> Small area low	Should potentially intrusive works be required to the Bottling Plant (e.g. refurbishment / dismantling / demolition). <b>No further survey, except area denoted as Low BRP. For this area only, one Nocturnal Activity Surveys to be conducted in May-September 2018.</b>
Tank and Garages -	<b>Negligible</b> Small area low	Should potentially intrusive works be required at the garages (e.g. refurbishment / dismantling /

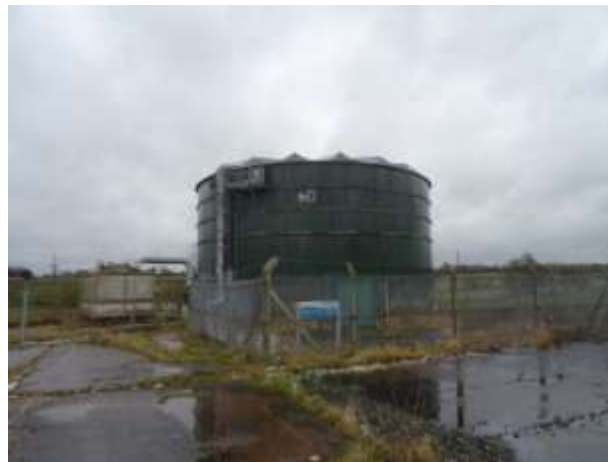
*Water storage tank*

External inspection revealed no signs of bats and no suitable features.

**This building was therefore assessed as having negligible BRP.**

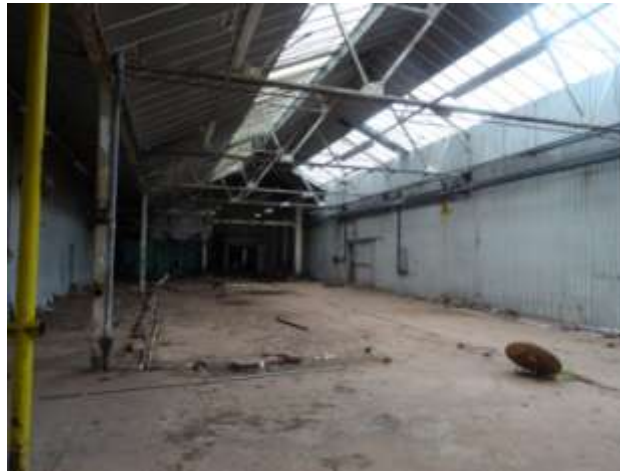
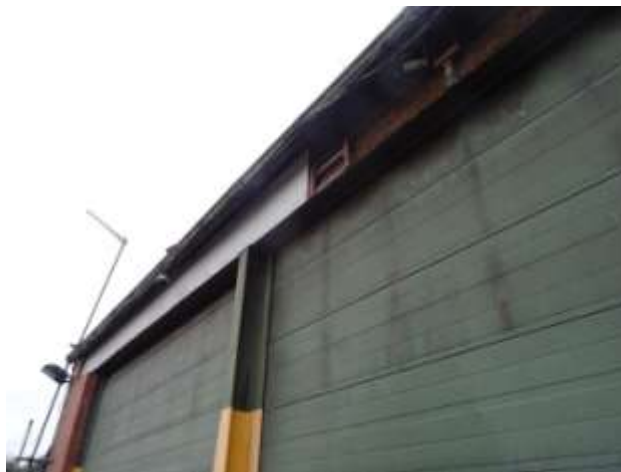
*Loading bays and Garages*

The building is constructed, predominantly, out of corrugated metal with brick built wing walls and corrugated sheet, pitched roofing. Corrugated sheeting creates no suitable opportunities for roosting bats and no cracks or crevices were noted within the bricked sections of the cold storage building. A low quality potential bird nesting/roosting feature was noted underneath a white fascia board, bordering the southern face of the building. This was stripped under direct ecological supervision on 13th February 2018 with Dr. S. Bodnar in attendance. The results showed a number of former nests of House sparrow and stock dove. The removal of this fascia removes any bat roosting or bird breeding potential from this structure. see below:

**This building is assessed as having negligible BRP.**

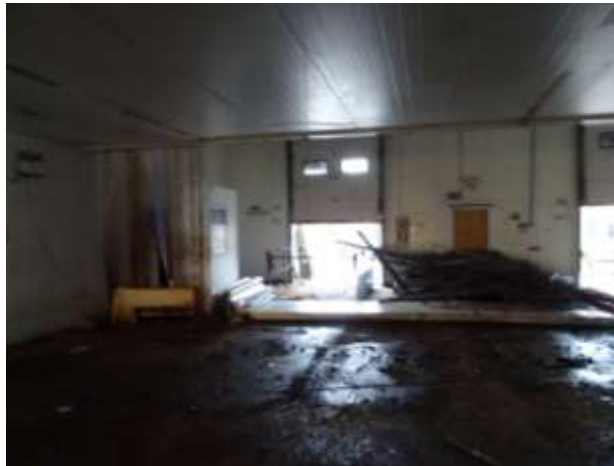
*Cold storage*

The corrugated sheet metal construction of the cold store and the exposure of the building to natural elements (e.g. weather), creates an unsuitable roosting habitat for bats.

**This building is assessed as having negligible BRP.**

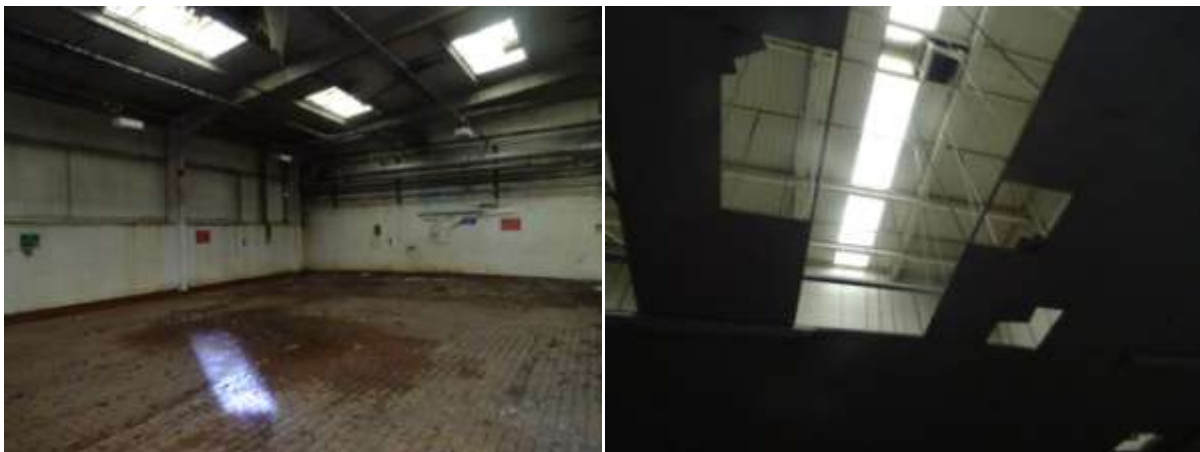
*Bottling Plant*

The former bottling plant is a brick-built building with several chipboard windows. No obvious cracks or crevices for bats were noted along the brickwork, with the majority of the brickwork noted as being in good condition. However, a number of holes were noted along the extreme north-eastern face of the building, where there are suitable access/egress point for bats.

Internally there are a number of suspended ceilings, partly dismantled, though it can be clearly seen that there are roof lights present in the roof, and these areas are unsuitable for roost formation. Internal insulation is tight packed with no obvious cavities where bats could access (image shows cut away section, revealing this structure). A section to the extreme East of this building has a roof-space with a wooden lined corrugated metal pitched roof. This roof-space was inspected, although suitable for bats to use, the

only access was a chute which had substantive previous nesting use by jackdaws (large amounts of nesting debris) and as such the BRP of this particular area of the bottling plant is Low. See images below:

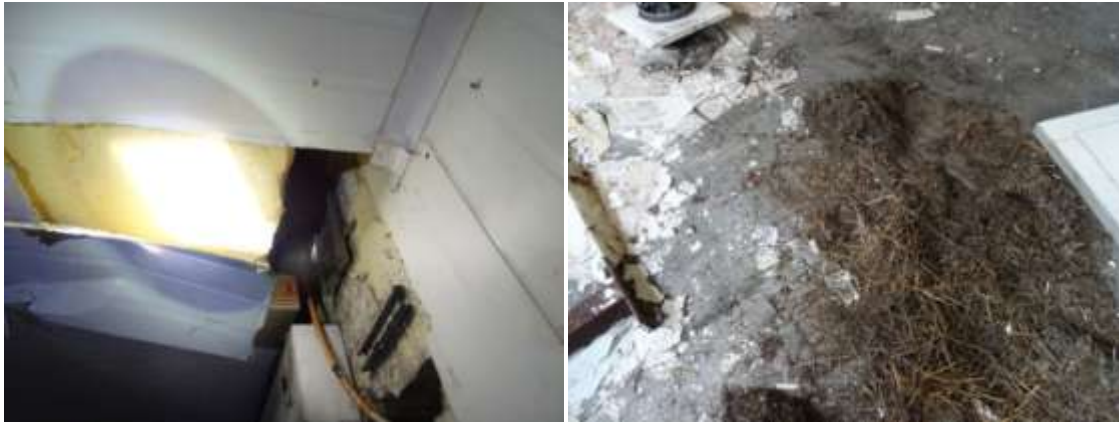
**Lining structure and remains of jackdaw nest**

**This building is assessed as being of negligible BRP, with the exception of the area noted on the plan and shown above which are classified as low BRP.**

demolition). **No further survey, except area denoted as Low BRP. For this area only, one Nocturnal Activity Surveys to be conducted in May-September 2018.**

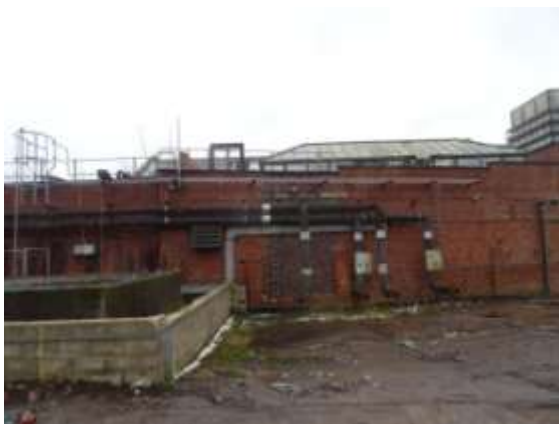
**Gaps in brickwork in this section (NW of bottling plant)**

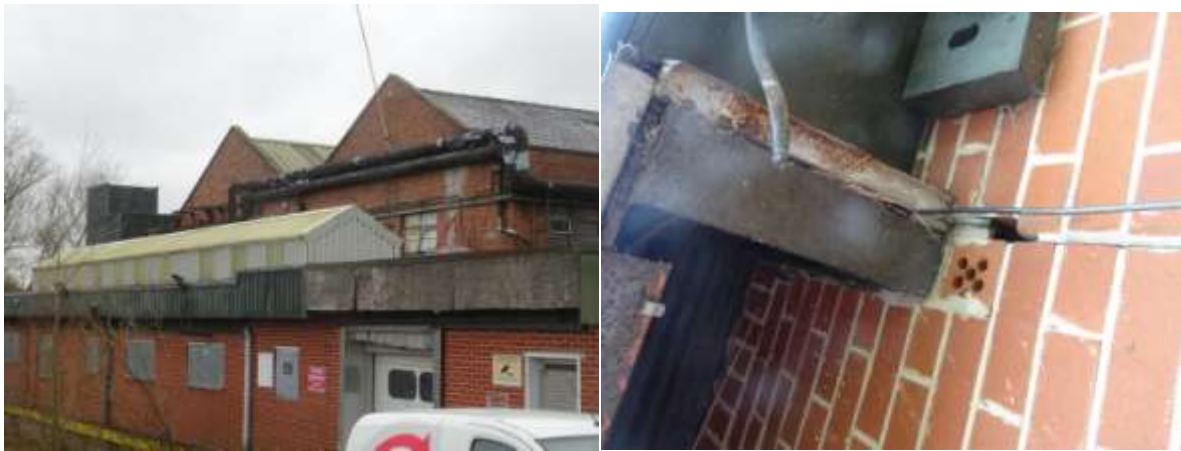
The garages had no access/egress features noted with the windows bordered with metal sheeting and the roller door closed. The brickwork was considered to be in good condition with no cracks/crevices identified. Areas of the fascia were lifting with evidence of previous blue tit nesting at one location, which creates a potential access/egress point for bats.

**This building is assessed as being of negligible BRP, with the exception of the area noted on the plan and shown above which is classified as low BRP.**

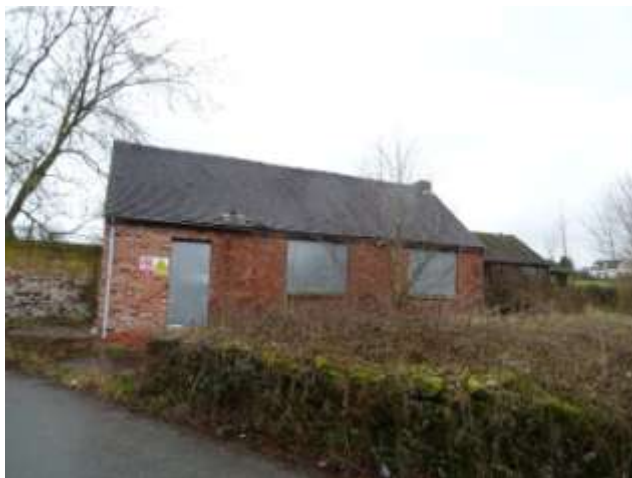
### *Cottage*

The cottage situated beyond a lane to the east of the site is brick constructed with a pitched roof supporting a combination of tiles and corrugated sheeting. The building is currently redundant and boarded across the windows but was considered to be in reasonable condition with the exception of a number of absent/slipped roof tiles. However, close up observations of the building exterior were not possible, nor was the interior of the building investigated due to restricted access.

**On a precautionary basis, due to limitations, this building was assessed as having moderate BRP due to the condition of the building and level of deterioration.**

Cottage - **Moderate** Should potentially intrusive works be required at the *Exterior* cottage (e.g. refurbishment / dismantling / demolition). **Two Nocturnal Activity Surveys to be conducted in May-September 2018.**

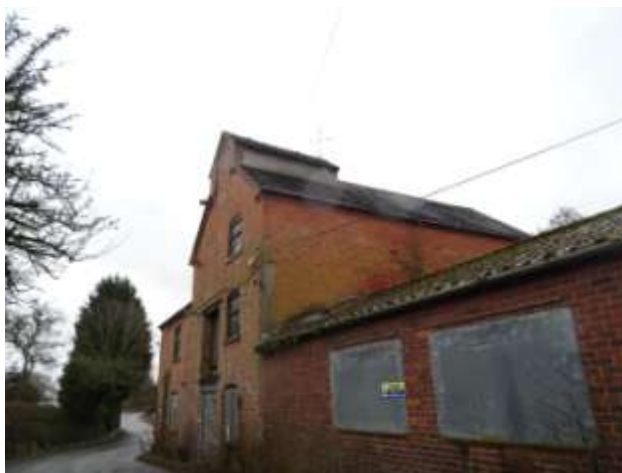
### *Mill House*

The southernmost extent of the site is occupied by Mill House which is a 2-3 storey, red brick building with a pitched, tiled roof. This has been formerly assessed by WSP as documented within an initial Bat survey report (WSP, 2013<sup>2</sup>) and Bat Emergence Survey Report (WSP, 2013<sup>3</sup>) as having a confirmed

Brown Long-eared and Pipistrelle bat roost with evidence of emergence activity and former field signs being observed. Access to the internal fabric of the building could not be achieved at the time of the PEA survey, although the exterior of the building was determined as being generally intact and largely unchanged from the assessment within the former bat surveys.

**The Mill House was, therefore, assessed as having a confirmed roost, although the level and extent of bat activity associated with the structure would require further investigation.**

Mill House - **Confirmed** Should potentially intrusive works be required at Mill *Exterior* **Roost** House (e.g. refurbishment / dismantling / roof repairs). **Three Nocturnal Activity Surveys will require conducting in May-September 2018 and an appropriate EPSL/Low Impact Licence obtained from Natural England.** In addition, it is advised that the building is subjected to a detailed internal inspection. It is advised that this is combined undertaken during the winter months - preferably January to February 2018 – to ensure that the potential for the building to be utilised by hibernating bats has been explored.
