**Dusk bat activity survey**  
**Site at former Fole Dairy**

**Report to C B Collier F.D. Ltd.**

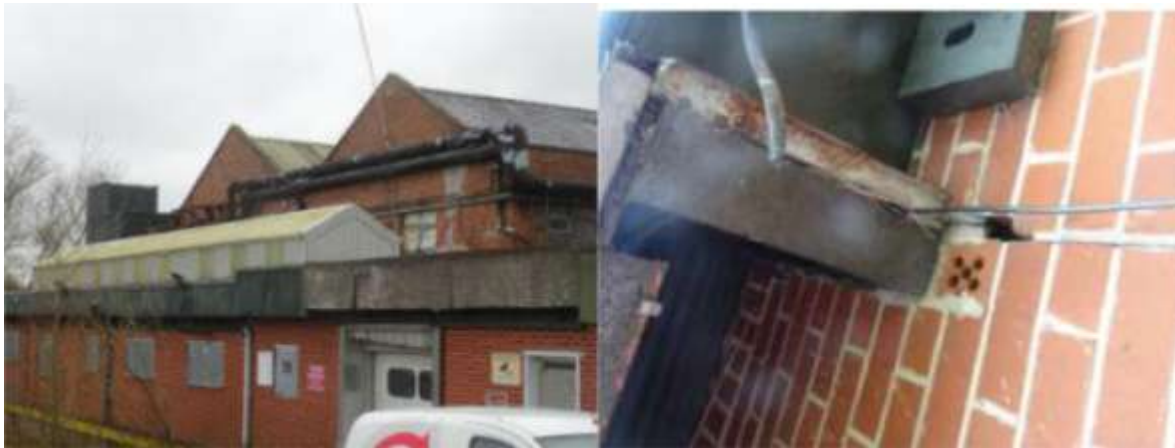
The surveys detailed here have been carried out to determine if the level of activity and presence of any potential roosts at a section of a site known as Fole Dairy, Uttoxeter. It was required to ensure no roosts were present at a section of the Bottling plant (the section identified with low bat roost potential) and in addition a canteen area (attached to, but not part of the old Mill building, Category: Low Roost Potential) ) prior to demolition of these structures. There is a recorded roost on the site, though this is confined to the Old Mill building (not affected by the proposed works at this stage). The areas are shown below:

The garages had no access/egress features noted with the windows bordered with metal sheeting and the roller door closed. The brickwork was considered to be in good condition with no cracks/crevices identified. Areas of the fascia were lifting with evidence of previous blue tit nesting at one location, which creates a potential access/egress point for bats.
