Dusk bat activity survey
Site at former Fole Dairy

Report to C B Collier F.D. Ltd.

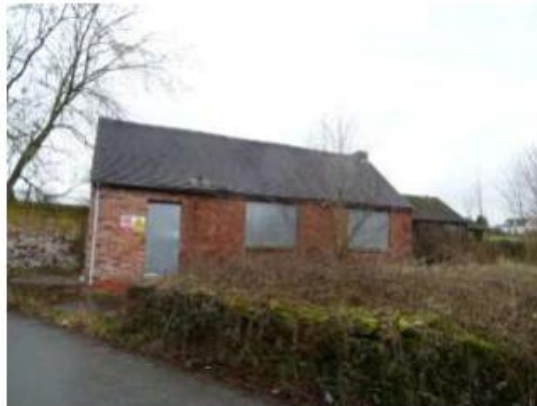
Cottage

The cottage situated beyond a lane to the east of the site is brick constructed with a pitched roof supporting a combination of tiles and corrugated sheeting. The building is currently redundant and boarded across the windows but was considered to be in reasonable condition with the exception of a number of absent/slipped roof tiles. However, close up observations of the building exterior were not possible, nor was the interior of the building investigated due to restricted access.

On a precautionary basis, due to limitations, this building was assessed as having moderate BRP due to the condition of the building and level of deterioration.

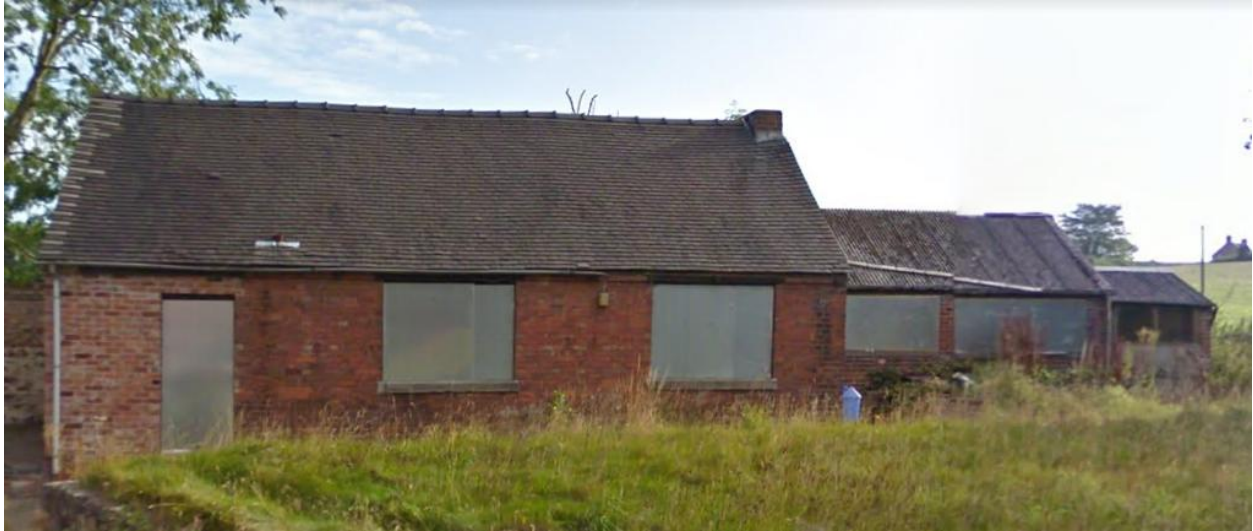
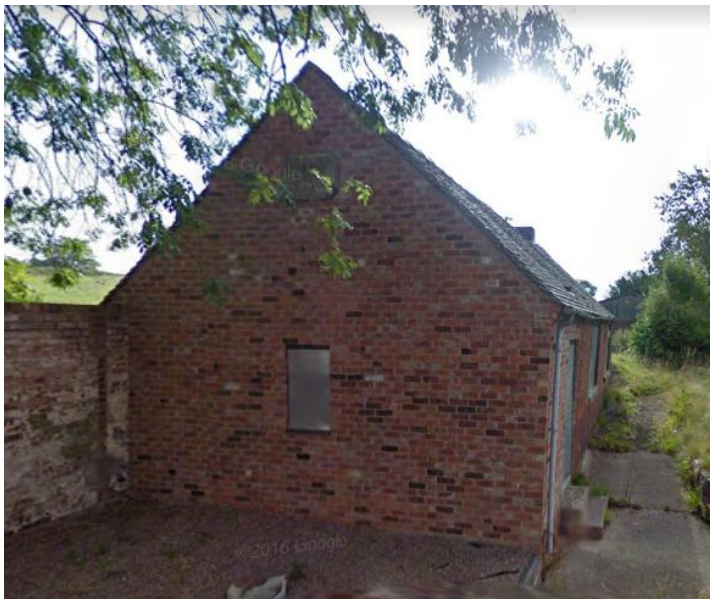
The building was inspected exteriorly and the findings were the same as the previous evaluation in February 2018. Internal access was gained. The interior of the building has no roof space present and has a roof lined with plaster. The interior is heavily cobwebbed and there were no signs of bat usage either current or previously.

- I can confirm that there was no bat emergence from the former cottage/reading room area of the buildings and that this can therefore be demolished. I was able to confirm that the former office areas also were clear of bats and breeding birds and that demolition work can proceed here also.
