### Figure E3 Mitigation/Compensation Plan

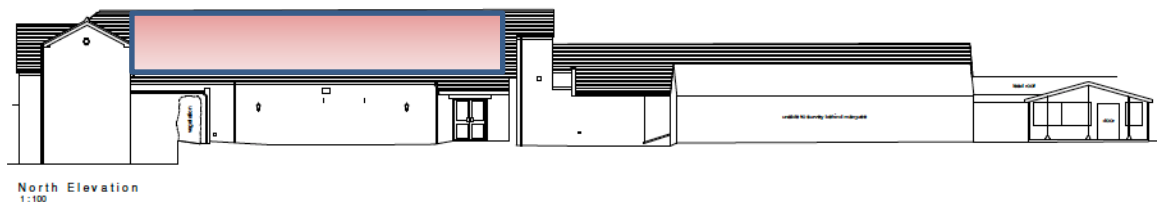
Location of proposed compensation roost void for the maternity colony of Brown Long-eared Bats above the existing wedding venue

Compensation roost to be created within the roof void of existing Wedding Venue (ca. 20m to the north of the existing roost) – ca. 13m x 18m x 2.2m (height).

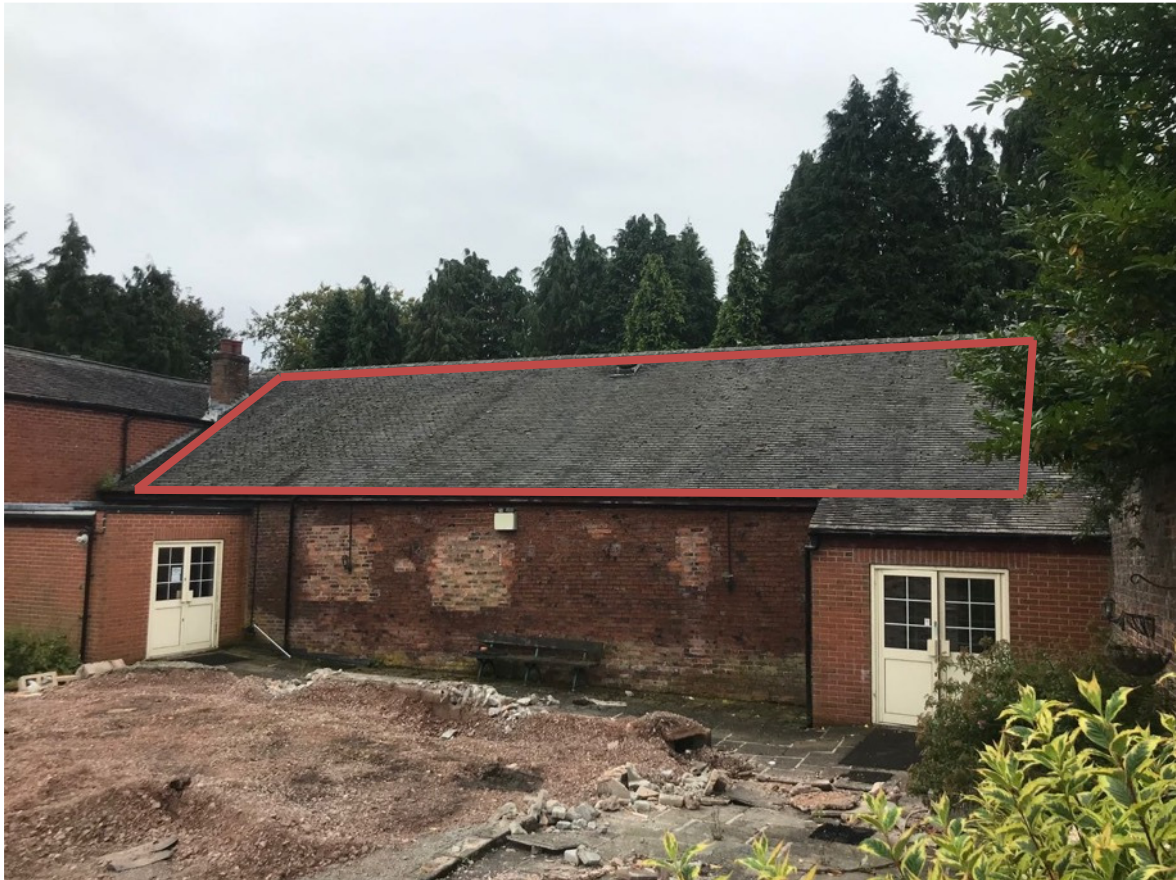
Proposed compensation roost void for Brown Long-eared Bats (above current Wedding Venue)

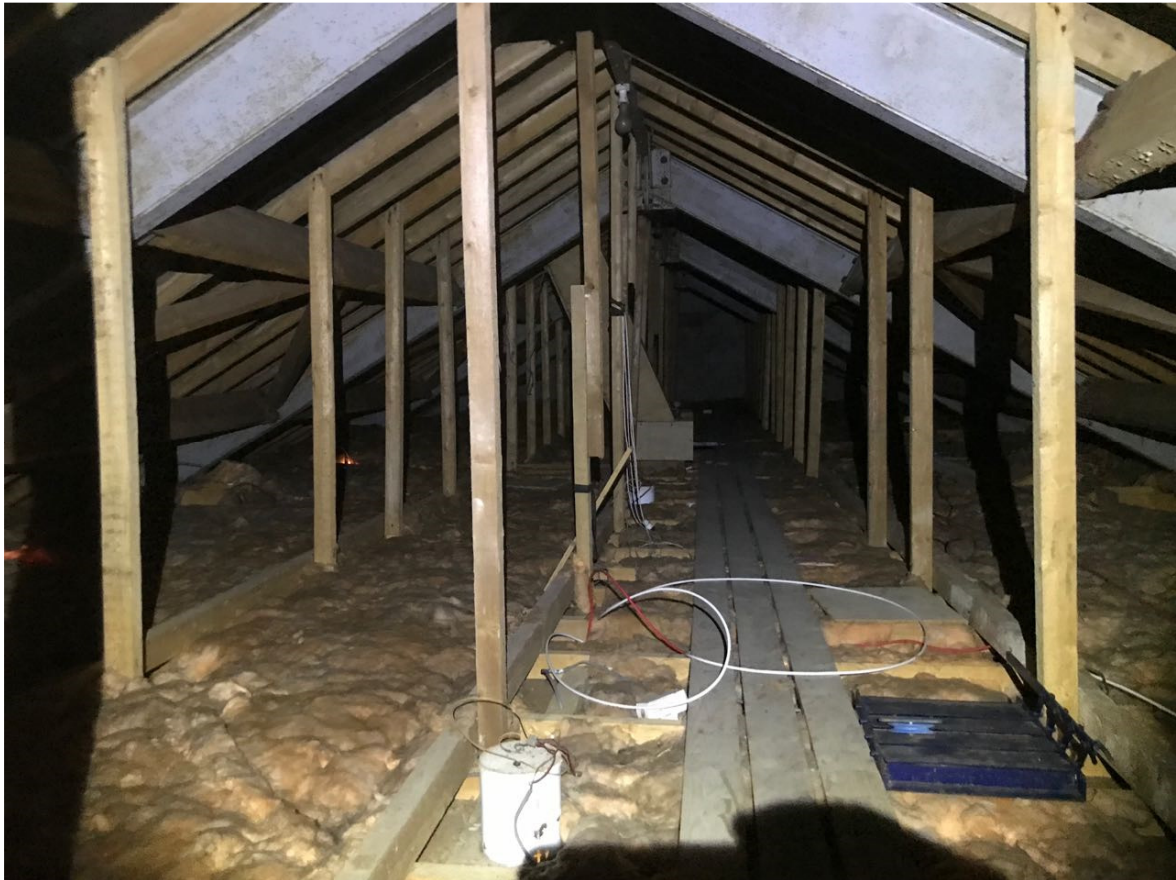
Roof void of Wedding Venue – central vertical support timbers to be removed to enable uncluttered environment for flying

Existing central vertical support timbers to be removed (see picture below) to allow uncluttered central flight space. Bat access will be created on the southern roof slope (nearest the existing colony in the main house) to enable the colony to enter dense vegetation immediately upon roost exit. Access will be created by raising a single ridge tile and also by installing a 'habitat bat access slate' on the southern roof slope. A small number of roost features will also be incorporated into the void to further enhance the likelihood that the void will be adopted by the maternity colony. These will include a number of purpose-built roost crevices constructed of parallel rough-sawn timbers that will be placed within the existing steel support girders.

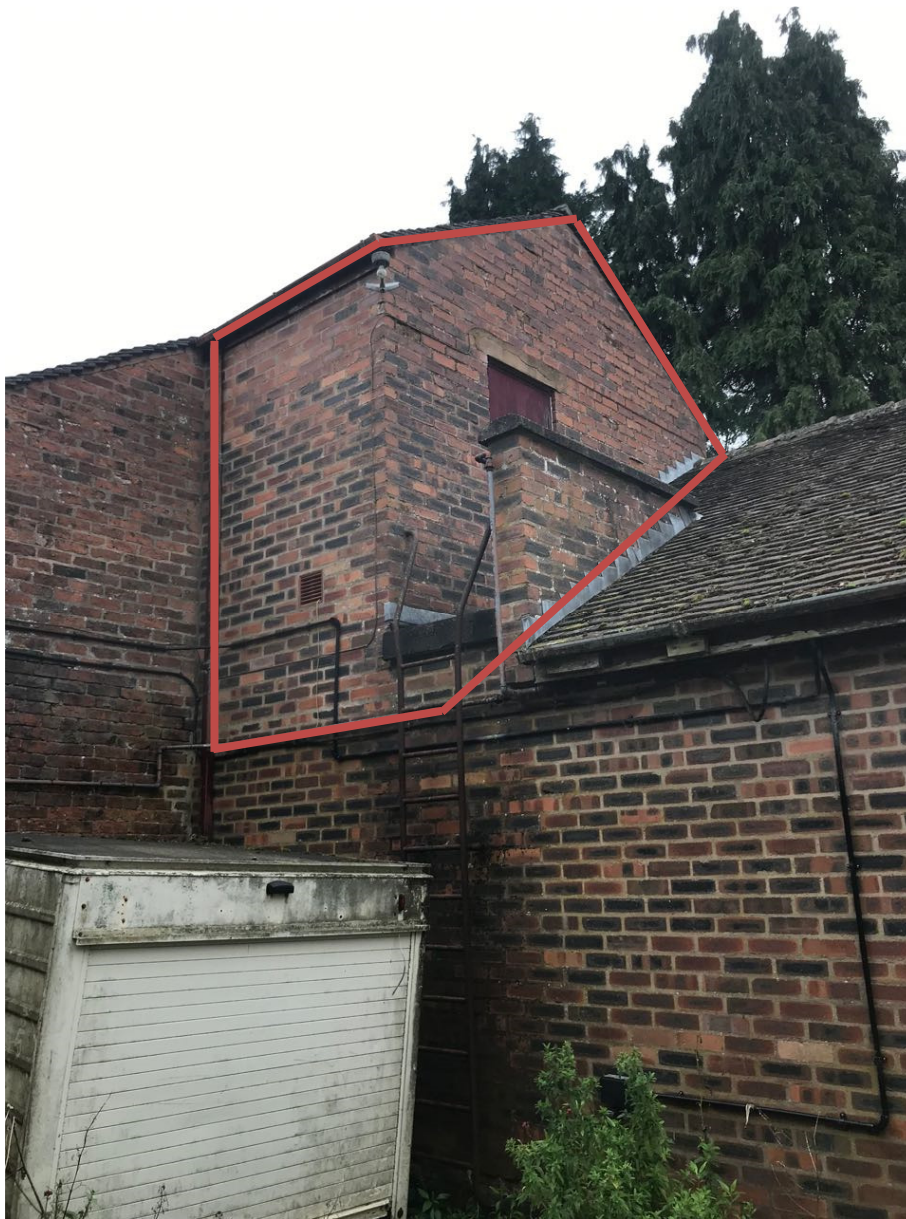
Roof void room to be modified for use by Common Pipistrelle maternity colony

False wall cavities will be created in the void above the entrance door at the gable end and also on the south side of this room. The gable end cavity will be created by installing a breezeblock wall and rough-sawn, untreated timber 'lining' whilst the south side cavity will be created using rough-sawn, untreated timber.

Two maternity bat boxes suitable for common pipistrelle will also be installed within this roost compensation area with a further two maternity boxes placed on the gable end external wall.

Access will be created by raising a roof slope tile on the south roof slope and raising a ridge tile one-in from the gable end.
