# PHASE II GEO-ENVIRONMENTAL ASSESSMENT

TEARNE QUARRY, HOLLINGTON

HOLLINGTON STONE QUARRIES LTD

| SUMMARY TABLE: PHASE II GEO-ENVIRONMENTAL ASSESSMENT | | |
|---|---|---|
| <b>REFERENCE:</b> | IV.416.19 | |

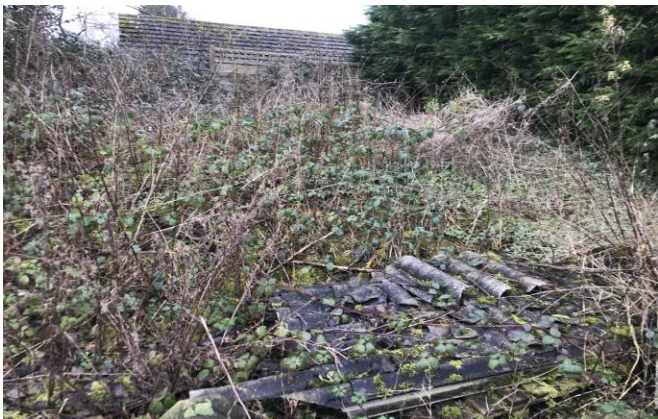
However, Asbestos containing materials (ACMs) were observed along the western edge of the site, to the north of the existing garage. The ACMs comprised of stored corrugated sheeting that were broken and in a poor state of repair. Removal of the ACMs and surface picking should be conducted with subsequent verification sampling of in-situ soils in this area.

Asbestos Sheets stored on site

The ACMs should be carefully removed, with minimal breakages or other damage to limit fibre release, and transferred to either an asbestos skip or into double-bagged and swan-necked specialist asbestos sacks. The ACMs should be disposed of at a suitably licenced facility.

It is recommended that the material within the vicinity of the stored ACMs is either removed and replaced with clean material or capped with 600mm of a clean imported validated soil.

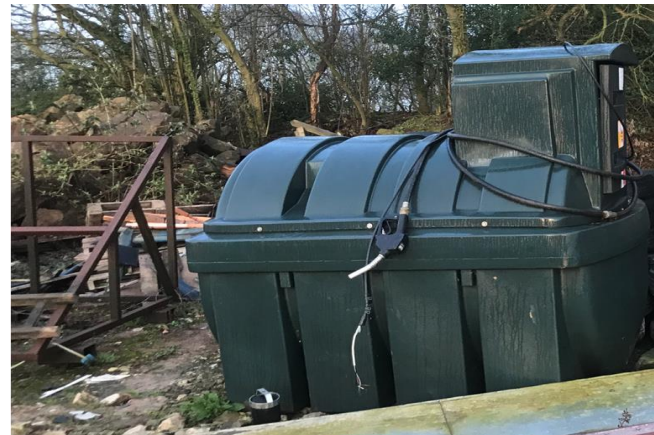
\* Following conversations between Ivy House and the site owners it has been confirmed that the underground storage tank was instead an above ground that was placed immediately to the east of the garage building that is located along the western edge of the site.

Contaminants of concern for the end user include Asbestos and Ground Gases (CO<sub>2</sub> and CH<sub>4</sub>). Laboratory analysis of Made Ground samples illustrates that concentrations of Polycyclic Aromatic Hydrocarbons (PAHs), Total Petroleum Hydrocarbons and BTEX/MTBE are within Tier 1 thresholds for the proposed residential with gardens end use. No evidence of contamination related to the above ground storage tank was noted.

Above Ground Fuel Storage Tank (AST)

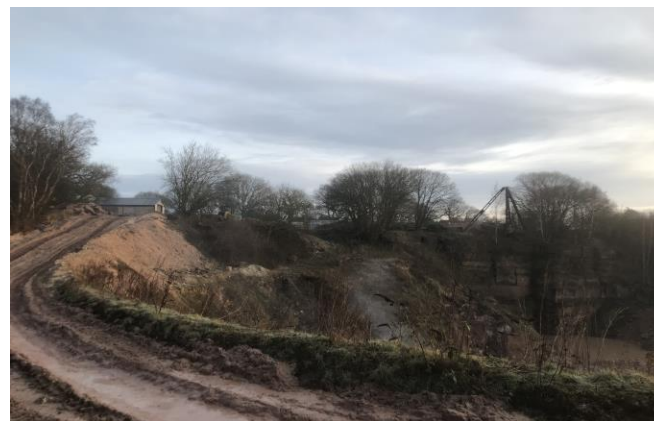
It is thought that the instability was caused by the backfilling of unrecorded, historic stone quarries with non-engineered materials that have subsequently suffered secondary consolidation and localised subsidence.

Quarry to South showing potential depth of Backfilled Quarry
