# **Old Engine Farm, Dilhorne**

## **Bat and Bird Presence/Absence Survey Report**

**November 2020**

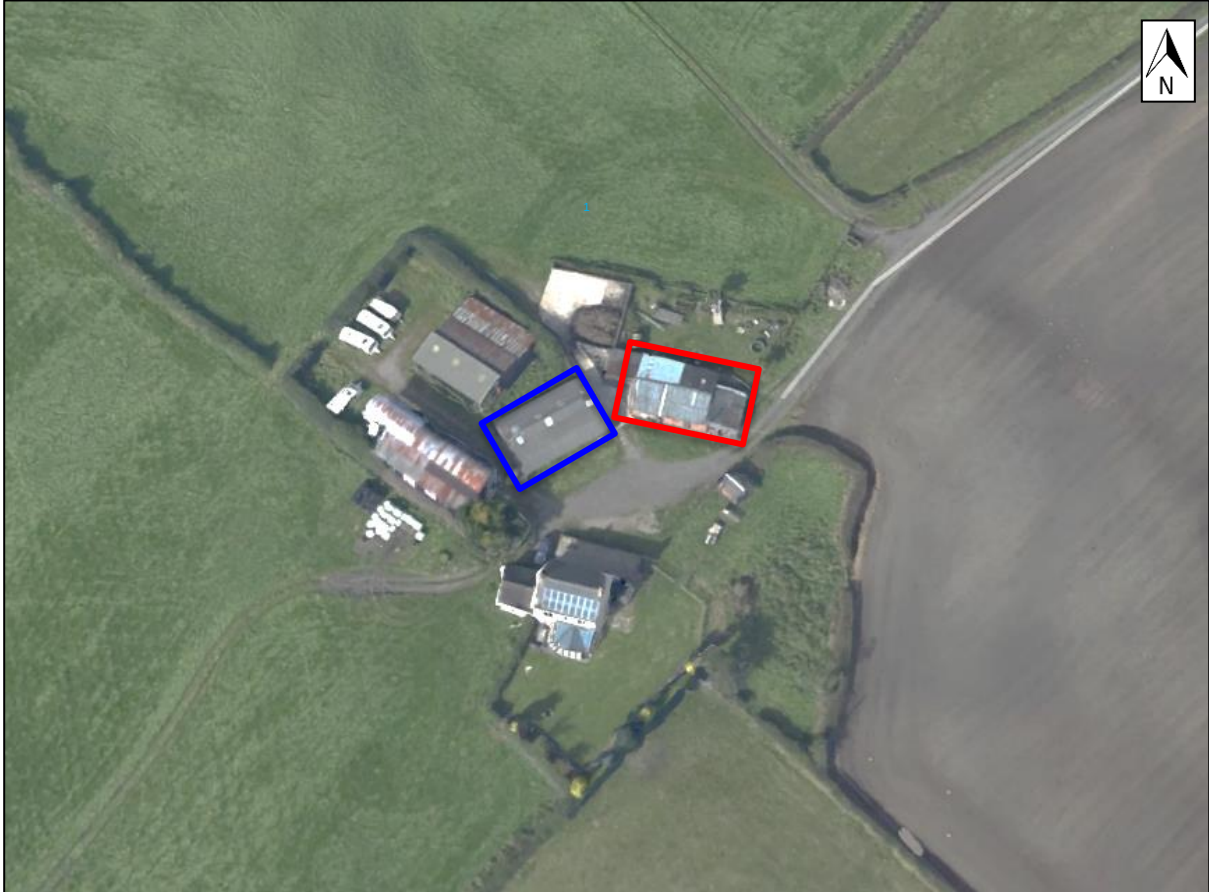
**Figure 1:** An aerial map showing the surveyed buildings at the 'Old Engine Farm, Dilhorne' in relation to some of the local landscape. The former Milking Parlour is highlighted within the red outline with the adjacent barn highlighted in blue.

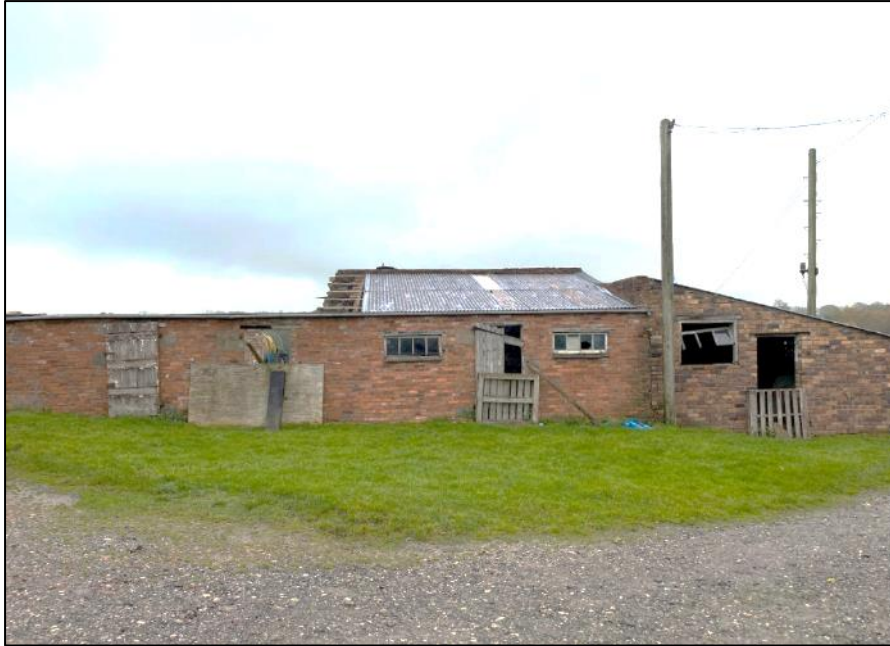
**Plate 1:** This image shows the southwest elevation of the former Milking Parlour, here you can see a number of open doors and windows.

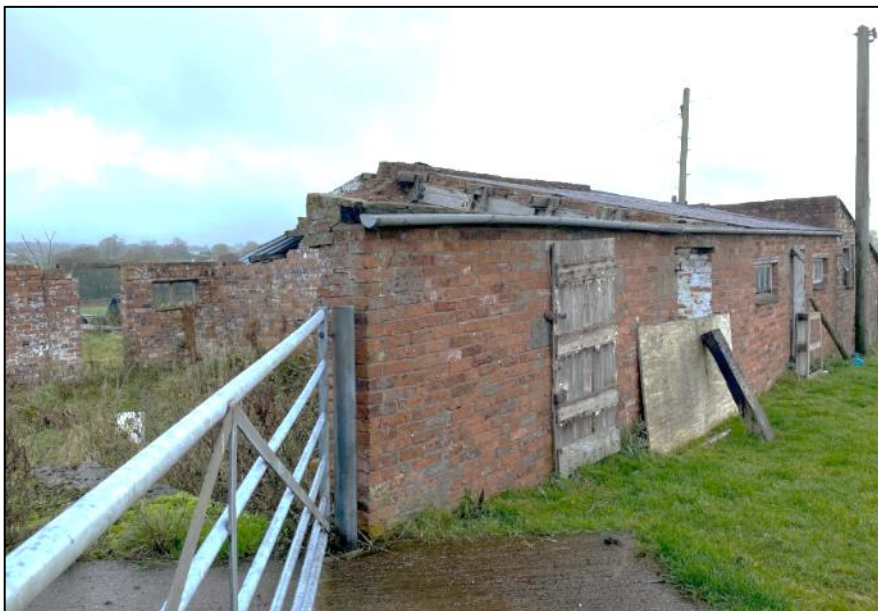
**Plate 2:** Another image of the southwest elevation of the former Milking Parlour, this image is taken from the southwest corner, here you can see a collapsed section of the parlour.

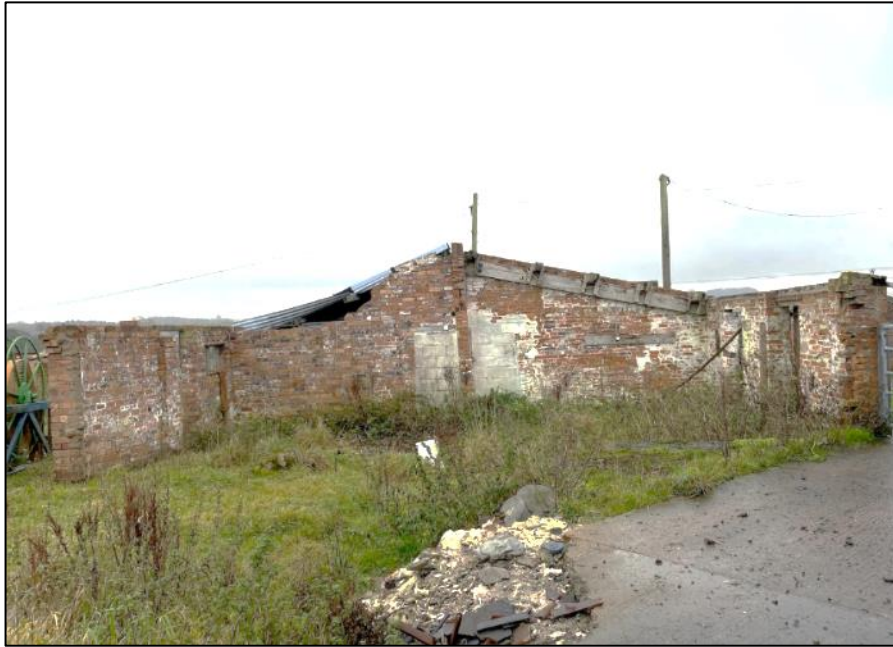
**Plate 3:** This photo shows the collapsed west gable end section of the former Milking Parlour.

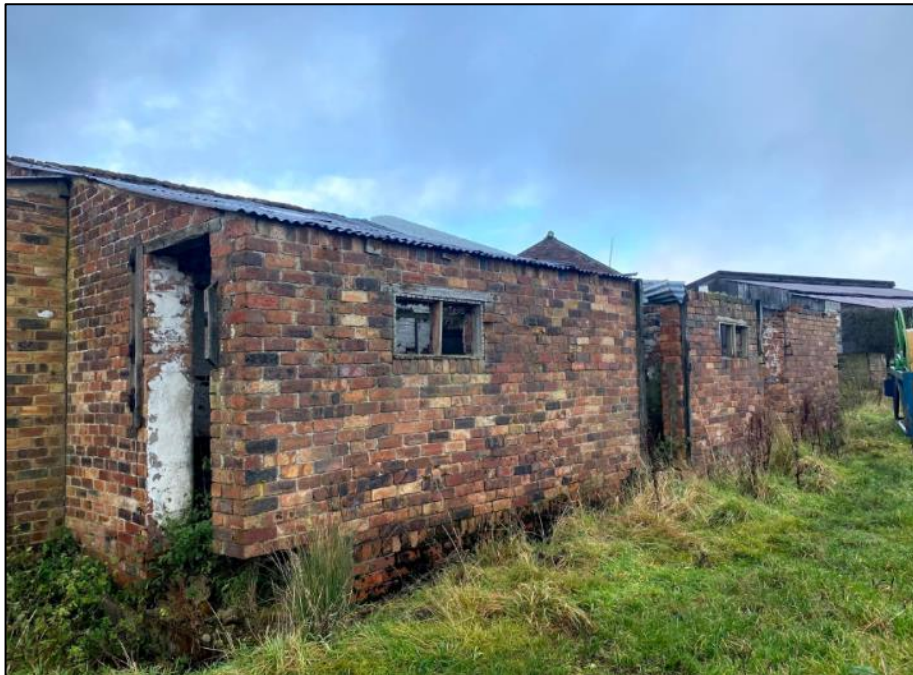
**Plate 4:** An image of the northeast elevation of the Milking Parlour, again here, you can see open doors and windows.

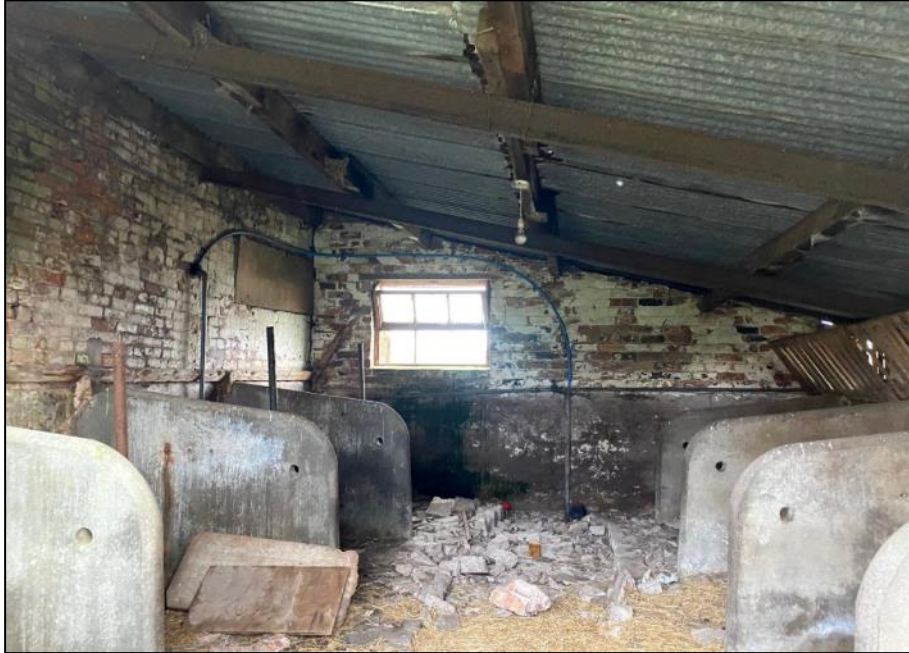
**Plate 5:** An image inside the east gable end room of the Milking Parlour. This room has a corrugated steel roof with timber beams. Recently active swallow nest are evident on the wooden beams.

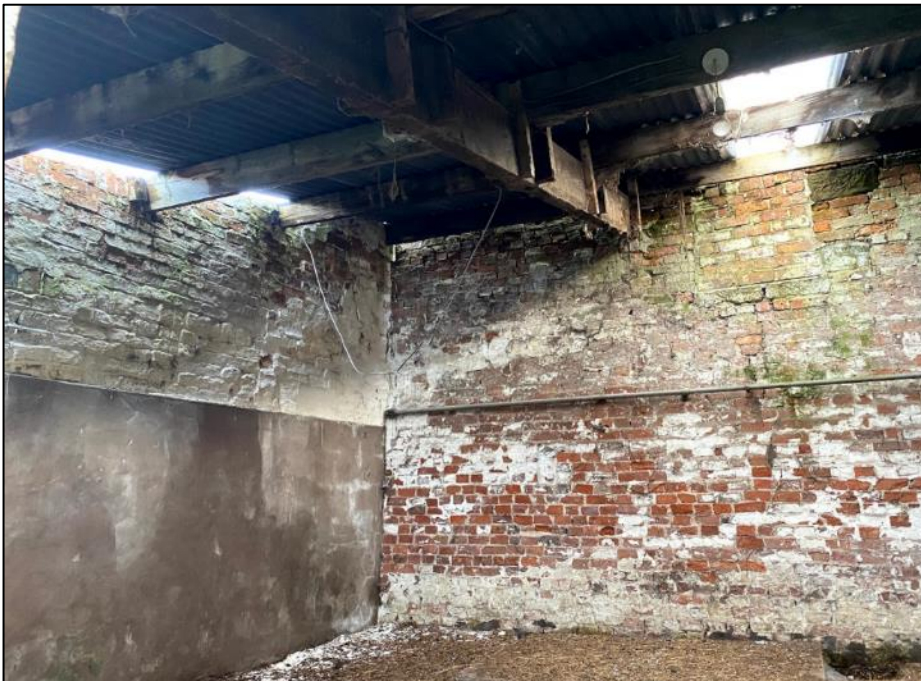
**Plate 6:** An image of another room located within the Milking Parlour; this room contains a skylight within the corrugated roof. Again recently active swallow nests can be located along the wooden beams.

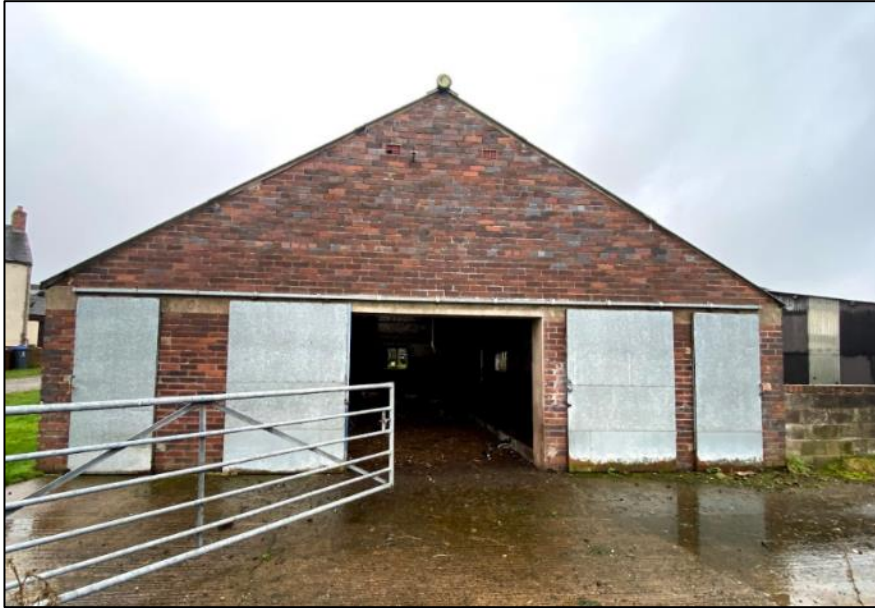
**Plate 7:** This image shows the northeast gable end of the barn, this barn again has open doors and missing/broken windows.

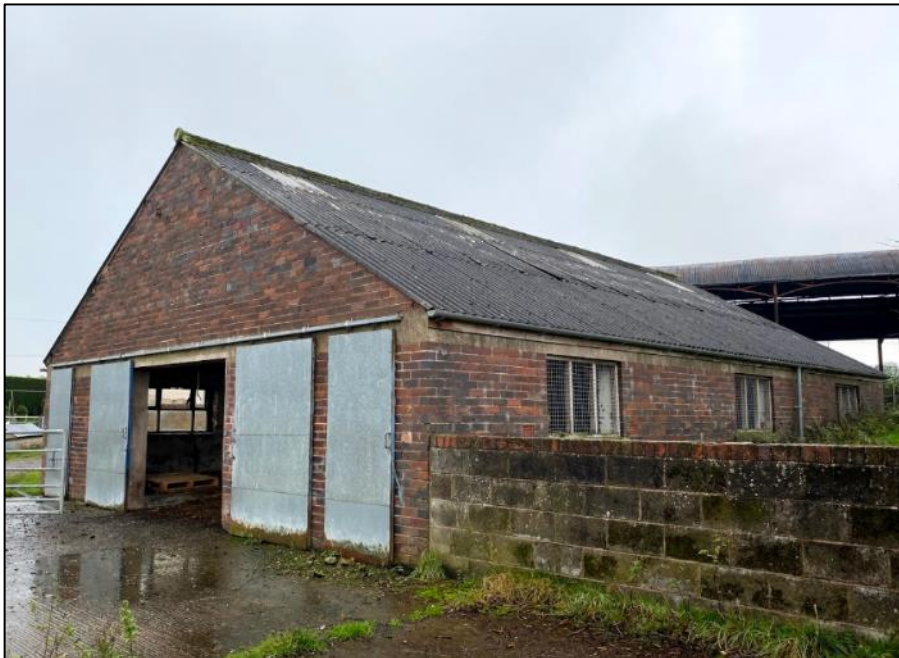
**Plate 8:** An image of the northwest elevation, here you can see the corrugated roof with skylights.

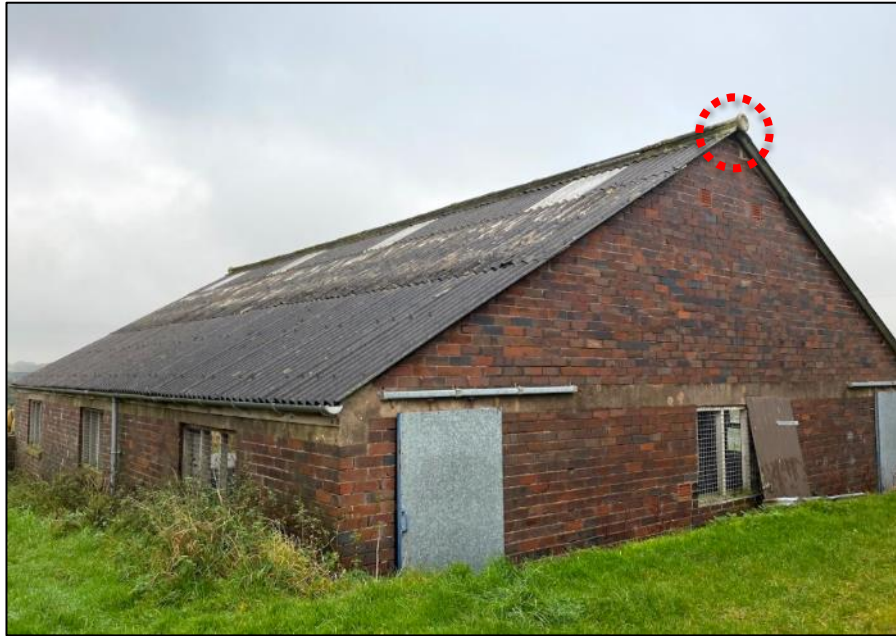
**Plate 9:** An image of the southwest gable end of the barn. A house sparrow nest is located within the apex of the roof underneath the corrugated steel roof (highlighted in red).

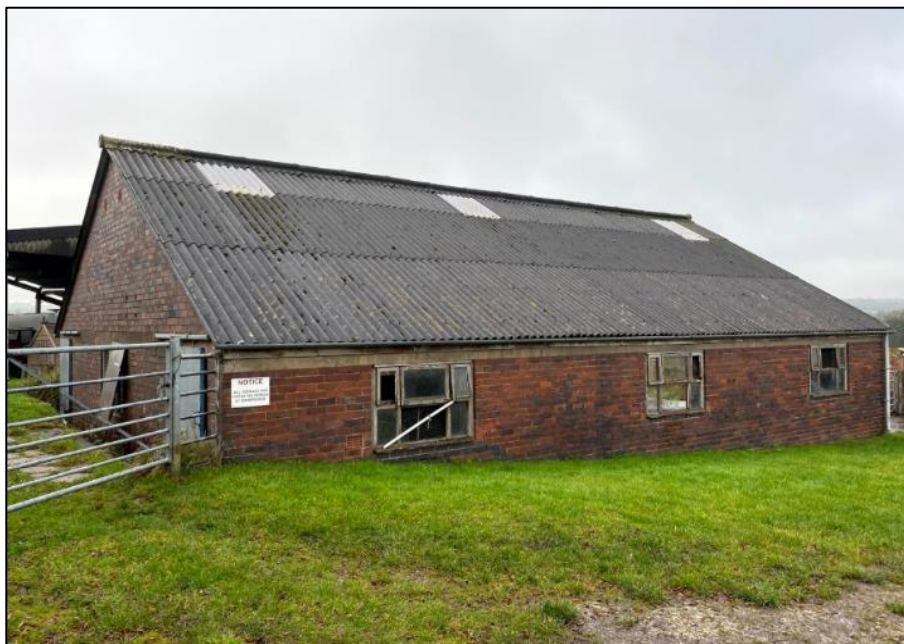
**Plate 10:** This image shows the southeast elevation of the barn. Here you can see some of the open/broken windows.

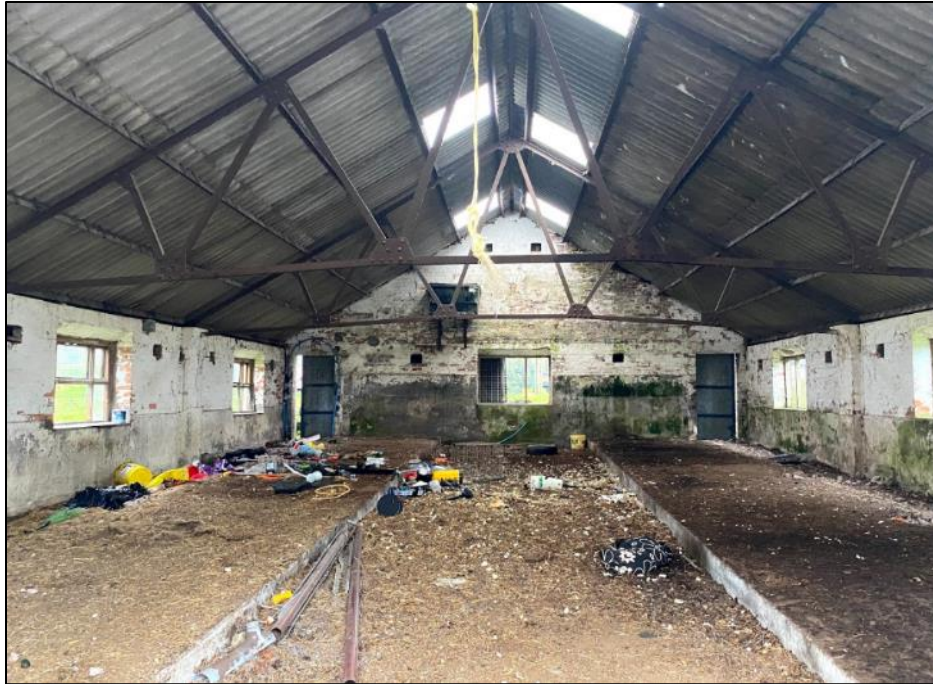
**Plate 11:** An internal image of the barn, looking towards the southwest gable end. The barn is internally made up of a steel structure, and solid brick walls.

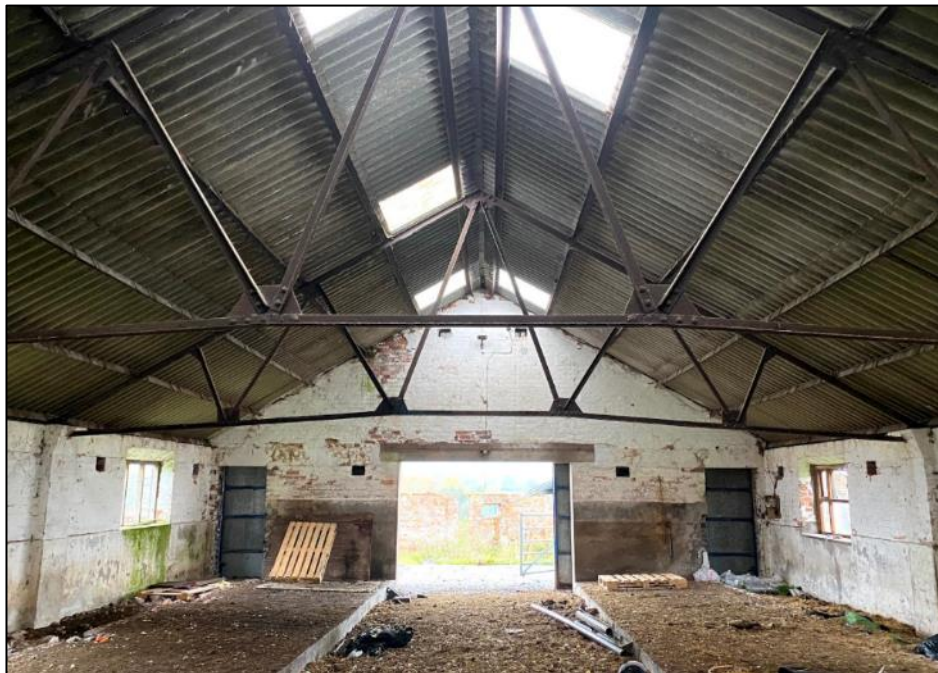
**Plate 12:** This image shows the internal northeast gable end.
