**RE: MOSS COTTAGE BARN, MACCLESFIELD ROAD, RUSHTON SPENCER,  
STAFFORDSHIRE, SK11 0SE**

## Photographs

### HAND DUG TRIAL PIT PHOTOGRAPHS

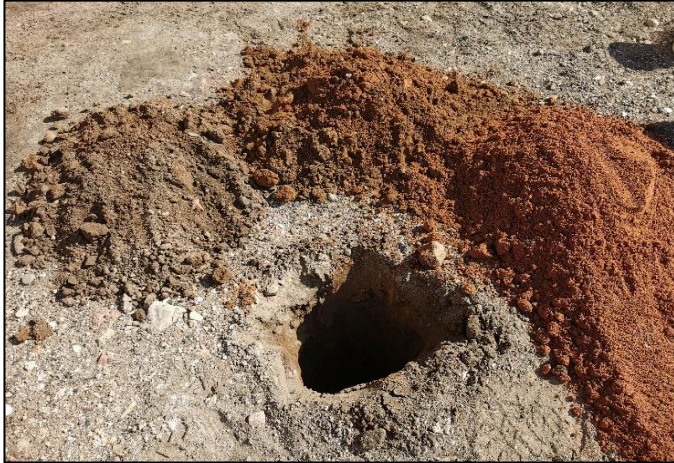
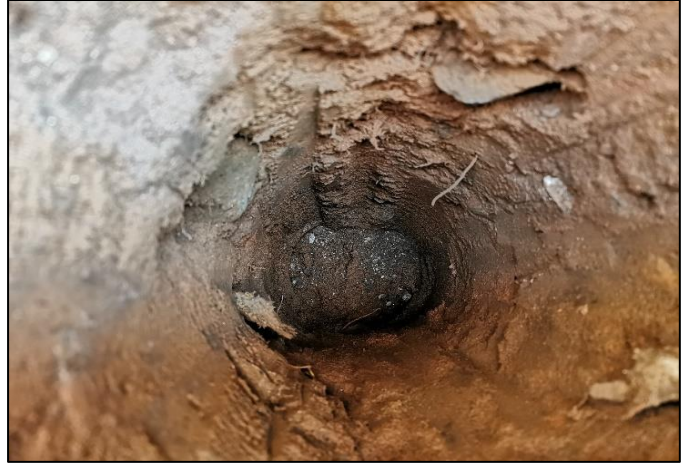
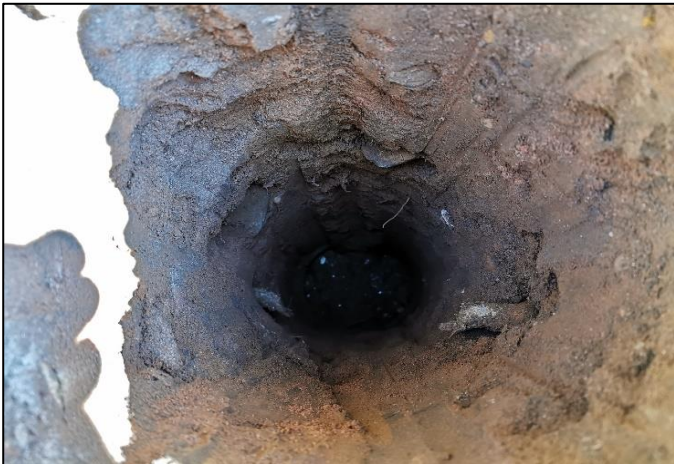
1 HD1

The ground investigation found two layers of Made Ground at depths between 0.55 and 0.60m with an orangish brown gravelly fine to coarse sand beneath. In HD1 the Made Ground comprised of a greyish brown, very gravelly slightly silty fine to coarse sand with low concrete cobble size fragments to 0.18m. The second strata to 0.55m, comprised of a light brown gravelly fine to coarse sand with low stone cobble size fragments. HD1 soil sample, 0.25-0.35m, showed no elevated levels of the contaminants tested.

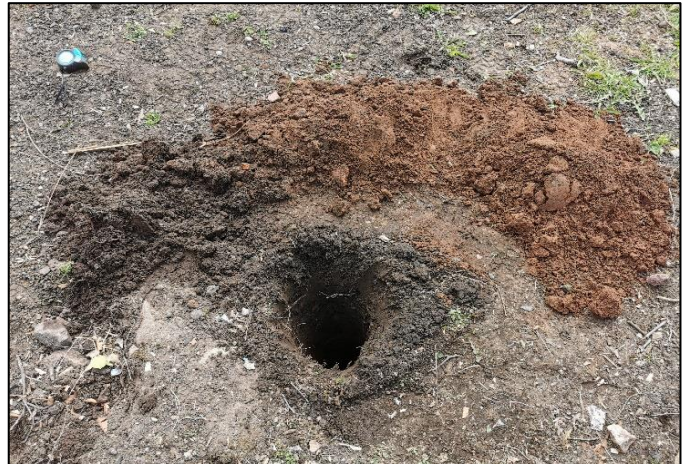
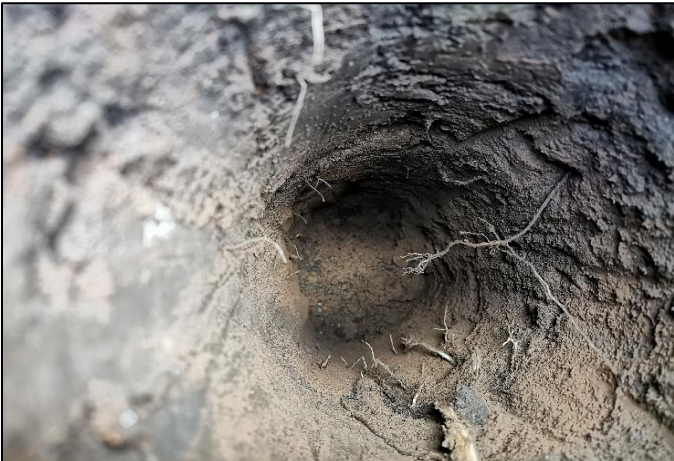
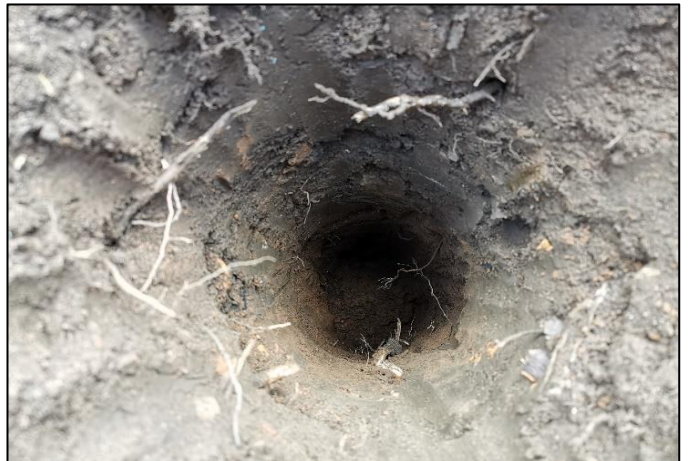
The Made Ground found in HD2 and 3 was first comprised of a topsoil at depths between 0.30-0.35m and was composed of a dark brown gravelly silty fine to coarse sand with some rootlets. In HD3 at 0.20m, fragments of an old metal cable were identified. Gravel sized fragments included stone, brick and occasional tile. HD2, 0.35 to 0.60m, Made Ground then consisted of a light brown, gravelly fine to coarse sand with occasional rootlets and the gravel sized fragments were of stone and brick. In HD3 the Made Ground comprised of a brown gravelly, slightly silt fine to coarse sand with occasional rootlets and the gravel sized fragments were of stone and concrete. HD2 and 3 soil samples, 0.10-0.20m identified elevated lead levels and an elevated benzo(a)pyrene level in HD2.

We recommend that the made ground encountered in the hand excavated trial pits to a depth of up to 0.60m is excavated out and disposed of at an appropriately licenced tip. The remaining natural strata should then be sampled and tested to confirm that all the contaminated material had been removed. The level could then be built up as required with a clean topsoil material.

Alternatively, a 600mm blanket of clean topsoil/ subsoil (equivalent to two spade depths) could be provided on top of the contaminated made ground to break any pathway for the contamination. In addition, any deeper rooted bushes and trees should be pit planted on and in clean topsoil.
