**PHASE 2 GROUND INVESTIGATION REPORT FOR PROPOSED  
RESIDENTIAL DEVELOPMENT AT THE  
FORMER CROWN PUBLIC HOUSE IN MOBBERLEY, CHEADLE.**

**Date:** 19<sup>th</sup> June 2019  
**Our Ref:** ML/27226  
**Revision:** Rev 1

**Client:** AJ Developments  
Grosvenor Garage  
Teon Road  
Cheadle  
Staffs  
ST10 1LQ

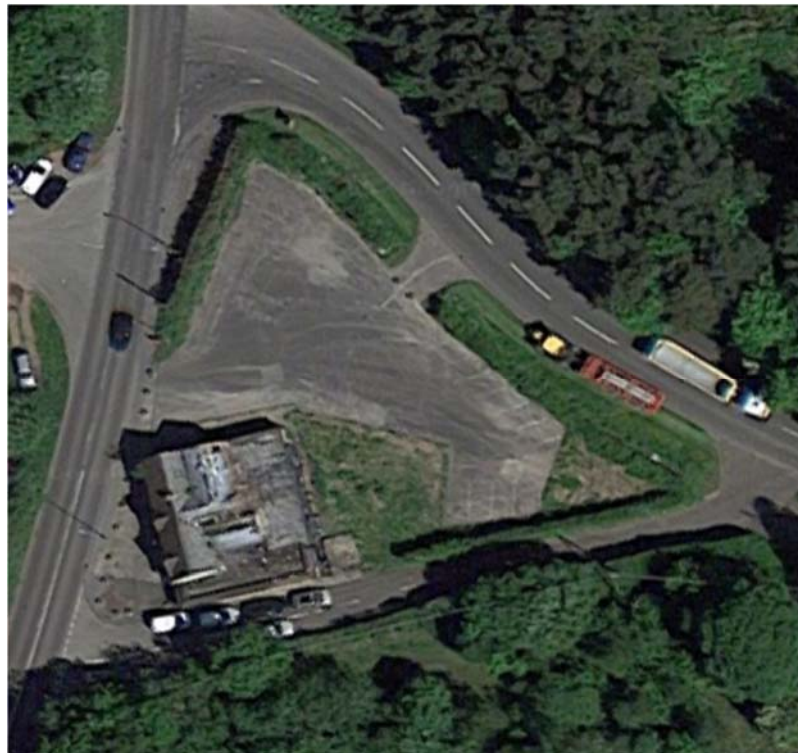
Aerial image of the site.

- 2.1 At the time of the walkover the site consisted of a triangular plot of land bound by Tean Road to the west, Freehay Road to the north-east and another unnamed road to the south. The former Crown Public House building was still standing in the south-western corner of the plot, it is understood that a basement was located beneath the western older portion of the building. The remainder of the plot was covered with hardstanding and small areas of rough grass. The site gently sloped from the east to the west. A hedge was located along the northern-eastern, north-western and south-eastern boundaries. At the time of the return visit to site the existing building was in the process of being demolished. The approximate centre of the site is denoted by Nation Grid Ref. 400780, 341360.
