# AB WILDLIFE SURVEYS

## Bat Survey Report

Location: **BRADLEY ELMS FARM, ALTON ROAD, THREAPWOOD,  
Cheadle, Stoke-on-Trent, ST10 4RB**

Date of Surveys: **14<sup>th</sup> July 2018**

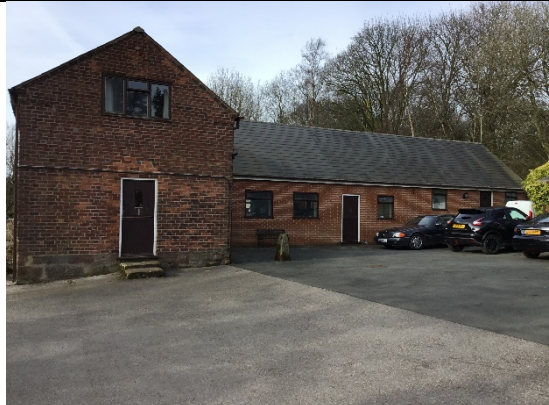
| <p><b>1. Building A</b></p> | <p><b>2. Building B</b></p> |

- 6.2. Externally, as is evident from the photographs, Buildings A, B and C appear to be in good condition; the mortar appears sound and in place and the roof tiles are tight. There were no visible entry points apart from two possible small gaps beneath the ridge tiles on the southern elevation of Building A. Building D is a portal frame building with long axis from north to south and open at the southern end and with a wide entry opening at the northern end. No evidence of bats was found on the outside of any of the buildings.

- 6.3. Internally, the buildings were inspected for droppings and other signs of bats such as feeding remains. None of the rooms in Buildings A, B and C were considered suitable for bats and no evidence of bat use was found in them. There are two roof-spaces in Building A; one in the two-storey part of the building and one at the western end of the single-storey part. Both were inspected using a torch. There are no accessible roof-spaces in Buildings B and C. Building D is open to the roof.

- 6.4. The floor of the roof-space in the two-storey part of Building A is lined with glass fibre and no droppings could be found. The roof is felted with plastic-coated BRM (breathable roof-membrane) which is unsuitable for bats. Height of space about 2.5 to 3 metres. The roof space stretches from across the full width and the full length of the building. With the torch switched off no light penetrated the space indicating that there were no visible entry points into the space. No shredding of the BRM could be seen which would most likely occur if bats used the roof-space and hung on to the roof felt which is where bats regularly hang.

- 6.5. The roof-space in the single-storey part of Building A has glass-fibre insulation on the floor and plastic-coated BRM (breathable roof-membrane) on the roof. The latter is unsuitable for bats. The roof-space is about 2 metres wide and extends the full width of the building and there is a partial sub-dividing brick wall the top of which is missing which would allow bats to fly between the two parts of the space. No bat droppings were found and no evidence of shredding of the BRM could be seen.

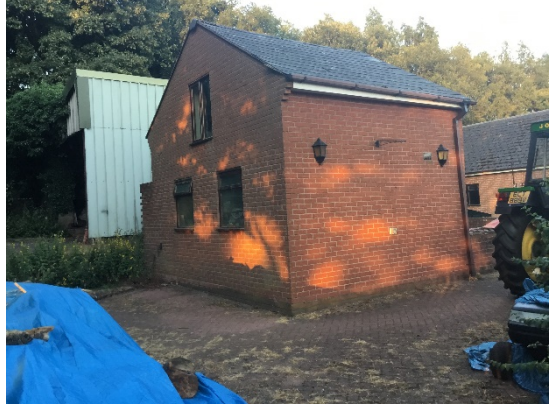
| <p><b>3. Building C</b></p> | <p><b>4. Building D</b></p> |

- 6.6. No sign of bats was found in Buildings C and D.
- 6.7. To provide additional verification of the situation an emergence survey was carried out on the evening of the 14<sup>th</sup> July. The conditions were good for bats, a warm evening about 21 degrees Centigrade, light breeze with two heterodyne detectors used. Sunset was 21:36 hours. From sunset until too dark to observe at around 22.30hrs, no bats were detected emerging from any of the buildings. However, four Pipistrelle bats were seen flying past the western side of the courtyard and building approximately 20 minutes after sunset. These bats were travelling at speed in a direct line from south to north and probably had just left a roost to the south and were going to the north to forage. The speed at which they were travelling made precise identification impossible. However, it
