## **Activity Survey for Bats**

**Lilac Grove Cottage**

**September 2021**

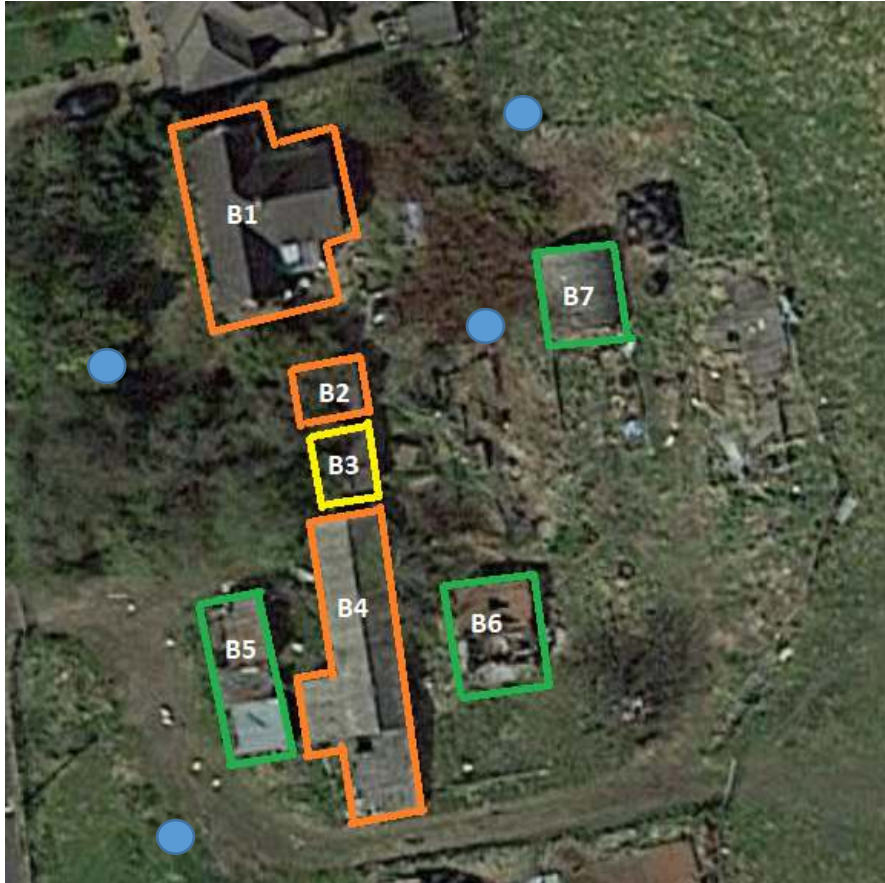
Surveyor location indicated by:

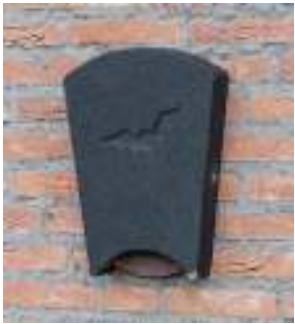
**Table 17:** Example bat features (Photos taken from [www.nhbs.com](http://www.nhbs.com))

| Bat Feature Type | | | |
|---|---|---|---|
| Bat boxes installed external on walls | Beaumaris Woodstone Bat Box<br> | Schwegler 1FQ<br> | Vincent Pro Bat Box<br> |

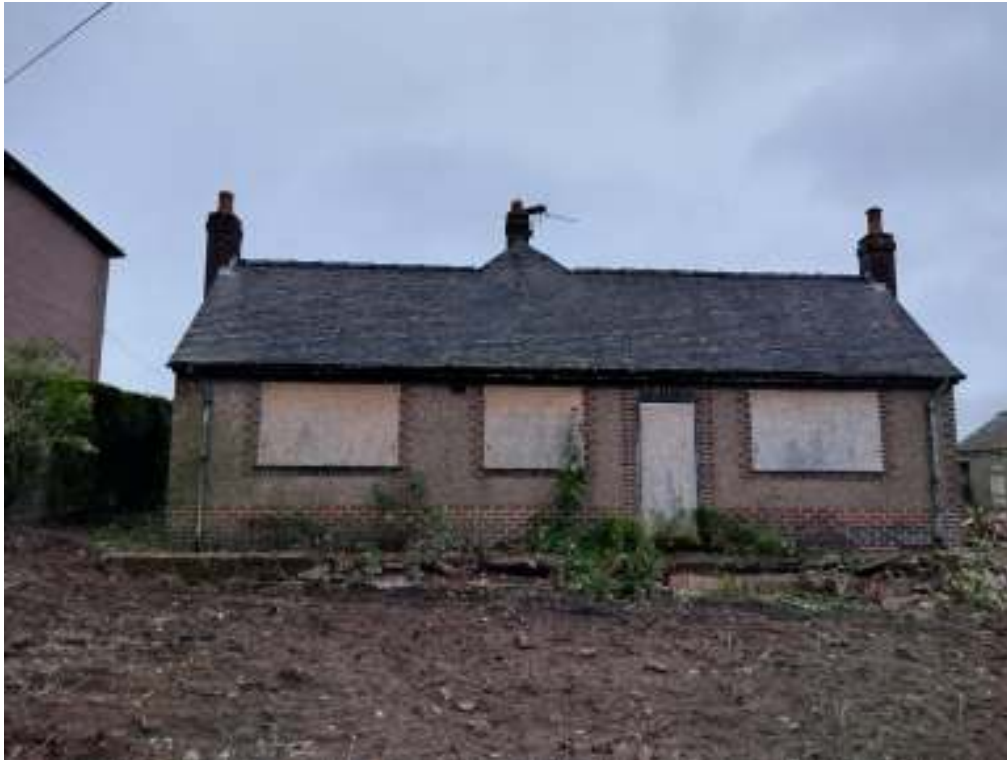
Plate 1: B1 western elevaion

| Building reference | External Inspection | Internal Inspection | Roost assessment category |
|---|---|---|---|
| B1<br>Lilac Grove Cottage | B1 is a brick bungalow with a tiled pitched roof. The walls are externally rendered. All doors and windows are boarded up. The building is in a state of disrepair and has been unoccupied for number of years following a house fire. The roof has a large number of slipped/missing tiles creating potential roosting features, and/or access into the building for bats. | Internally the building is severely fire damaged with the ceiling within the central part (above the sitting room) missing. The roof is lined with black bitumen felt. Due to health and safety concerns a full inspection of the loft was not carried out. The floor of the property is covered in large amounts of debris making finding bat evidence difficult although no obvious signs were found. The main part of the building is coated in soot/ash which may deter roosting bats. | <b>Moderate</b> based on the large number of external roosting features identified across the roof area. |

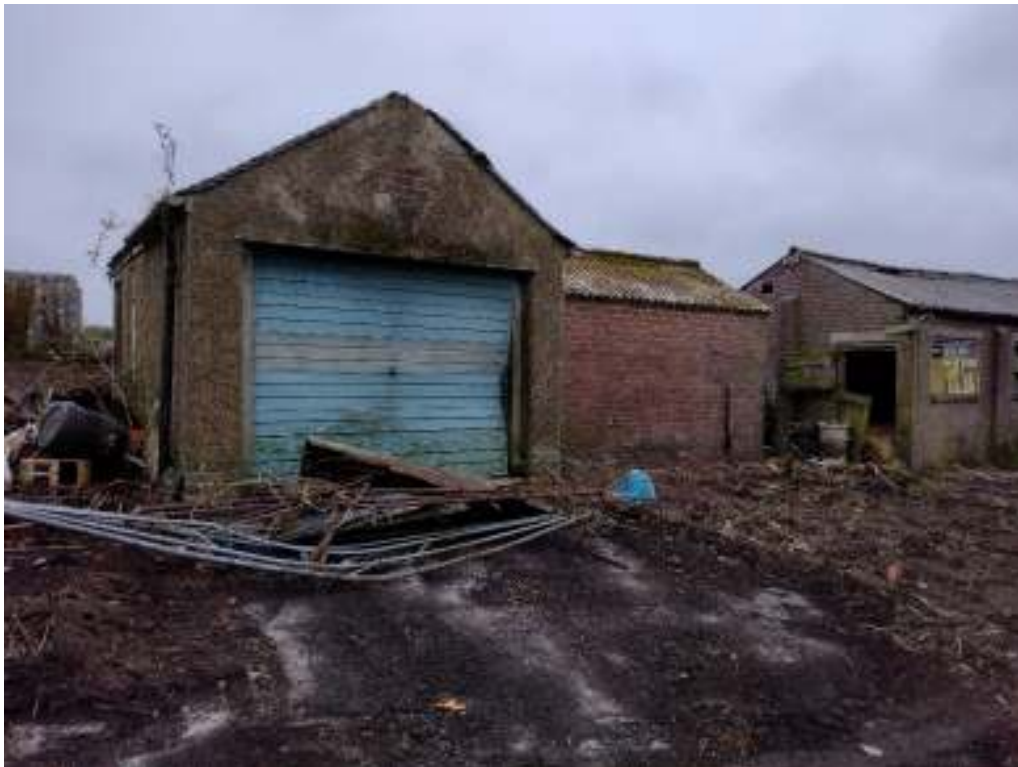
Plate 4: B2 western elevation

| Building reference | External Inspection | Internal Inspection | Roost assessment category |
|---|---|---|---|
| B2<br>Garage | B2 is a brick garage with a pitched tiled roof. It is externally rendered. The main garage door is intact. The side door and windows are open/damaged creating access opportunities for bats and birds. The roof has a large number of slipped/missing tiles, creating potential bat roosting features. | Internally the roof is not lined, and no evidence of bat or bird occupation was recorded. | <b>Moderate</b> based on the large number of external roosting features identified across the roof area. |

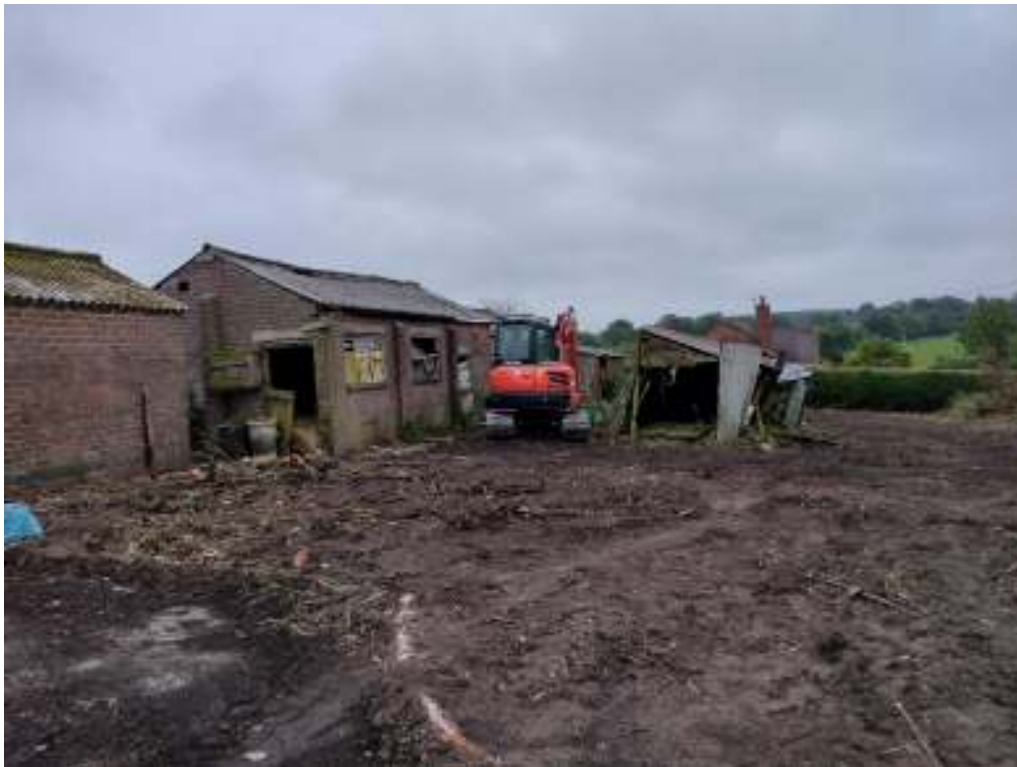
Plate 5: B3 and B4 western elevation, and north and west elevation of B5

| Building reference | External Inspection | Internal Inspection | Roost assessment category |
|---|---|---|---|
| B3<br>Barn | B3 is a brick barn with corrugated asbestos roof (located next to B2). The doors and windows are damaged/remain open creating access opportunities for bats and birds. The roof and walls are intact | Internally the roof is not lined. Occasional crevices noted where the roof joins the walls. No evidence of bat or bird occupation was recorded internally. | <b>Low</b> based on the presence of occasional internal roosting features |

| B4<br>Barn | B4 is a large single skin brick barn with corrugated asbestos roof. Doors and windows are damaged/missing creating access opportunities for bats and birds. The roof varies in condition with some sections damaged with obvious warping of the ridge. | Internally the building is divided into rooms/sections. The roof is not lined. Where damage is severe, water ingress noted. Occasional crevices noted where the roof joins the walls. No evidence of bat or bird occupation was recorded internally. | <b>Moderate</b><br>based on the presence of occasional internal roosting features |
| B5<br>Dilapidated shed (west side) | B5 is a dilapidated shed constructed of timber, metal sheeting and asbestos sheeting. It is structurally unstable. | Not accessed internally due to its unstable condition although it was seen that no roof lining is present and internally is exposed to the elements. | <b>Negligible</b><br>due to a lack of suitable roosting features. |

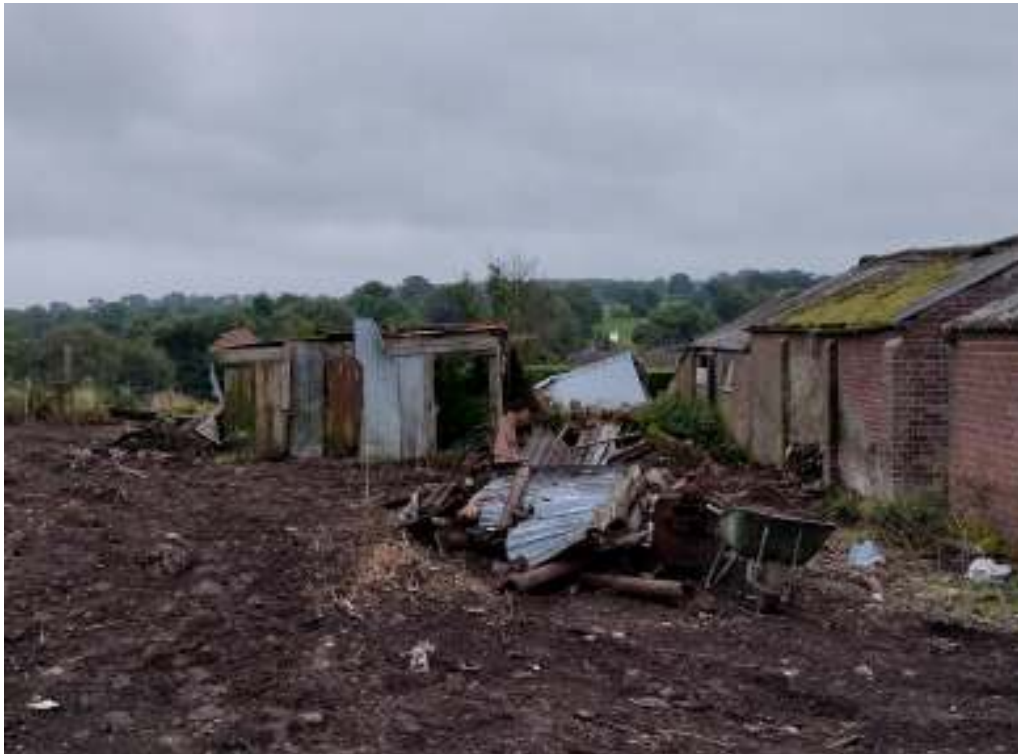
Plate 7: B6 north elevation

| B6<br>Dilapidated shed (east side) | B5 is a dilapidated shed constructed of timber, metal sheeting and asbestos sheeting. It is structurally unstable. | Not accessed internally due to its unstable condition although it was seen that no roof lining is present and internally is exposed to the elements. | <b>Negligible</b><br>due to a lack of suitable roosting features. |

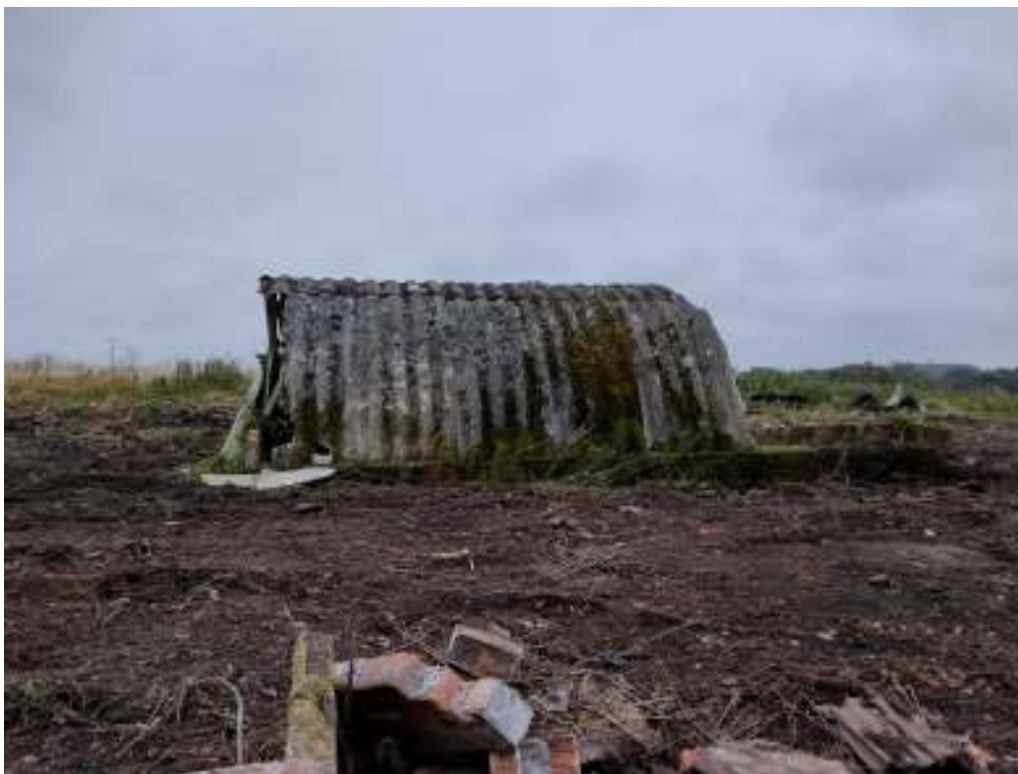
Plate 8: Building 7

| B7<br>Pig sty | B7 is a corrugated asbestos, arched building (pig sty style). The asbestos is damaged in places and the building lacks a door. | Not accessed internally due to presence of damaged asbestos although it can be seen that no lining is present and it is internally exposed to the elements (reducing suitability for roosting bats). | <b>Negligible</b><br>due to a lack of suitable roosting features. |
