**FORMER COACH HOUSE AT THE OLD  
VICARAGE, LONGSDON, STAFFORDSHIRE**

**PRELIMINARY ROOST ASSESSMENT  
OF BUILDING**

**March 2021**

| <b>Reference number</b> | <b>NW/210318</b> |

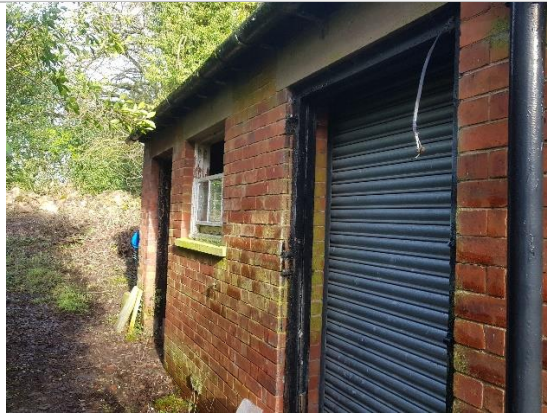
- 3.7 There are four wooden sash windows in the western wall of the building and a fifth on the northern gable. There are two small casements on the eastern wall and one on the southern gable. All of these windows are well sealed with no gaps around the frames, although one of the sash windows was open at the time of survey. A large. There is a large wooden sliding vehicle door on the southern gable end. A roller shutter door is located on the western wall. This has a gap along its top, approximately 80mm wide and provides a suitable egress point into the interior of the building for bats.

**Plate III. Roller shutters and open window and door along the western elevation.**

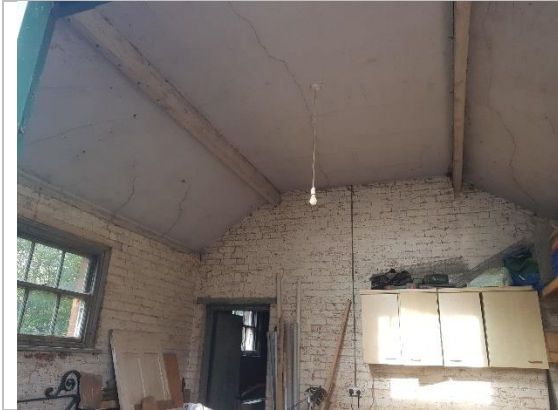
**Plate VII. Southern room with bare brick walls and plastered lath ceiling.**

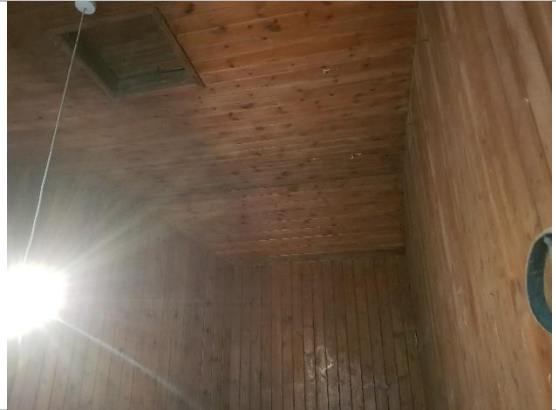
**Plate VIII. Second room clad in pine tongue and groove boards.**

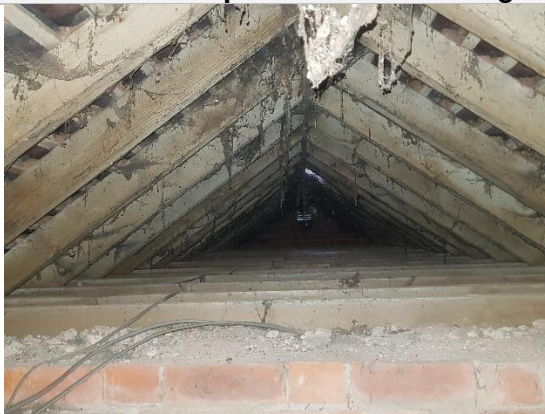
- 3.9 The roof void runs the length of the building between the gable ends and is approximately 1m in height to the apex. Much of the torching has been regarded from the underside of the tiles and forms a deep layer of mortar debris between ceiling joists. Cobwebbing is present throughout the roof void. There are crevices between rafters running towards the eaves where the sections of ceiling slope down from purlin height. Several gaps associated with lifted or broken common tiles and missing mortar under ridge tiles are evident in the roof void.

**Plate IX. Roof void looking northward. Gaps showing along the ridge, toward the gable wall.**

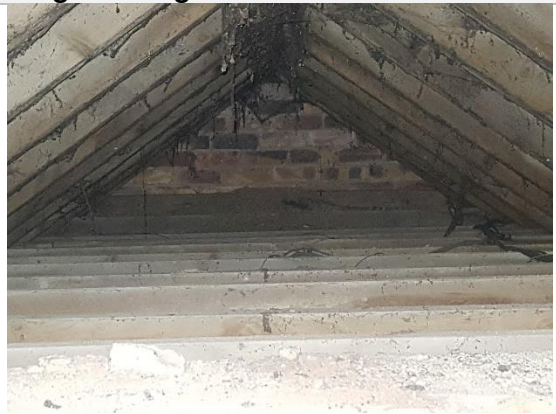
**Plate X. Roof void looking southward with no division.**
