## **Lower Whitemore Farm, Whitemore, CW12 3NF**

### **Arboricultural Report**

*December 2021*

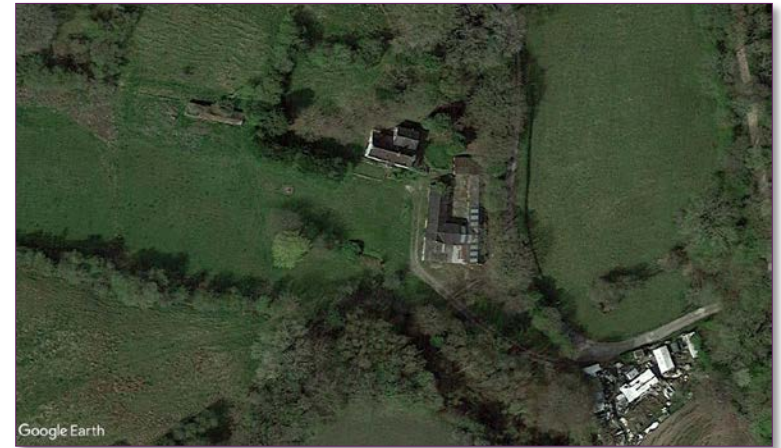
**Figure 1**

The site is a detached property in mature grounds with a workshop. It is a rural location accessed by a track from the A527. It is located to the west of the Biddulph Valley Way (Figure 1).

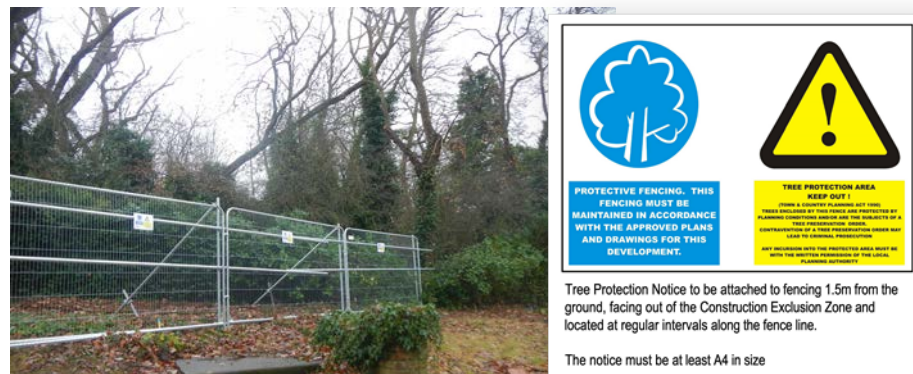
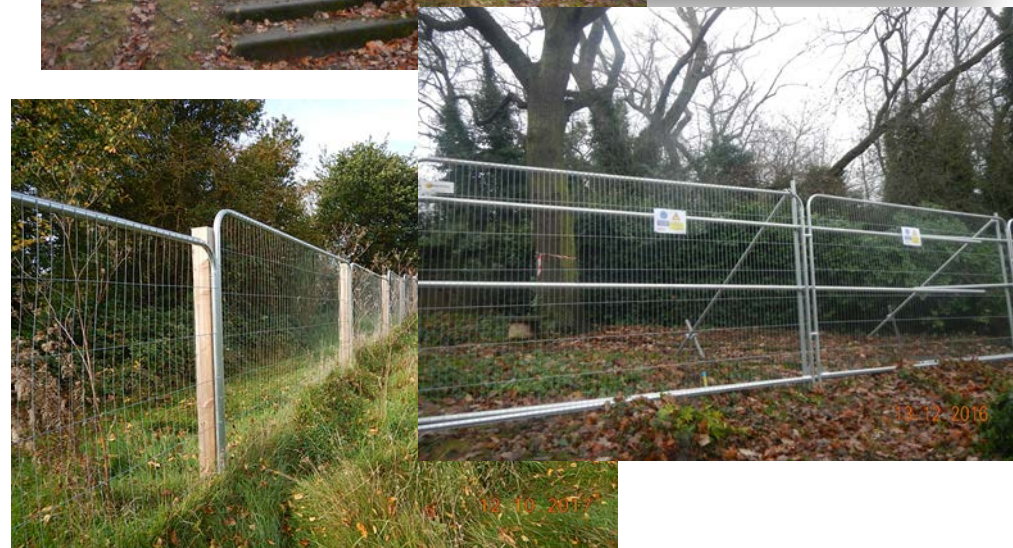
Due to the nature of the works, standard BS 5837 fencing will be used. The Construction Exclusion Zone fence will be heras fence panels fixed to a scaffold framework. Alternatively, heras panels fixed to timber posts. The location will be marked on site by the Arboricultural Consultant and are also shown on the Drawing No. – TPP/4515/Y/300. The requirement will be assessed on a weekly basis by the ACoW.

- Heras fencing fixed to a scaffold framework or timber posts as illustrated.
- Fencing installed at locations shown on the plan (TPP/4515/Y/300) and marked on site.
- Location and adequacy signed off by Arboricultural Consultant and LPA advised.
- Tool Box Talk – make construction staff aware of the importance of areas by site manager.
- Signs to be erected advising of the area's importance.
- Fence to be adjusted as noted in the Construction Timetable.

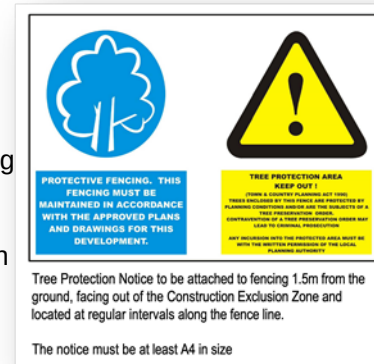
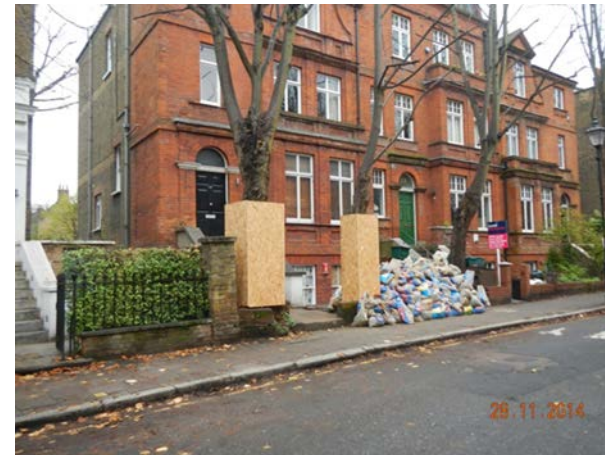
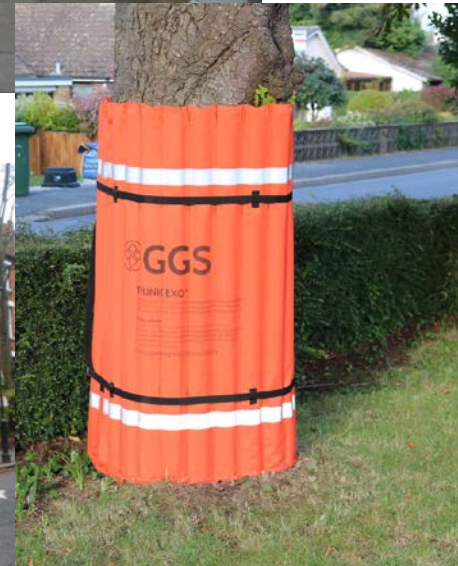
Due to the restricted nature of the site standard BS 5837 type fencing will not be used. Instead the trunk of the prunus T2 and beech T3 will be encased in plywood on a timber framework (image below). Alternatively, Trunk Protecta® by Greengrid Systems, Winchester can be used.

- The plywood box section constructed around the tree trunks.
- Plywood boards (24mm thickness EN 636-2 EN 314-3 CE4 CE2+ E1 – Grade - C+ / C) to be used.
- Location and adequacy signed off by Arboricultural Clerk of Works and LPA advised.
- Works to be monitored by Arboricultural Consultant.
- Completion to be reported to the LPA and signed off by Arboricultural Consultant.
- Tool Box talk.

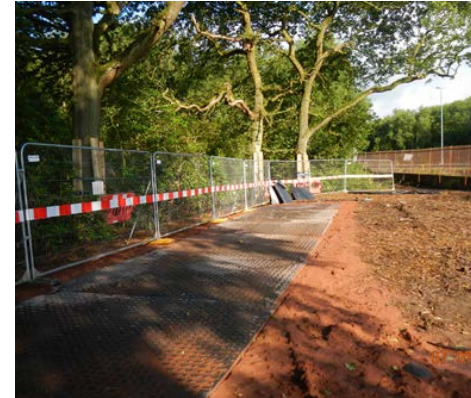
The Construction Exclusion Zone for T6 will be protected by Tuff Trak over a sand blinding. Adequate protection of trees requires the installation of the correct ground protection at the locations shown on the Drawing No. – TPP/4515/Y/300.

- The following applies to Tuff Trak (other systems follow a similar installation procedure).
- The existing grass and ground cover and any hard surfaces are to be removed by hand working.
- Permatex 300 geotextile to be laid with a sharp sand blinding layer, or wood chip compressible layer to bring to level.
- Tuff Trak laid over. This surface will be retained through the contract to form a working surface.
- Location and adequacy signed off by the Arboricultural Clerk of Works and the LPA advised.
- Works to be monitored by Arboricultural Consultant.
