# ECOLOGICAL APPRAISAL

LOWER WHITEMORE FARM, WHITEMORE,  
CHESHIRE, CW12 3NF

13 September 2021

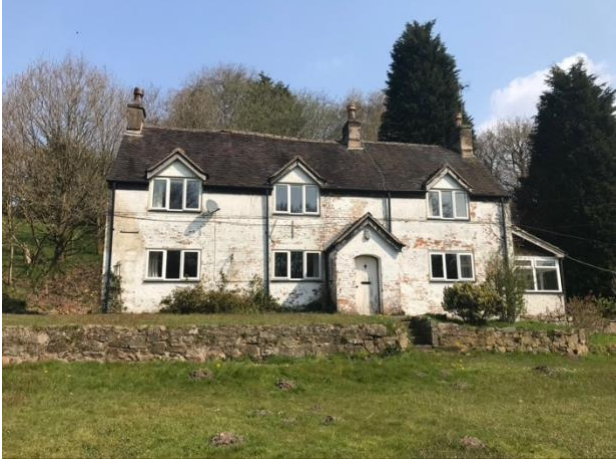
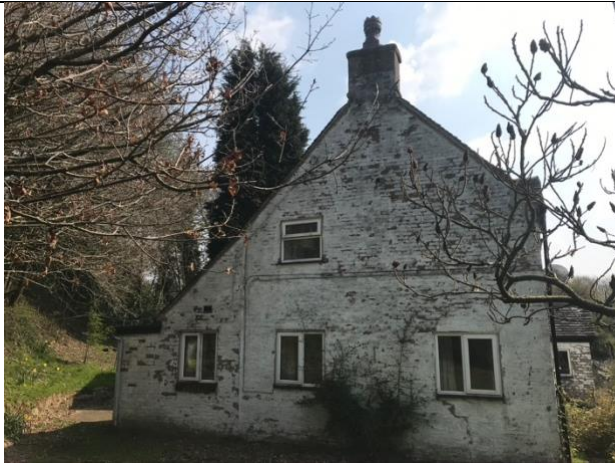
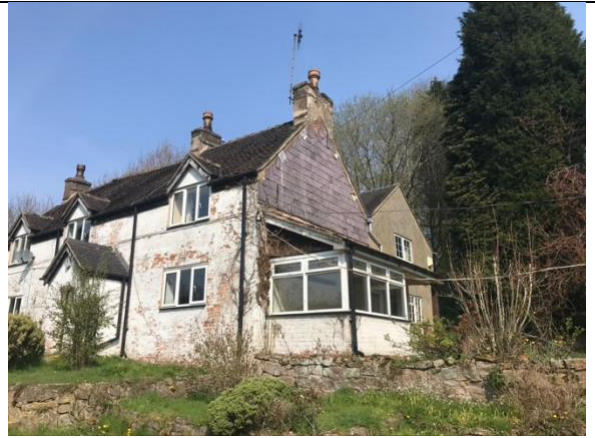
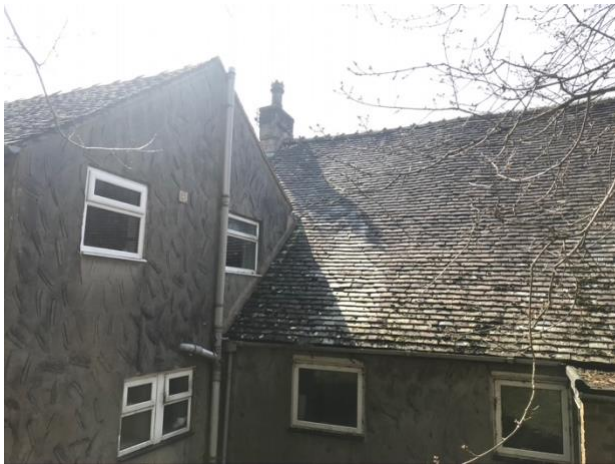
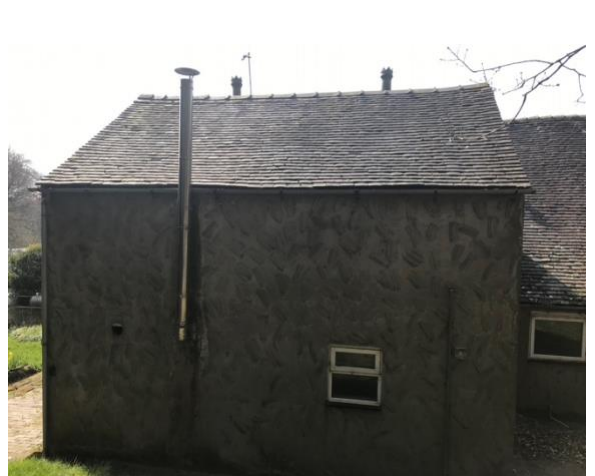
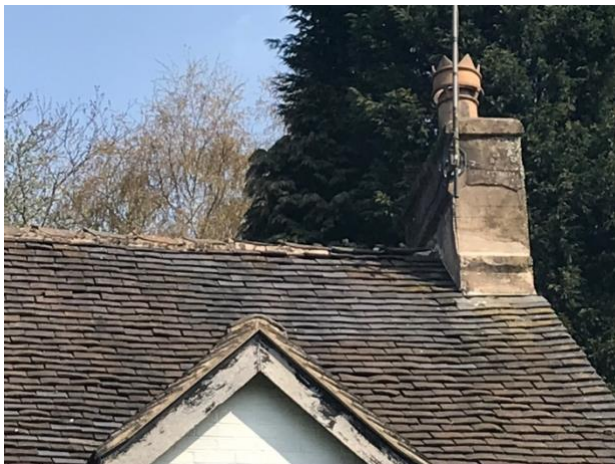
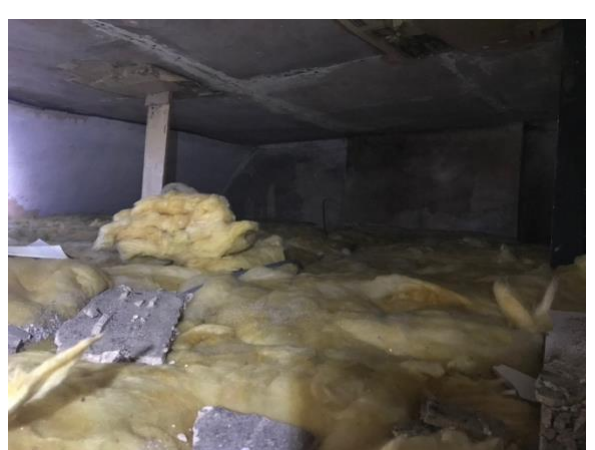
| Feature | Description |
|---|---|
| | <p>Painted brick detached farmhouse with slate roof and lead flashing. Timber windows and doors, all of which were in reasonable condition with no gaps. The roof is in a poor state of repair due to subsidence. This has created numerous gaps and crevices under the ridge slates and under some roof slates. There is a gap between the timber and bricks on the front porch.</p> <p>Internally, the ground floor and first floor are unremarkable. The loft space is divided into 3 separate sections, all of similar character and accessed via three different loft hatches. Lofts were small with a height of between 0.4m and 1.0m. Timber boarding lines all roofs.</p> <p>No evidence of bats.</p> |

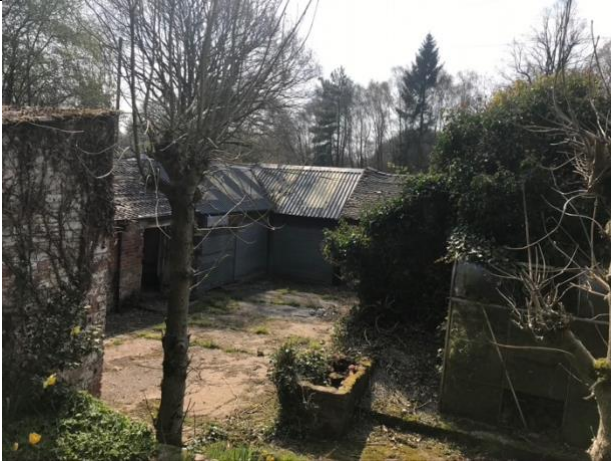
## Outbuildings B2

Brick and slate outbuilding organised around a courtyard, extended on the east and southern side by a steel portal building and single aspect corrugated cement roofs. Northern section comprises brick and single aspect corrugated roof.

The corrugated roof parts of the building are of limited potential for bats, but the brick and slate sections provide numerous cracks, gaps and crevices where bats could potentially roost.

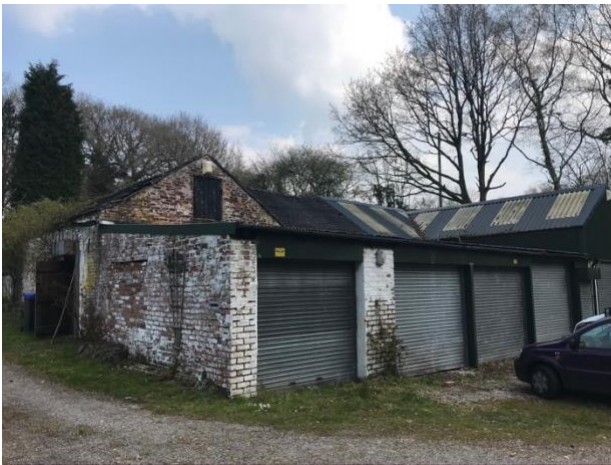
To the eastern side of the outbuilding there is a treeline which overhangs the outbuilding and creates a cluttered environment for bat flight; rendering that side of the building negligible.

Much of the building is well lit in daylight and so would not be suitable for bats that prefer to roost in open spaces/building apex.

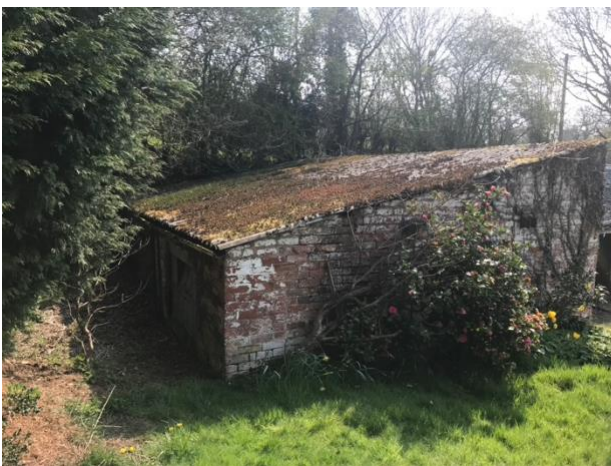
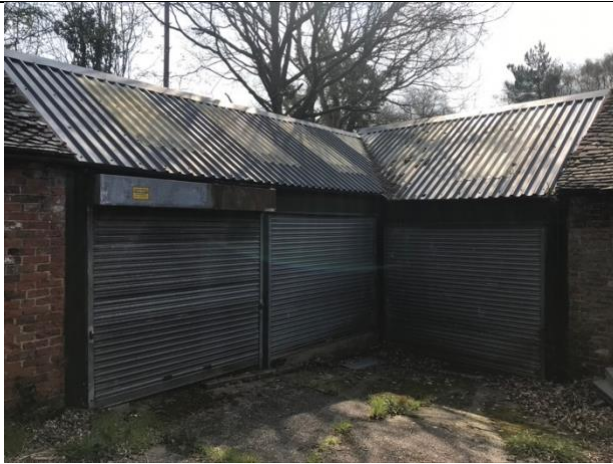
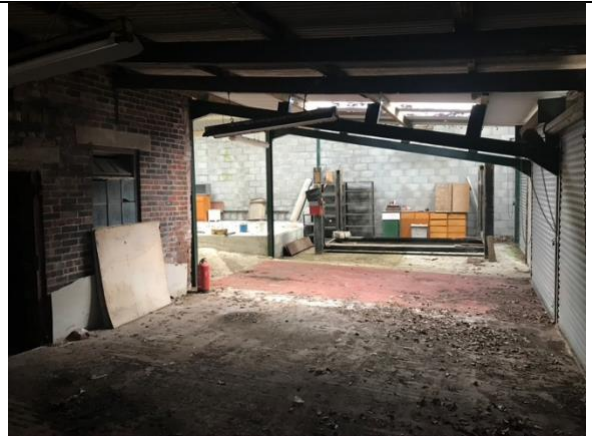
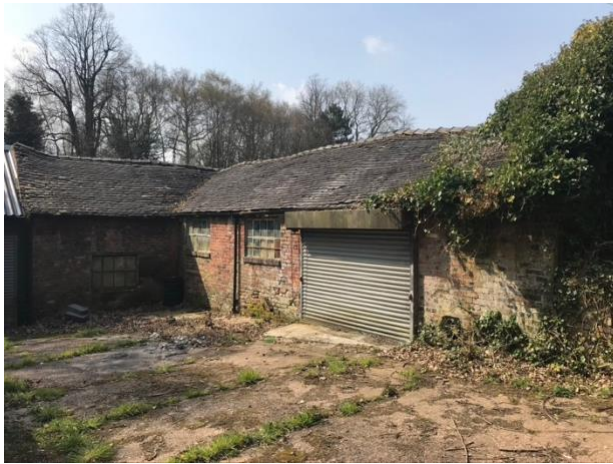
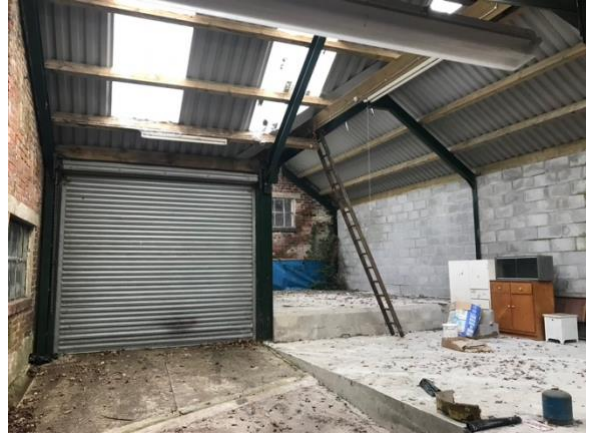
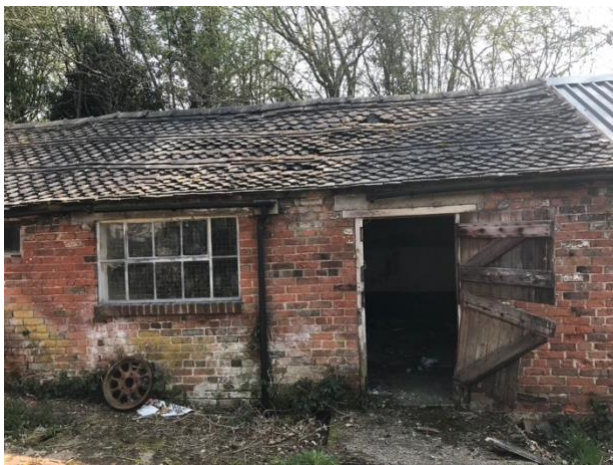
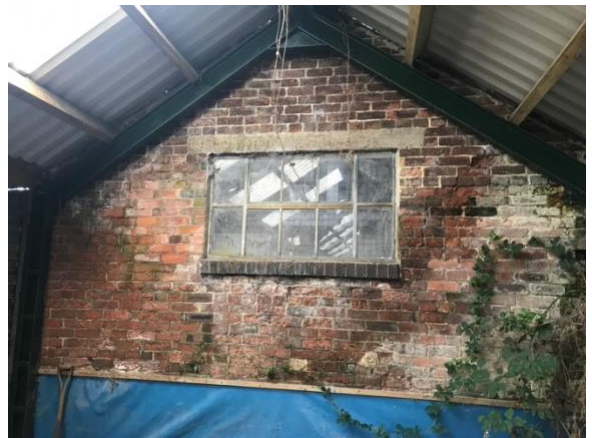
Overall, the brick and slate parts of the building i.e. those within the courtyard and the western elevation, plus the roof that can be viewed from the south are the most suitable for bats.

No evidence of bats.

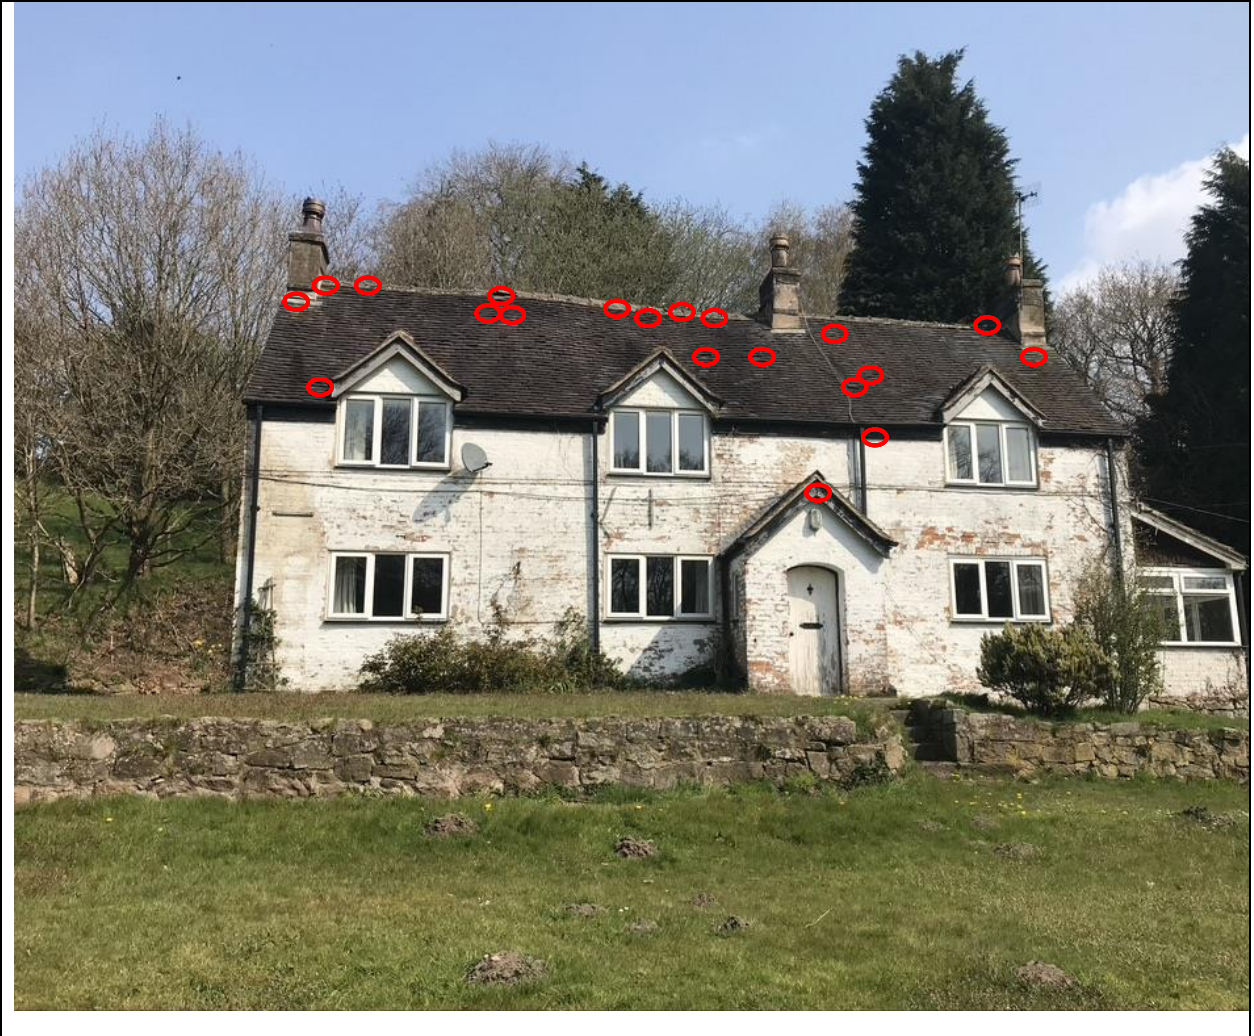
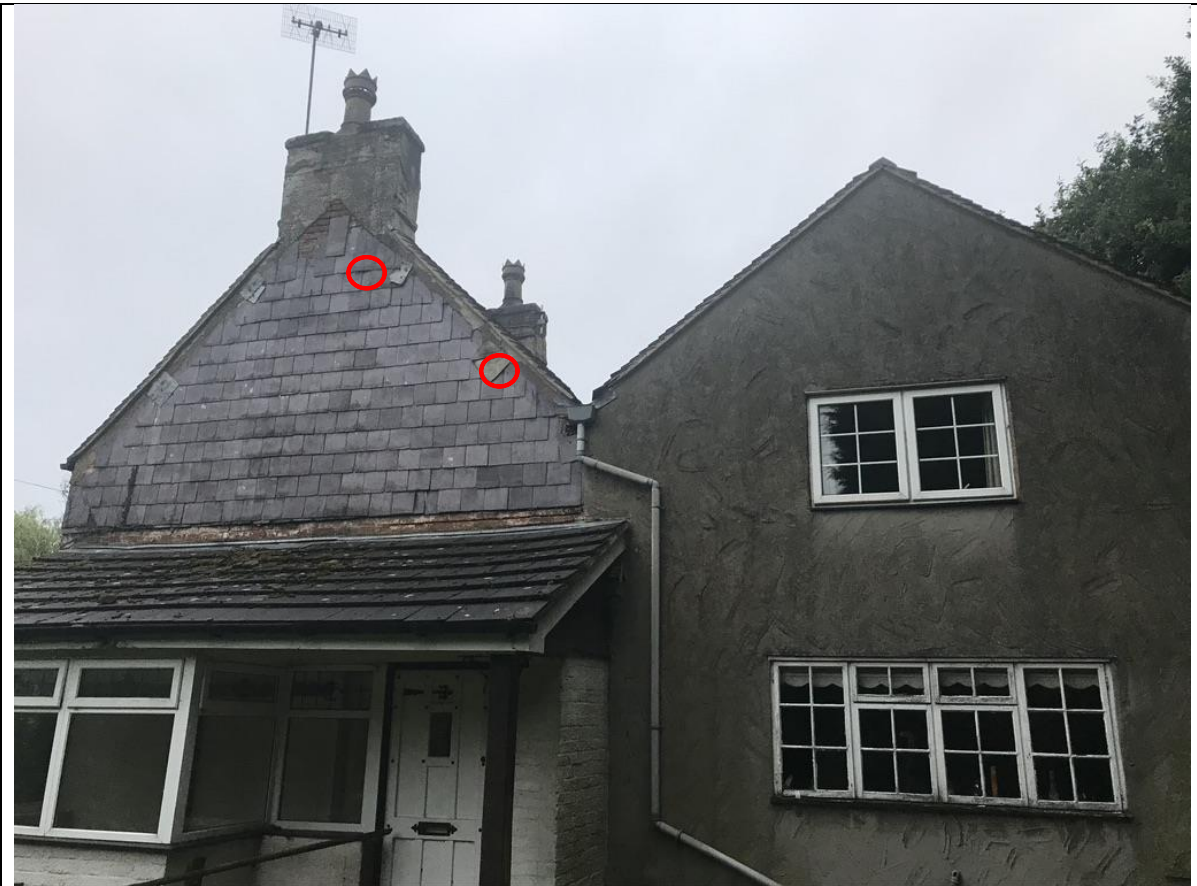
**Table 4.3: Roost Locations – Front Roof**

the timber fascia at the front of the house, the eaves of the porch and on the east side of the building behind wall slates. All roosts were identified on the south or east facing aspects of the house. Bats appeared to use different locations on different surveys, only a small number of locations were used consistently. There was one incidence of a bat re-entering a location at dawn, emerging a minute later and re-entering at another location. So, in the majority of cases, each of these roost access points are used transiently. The following photograph provides locations.

East side of house
