**Report No:** LTM0385.AIA.01

**Project:** Advanced Proteins Facility, Bones Lane, Cheddleton, Leek, ST13 7BT

# **BS 5837:2012 Arboricultural Impact Assessment**

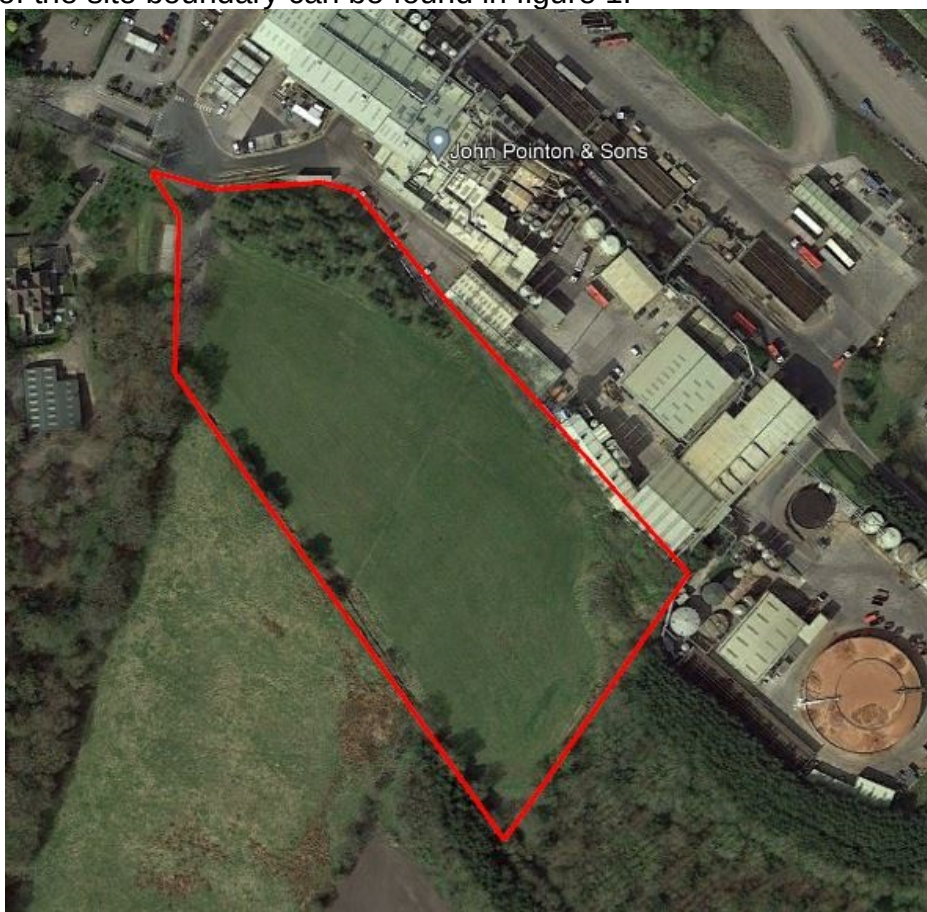
**Figure 1.** Assessment Boundary Plan

An outline of the site boundary can be found in figure 1.

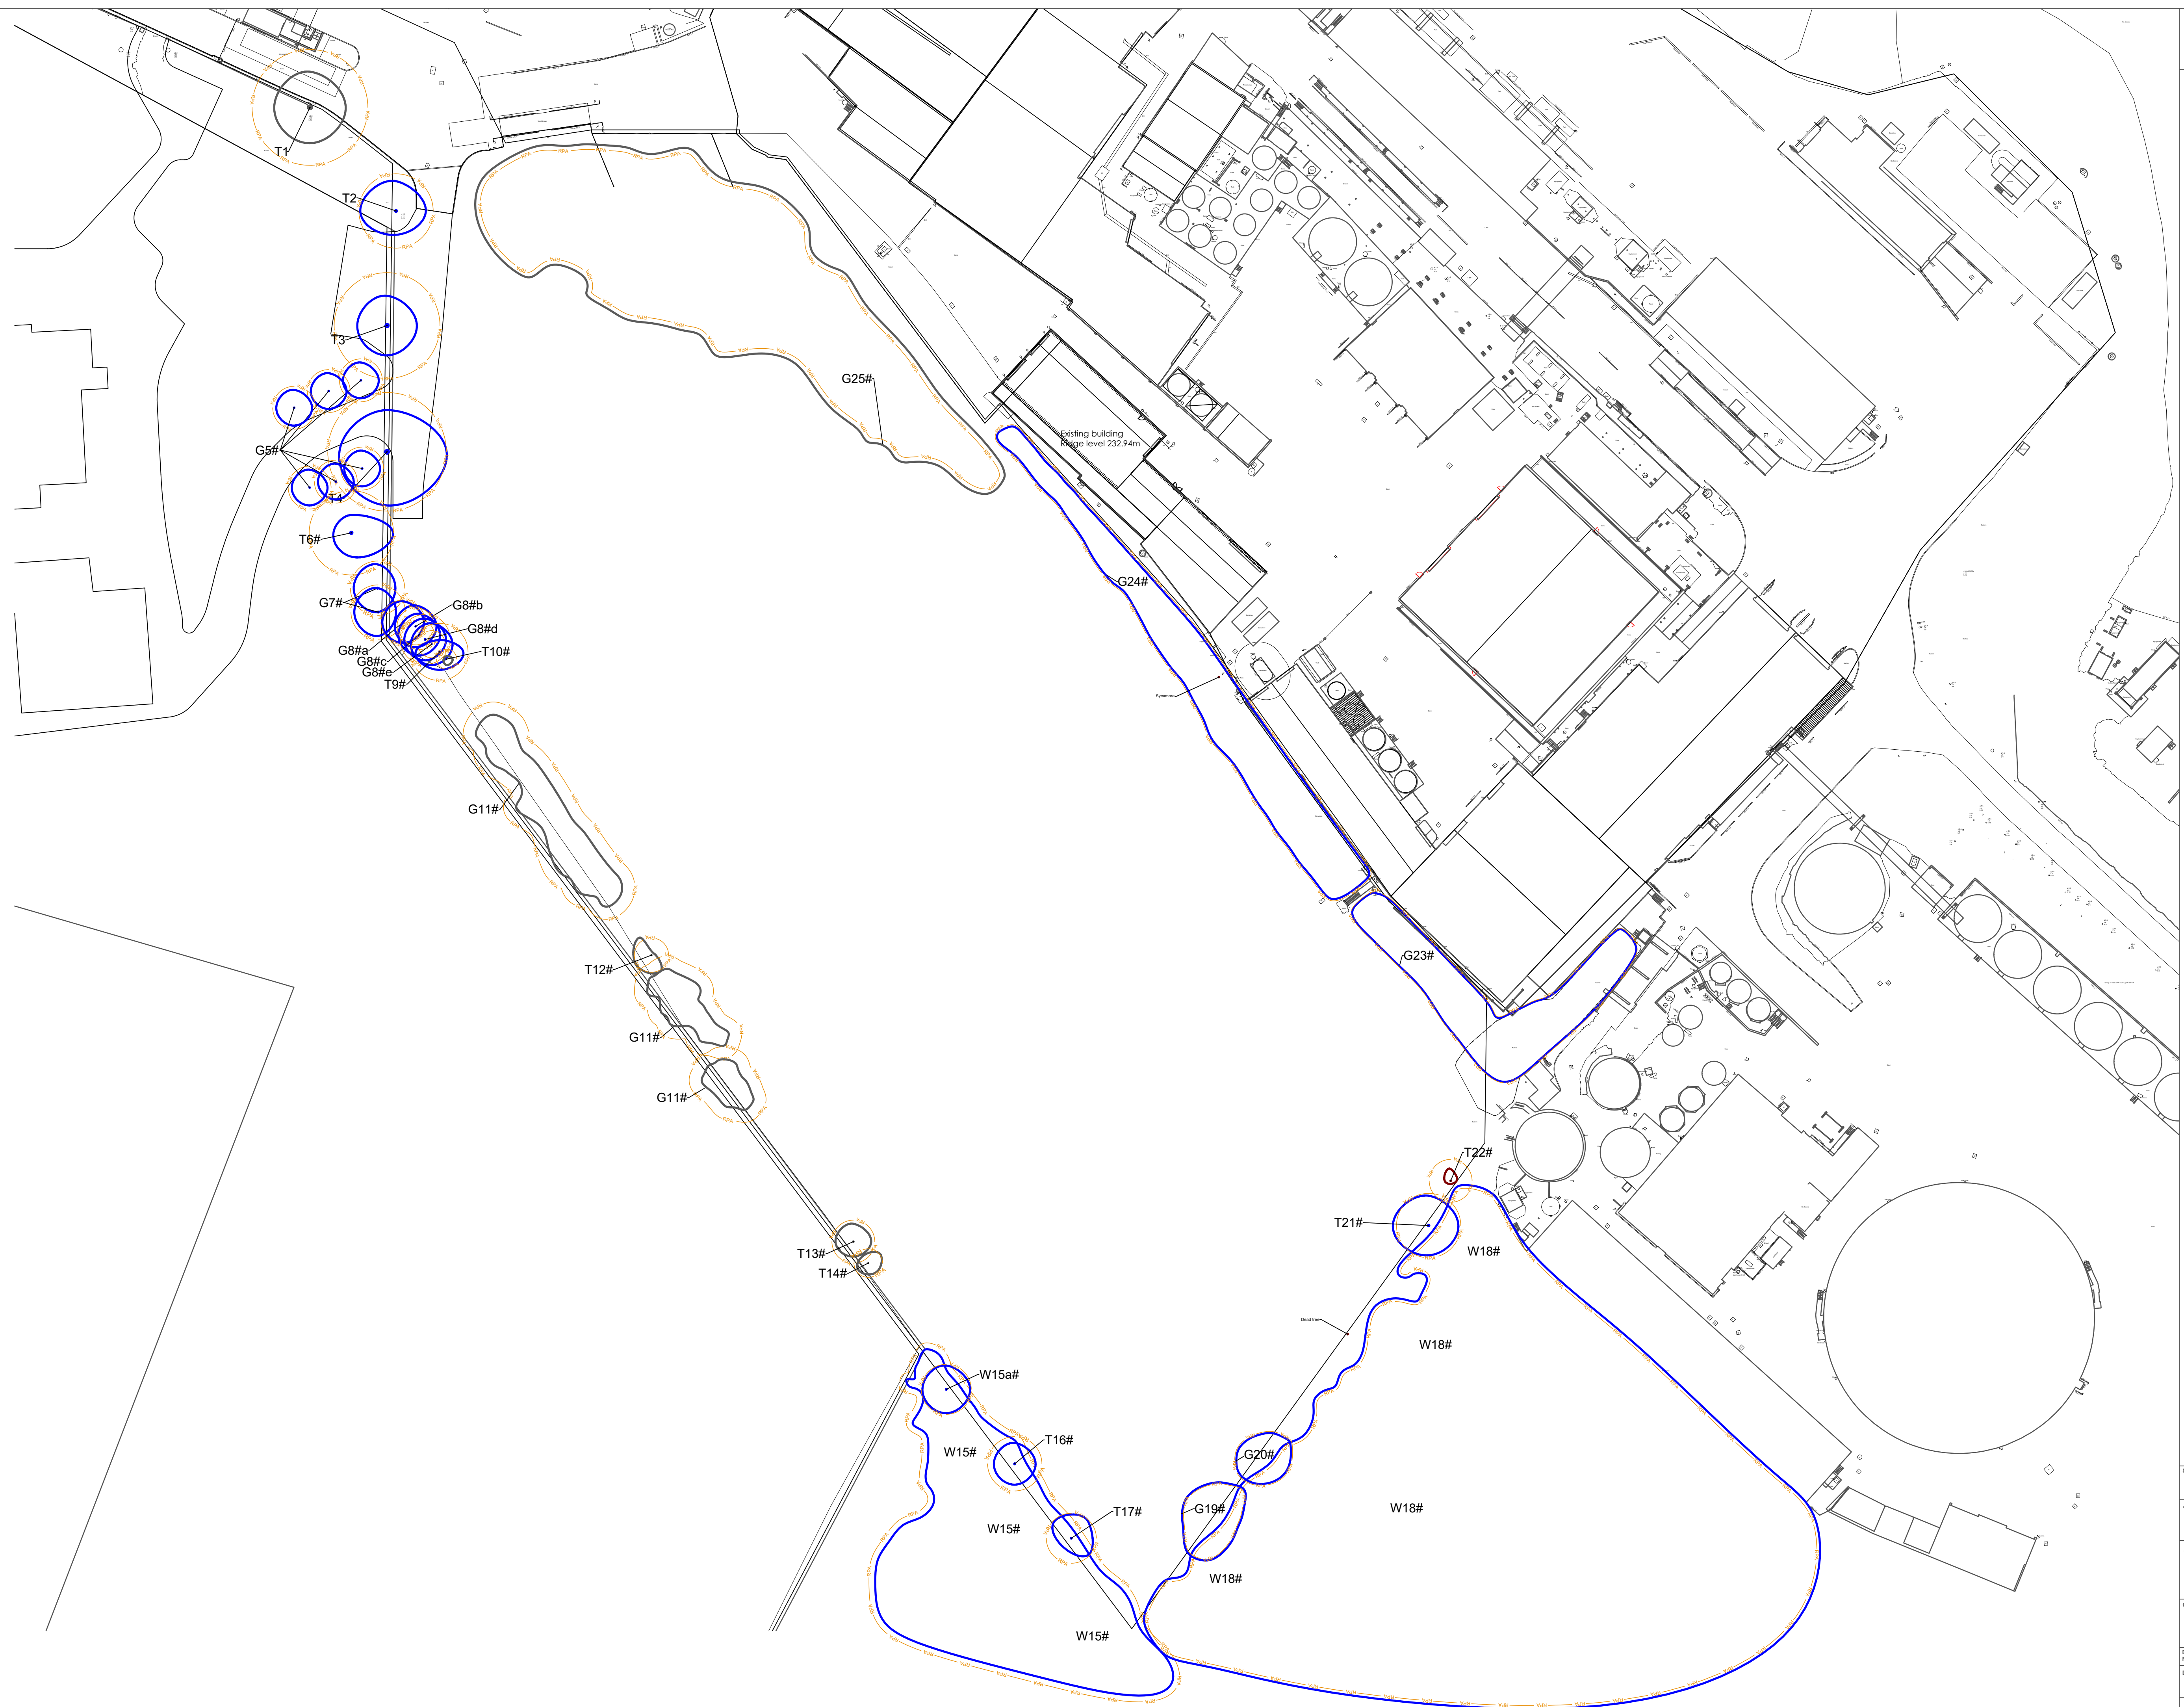
### TREE CONSTRAINTS PLAN

- 
- Category A
- Category B
- Category C
- Category U
- Root Protection Area (RPA)
- #
- Position estimated on site

- 4.0.3 All the trees were assessed using: a grading A to C (retention) and U (removal); condition and age class as defined in appendix two.
- 4.0.4 Where appropriate, canopy spread for each tree was recorded at four cardinal points in order to reproduce an accurate representation of the crown shape of the tree on the tree plan in appendix four.
