**REMEDICATION STRATEGY –  
CONVERSION OF EXISTING  
TEANFORD MILL, TEAN**

**GSL2747R02**

**05 SEPTEMBER 2022**

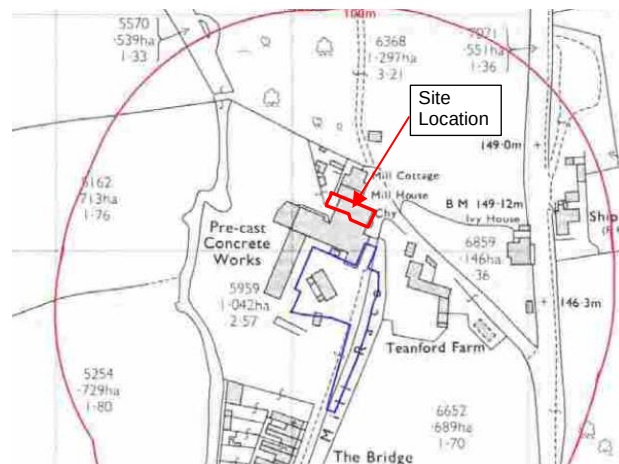
The 1:2500 map of 1969 shows the works has now been changed to a Precast Concrete Works, the mill pond appears to have been filled.

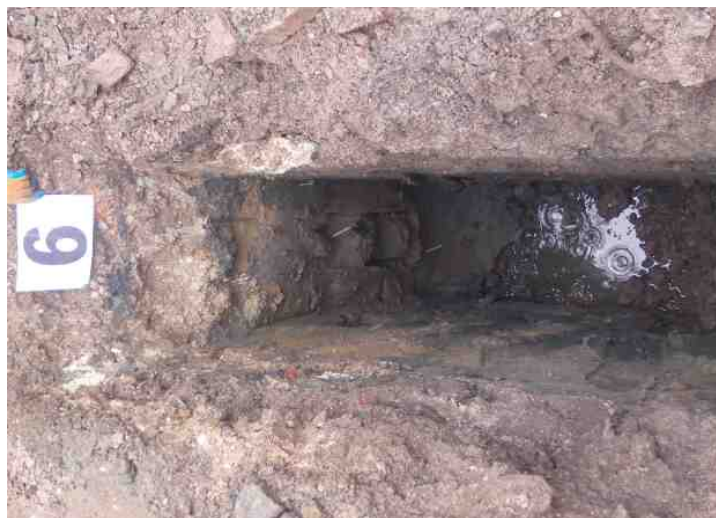
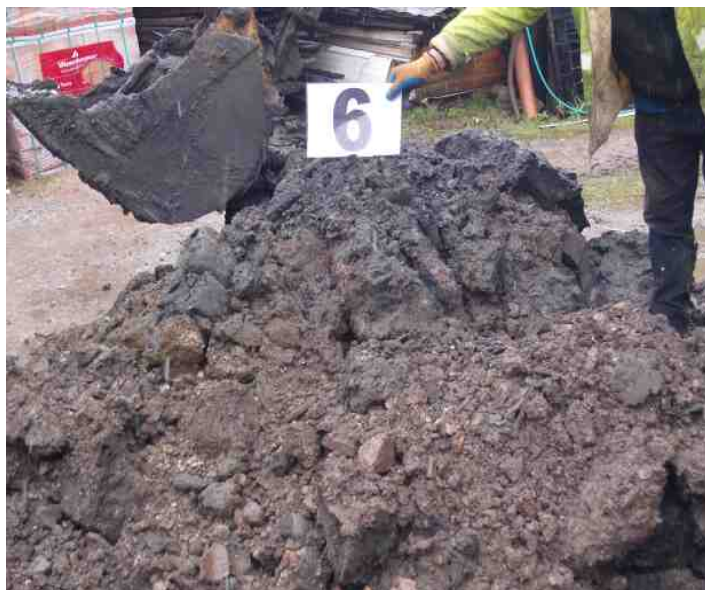
- 1) Excavated with 600mm bucket
- 2) HV1 taken in situ; 33mm vane used

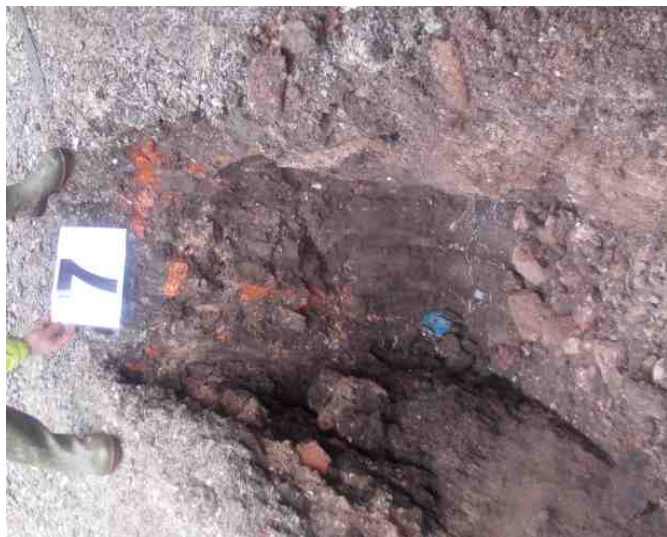
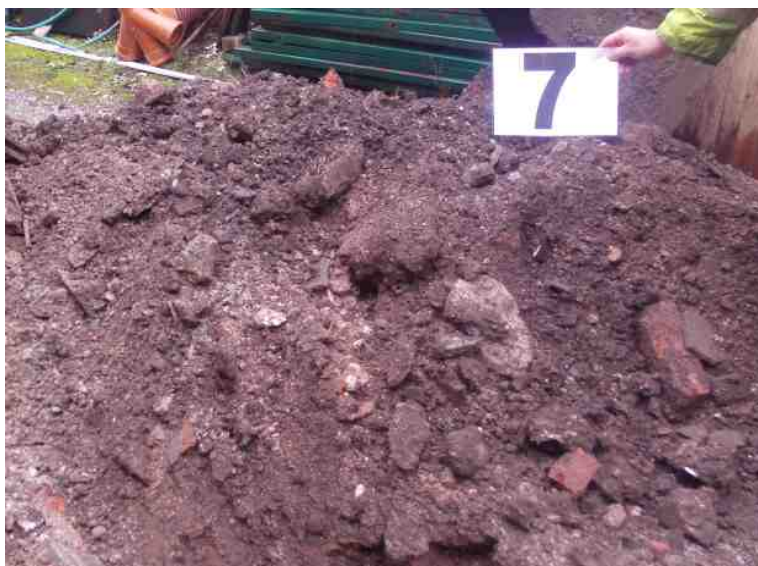
| Field Records | SAMPLES | | Description | Depth & Thickness (m) | Reduced Level (m AOD) | Strata Legend |
|---|---|---|---|---|---|---|
| | | | Very soft, dark brown/grey, silty CLAY<br>--- <i>slow water entry approx. 1.00m</i> | (0.30) | | |

- 1) Excavated with 600mm bucket
