# BAT SURVEY REPORT

**JULY 2022**

**Cornhill Regeneration Project, Leek**

| <b>Title:</b> | Bat Survey Report | | | |

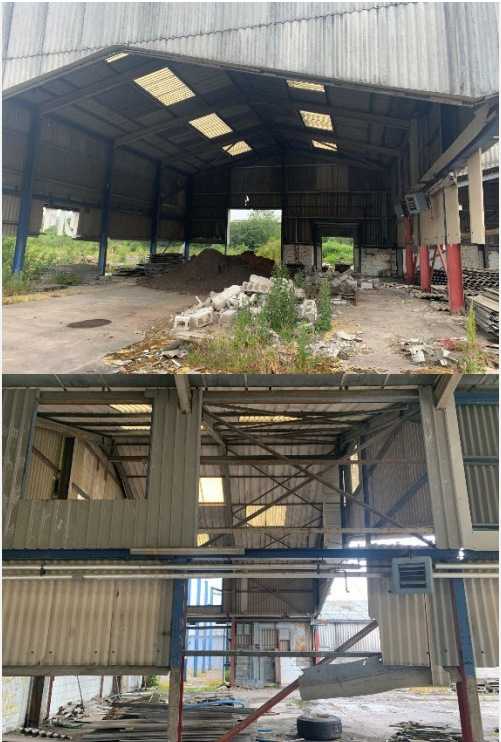
| Building Ref. | Description | Photograph |
|---|---|---|
| B1 | <p>Storage barn constructed of single panelled asbestos, supporting by metal frames. Plastic sheeting was present within the ceiling.</p> <p>No overlapping panels were identified which could provide a suitable PRF, whilst the building was considered too exposed to support non-crevice dwelling species.</p> <p>The building was assessed as <b>negligible</b>.</p> | |

B1 and B3 were identified as being utilised by nesting pigeons. It is also possible that other species, such as white collared doves (*Streptopelia decaocto*) which were spotted within B1, may use the buildings for nesting purposes. An active pigeon nest was identified within the rafters of B1, as well as atop a joist in B3, with multiple pigeons seen emerging from and perching within B2. As such, demolition works may impact nesting pigeons and therefore it is recommended that any works are undertaken outside of the nesting bird season (March – September, inclusive). If this is not possible, it is recommended that a suitably experienced ecologist should check the buildings internally and externally for breeding bird activity no more than 48 hours before any works commence. If nesting activity is found, nests must be left in situ until the young have fledged.

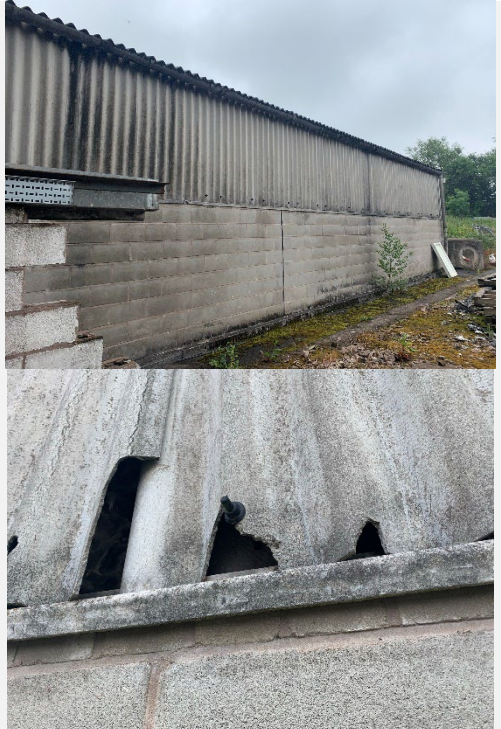
| Building Ref. | Description | Photograph |
|---|---|---|
| B2 | <p>Storage barn located to the east of B1. Its lower aspect was constructed of breeze blocks, whilst the upper elevation comprised double panelled asbestos sheets and roof, supported by metal frame. Multiple roller doors were located on its eastern aspect.</p> <p>Broken asbestos panels were located on the south- western aspect, where a small number of bat droppings were identified underneath demonstrating a bat roost location. Insulation felt was located between the panels for but a suitable gap for crevice dwelling bats in low number was present at the access point.</p> <p>Additional PRFs of similar roosting opportunities include a crack on the southern aspect and access above the roller doors.</p> <p>The building was assessed as <b>high (confirmed roost)</b>.</p> | |

A bat roost was identified at B2 during the PEA site visit in 2021. However, no emergence was identified during the nocturnal bat surveys at B2, nor at any of the other buildings, and it has there been assessed that the buildings present do not support bat roosts. It is likely that the signs observed during the 2021 survey were historical, and no further evidence of a roost was observed during the 2022 survey season.] As such, no further surveys or mitigation is required to facilitate the development relating to bats.

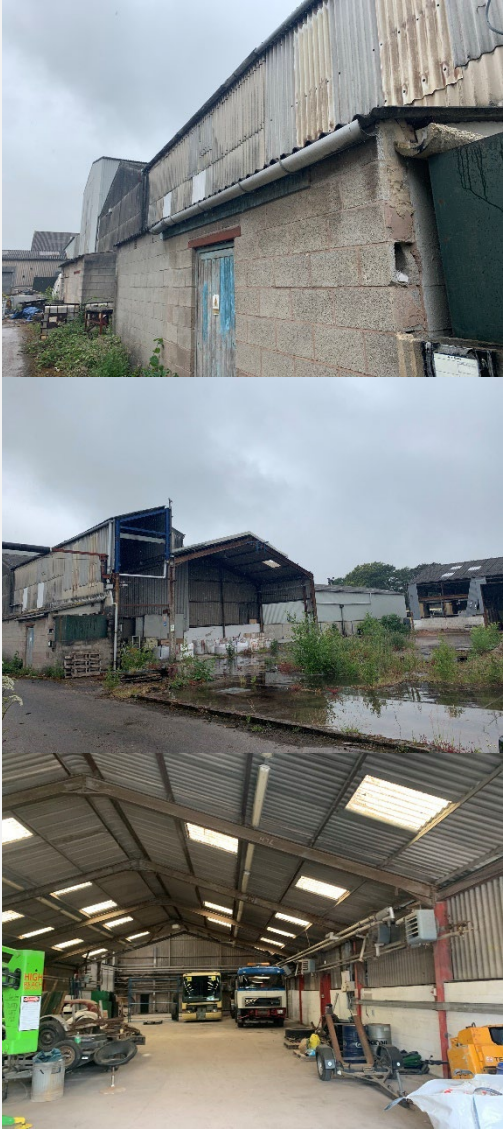
| Building Ref. | Description | Photograph |
|---|---|---|
| B3 | <p>Storage barn of similar construction as B2, and larger in size. Some aspects of the southern wall were constructed of metal panelling rather than asbestos.</p> <p>Northern aspects were constructed of single panelled asbestos with no suitable PRFs noted. However, the southern and eastern aspect were double layered, with a number of cracks present providing a suitable PRF for crevice dwelling bats. An additional PRF was noted within the brick work, where a crack was present.</p> <p>Two single storey breeze block buildings were located to the south of the building. PRFs were identified with cracks within the brick work.</p> <p>Internally, no suitable PRFs were identified with the building comprising bare asbestos and metal panels supported by metal frames.</p> <p>The building was assessed as <b>low</b>.</p> | |

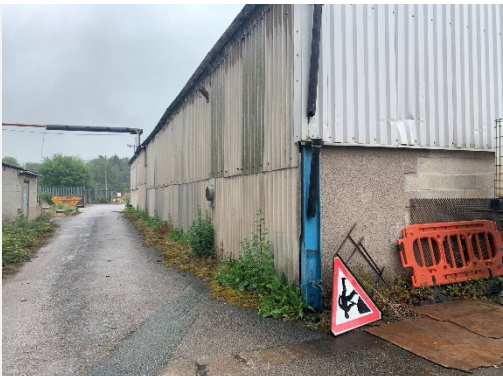
| Building Ref. | Description | Photograph |
|---|---|---|
| B4 | <p>Storage barn of similar construction of B2, though was of single panelled asbestos and metal. Whilst the brick was rendered. A single roller door was located on the eastern aspects.</p> <p>No suitable PRFs were identified during the survey.</p> <p>The building was assessed as <b>negligible</b>.</p> | |

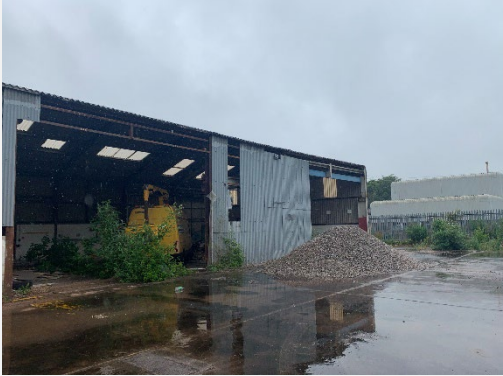
| Building Ref. | Description | Photograph |
|---|---|---|
| B5 | <p>Storage shed, constructed of breeze block walls and single panelled metal sheets. The southern aspect was open, and the building was supported by metal frames.</p> <p>No suitable PRFs were identified during the survey.</p> <p>The building was assessed as <b>negligible</b>.</p> | |

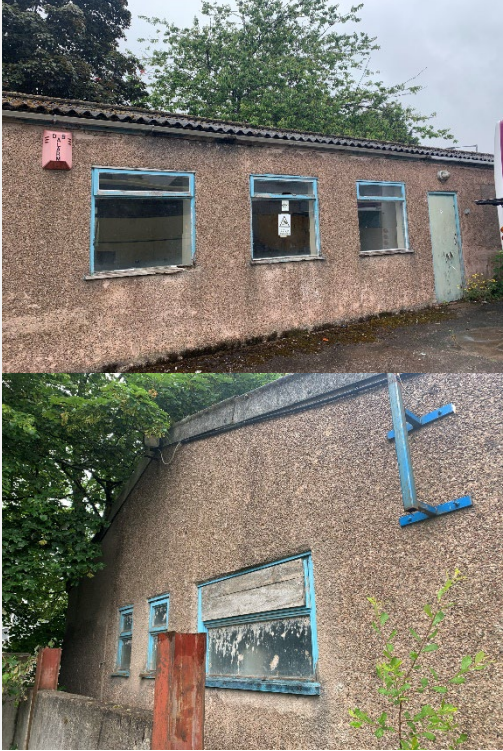
| Building Ref. | Description | Photograph |
|---|---|---|
| B6 | <p>Single storey, pebble dashed building. The roof was constructed of asbestos panels, with plastic guttering and wooden fascia boards. Gaps were located under overlapping asbestos on the ridges and the wooden fascia boards that may provide a PRF.</p> <p>The windows were constructed of wooden frames, with multiple windows open which may provide access to the building.</p> <p>No internal survey could be completed, though by observation through the windows a loft void was identified. Suitable access points to the loft could be gained via the open windows and gaps within the asbestos roof.</p> <p>The building was assessed as <b>moderate</b>.</p> | |

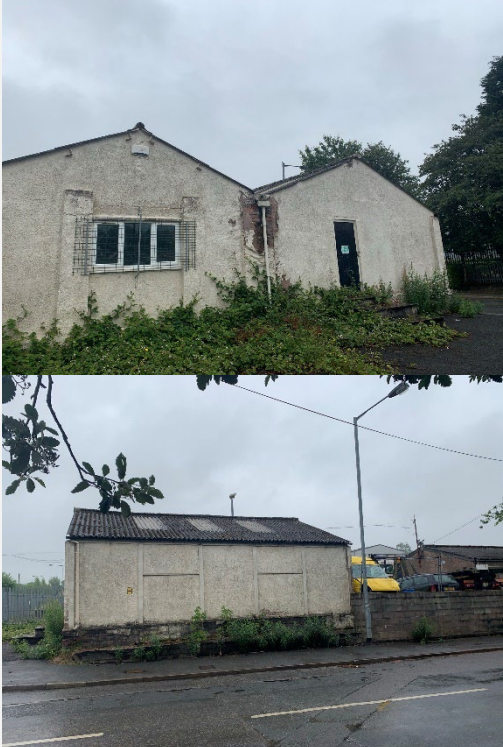
| Building Ref. | Description | Photograph |
|---|---|---|
| B7 | <p>Single storey pebble dashed building, located to the east of B6. No wooden fascia boards were present whilst the building appeared well-sealed in comparison to B6.</p> <p>The wooden framed windows were slightly opened on the southern aspect of the building which may provide internal access to the building. No internal survey was completed.</p> <p>The building was assessed as <b>low</b>.</p> | |

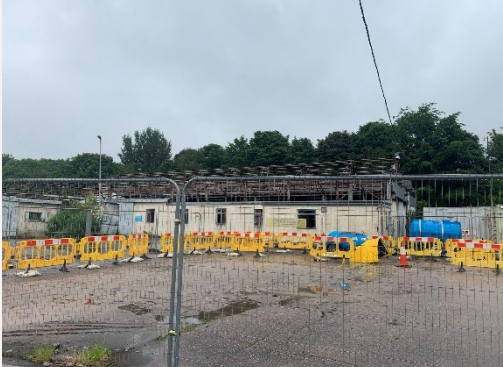
| Building Ref. | Description | Photograph |
|---|---|---|
| B8 | <p>Partially demolished building comprised of single storey painted breeze blocks and metal frames. Single panelled asbestos panels were present on some aspects of the roof though no PRFs were identified during the survey.</p> <p>The building was assessed as <b>negligible</b>.</p> | |

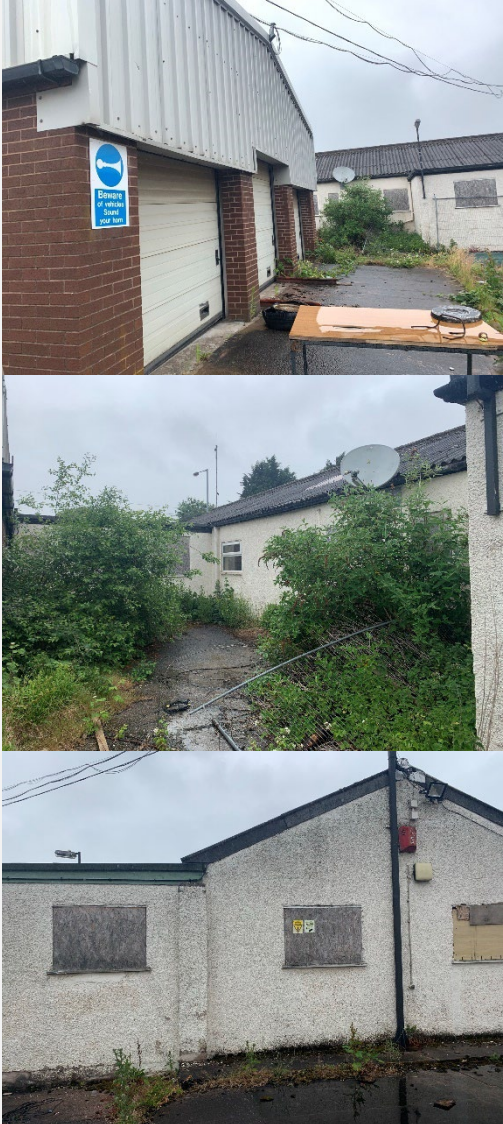
| Building Ref. | Description | Photograph |
|---|---|---|
| B9 | <p>Single storey building comprised of two sections. The northern section comprised rendered walls with a single panelled asbestos roof. Plastic guttering and wooden fascia boards were present. The walls contained no PRFs.</p> <p>Gaps were located under overlapping asbestos on the ridges and the wooden fascia boards that may provide a PRF. The windows were covered in wooden boarding, where bats may roost between the glass window and boards.</p> <p>This aspect of the building contained a loft void which could not be inspected during the survey. Access points to the loft could be obtained via the lifted overlapping asbestos.</p> <p>The southern aspect was of similar construction to B10, with no PRFs identified.</p> <p>The building was assessed as <b>moderate</b>.</p> | |

B9 underwent demolition before nocturnal surveys were able to be carried out, therefore it was not possible to conduct emergence or re-entry surveys on this building. A full suite of surveys was conducted on all other buildings identified within the PEA, Although; it is unknown whether or not the building supported any bat roosts prior to demolition, this does not pose a significant constraint to the assessment provided within this report.

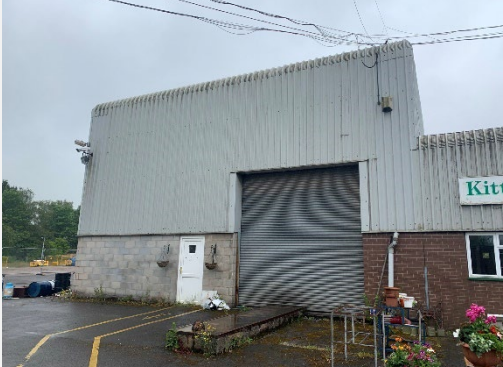
| Building Ref. | Description | Photograph |
|---|---|---|
| B10 | <p>Storage shed constructed of breeze block and red brick on its lower elevation and metal panelling walls and roof. A single roller door was located on its northern aspect.</p> <p>The building was well sealed with no PRFs identified during the survey.</p> <p>The building was assessed as <b>negligible</b>.</p> | |

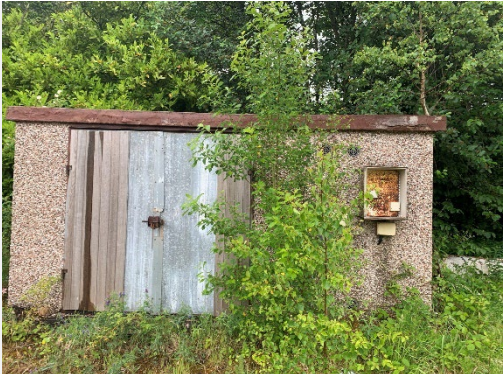
| Building Ref. | Description | Photograph |
|---|---|---|
| B11 | <p>Single storey flat roofed building. Constructed of pebbled dashed walls and a flat steel roof.</p> <p>No PRFs were identified, and the building was well-sealed with no internal access obtained.</p> <p>The building was assessed as <b>negligible</b>.</p> | |

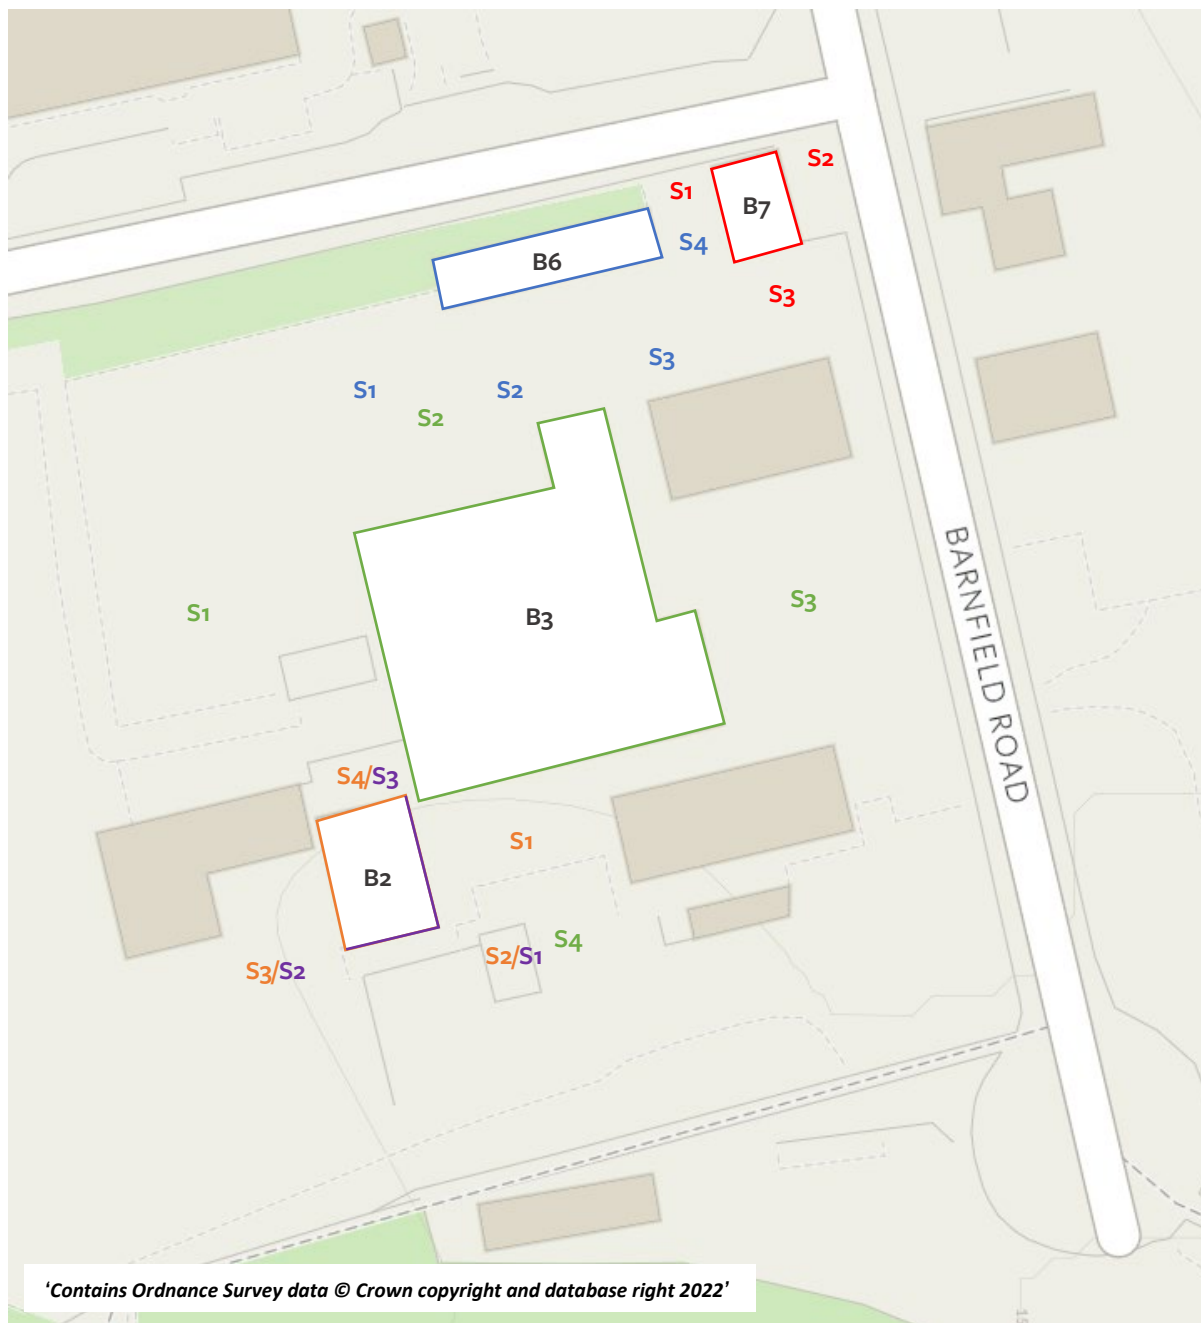
## Appendix 3 – Surveyor Location Map

Surveyor locations are colour coded according to their respective buildings. The surveys at B2 were carried out with three or four surveyors, depending on the night (see Table 1). The nights where B2 was surveyed with three surveyors have been denoted in purple, with the night where B2 was surveyed with four surveyors being denoted in orange.
