## **Rakeway Farm**

**Bat and Bird Presence/Absence Survey Report – August 2022**

**Rakeway Farm,**  
**Rakeway road,**  
**Cheadle,**  
**Staffordshire**

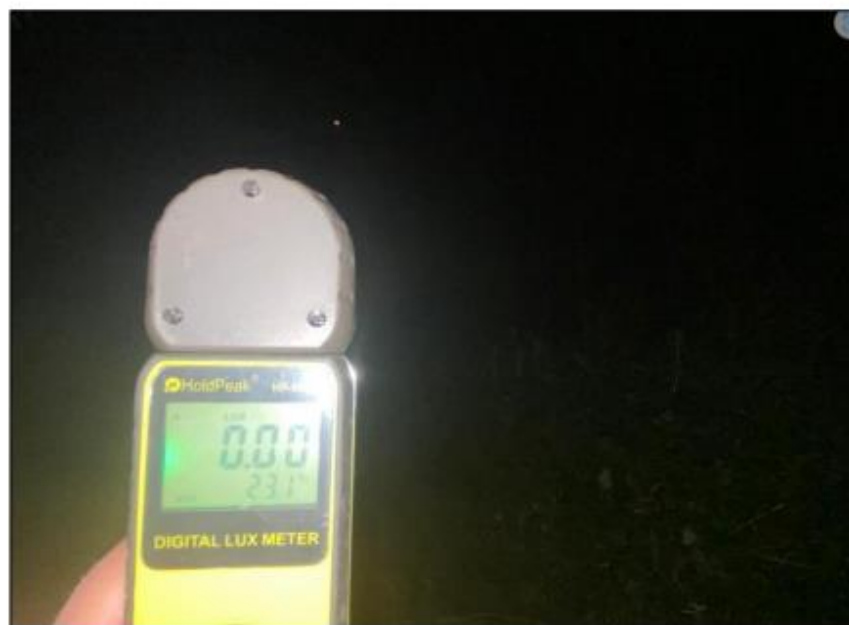
**Figure 5:** This image shows minimal artificial light pollution at the site (0.00lux).

Please see below the Lux meter reading recorded at the site (Middleton Hall).

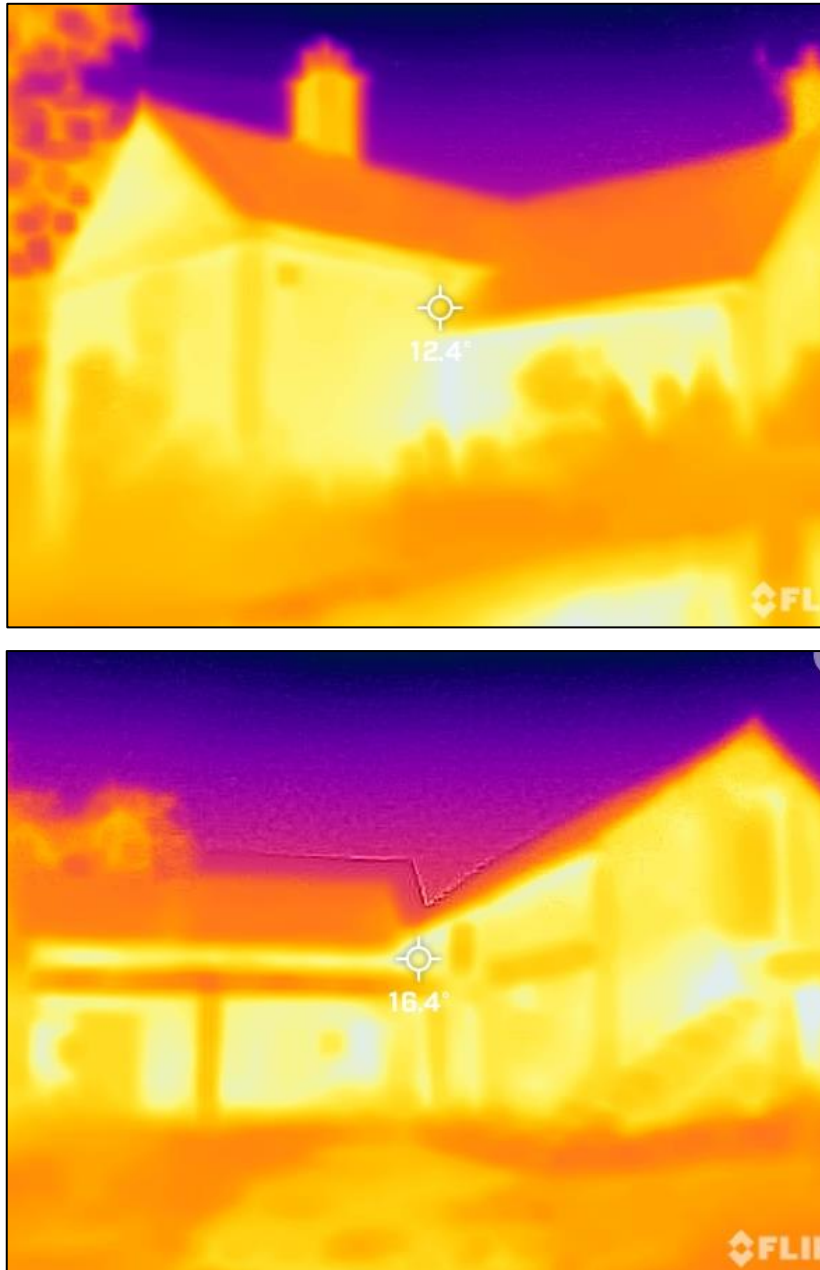
**Figure 6 and 7: Thermal image of the farmhouse and the traditional barns**

- 3.2.6 Thermal Image of the building (the thermal camera was used to aid in observing any bats emerging/returning from and to the buildings).

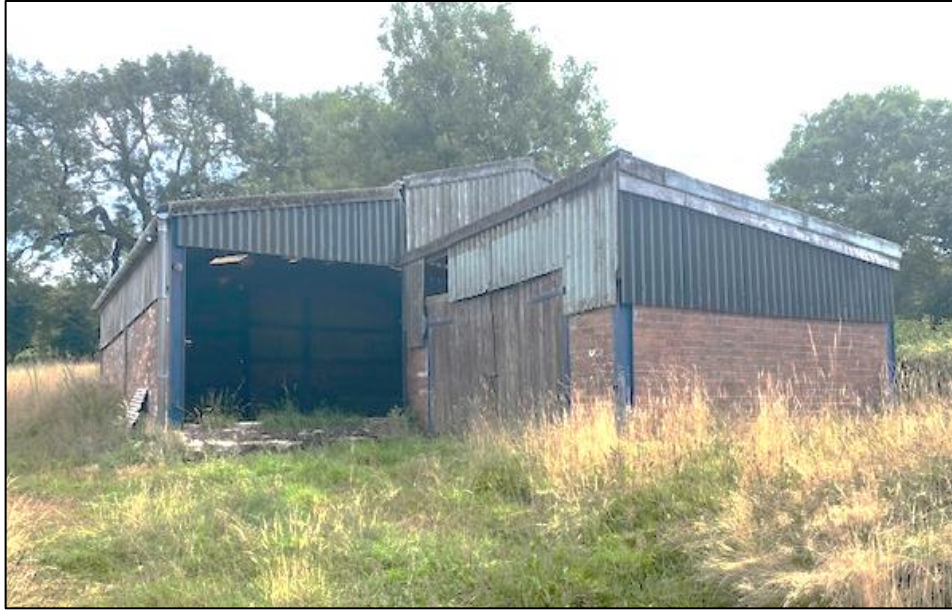
**Plate 1:** A photograph of the modern prefabricated barn. The bats were flying in and out of the open doorway.

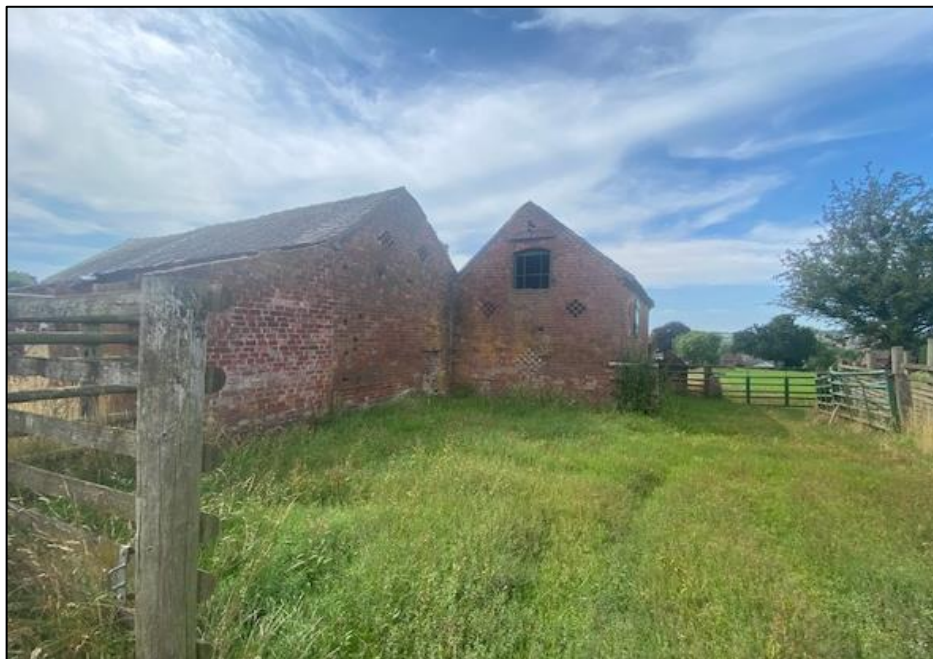
**Plate 4:** A photograph of the north and east elevations of the traditional barns.

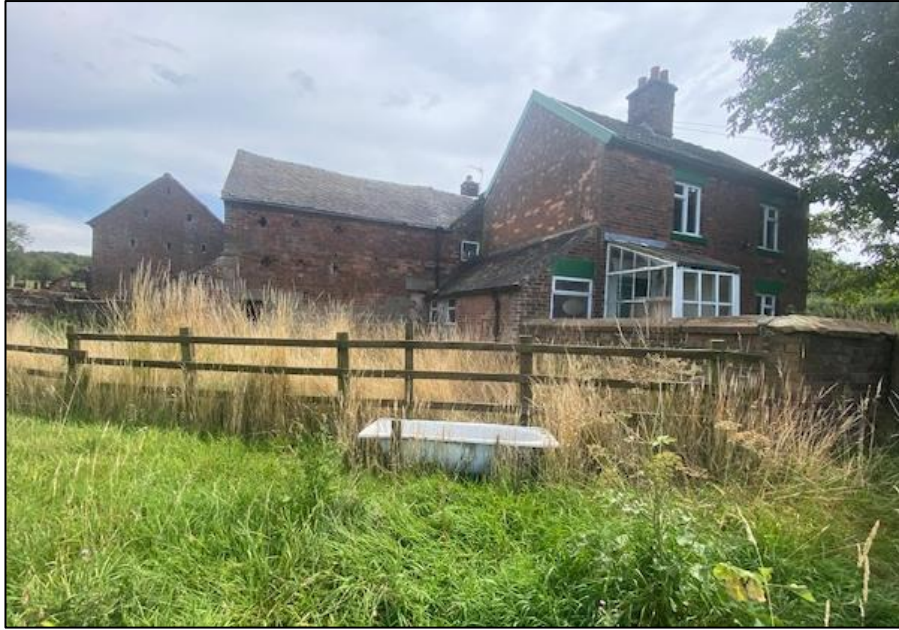
**Plate 5:** A photograph of the north and west elevations of the traditional barns and the farmhouse.

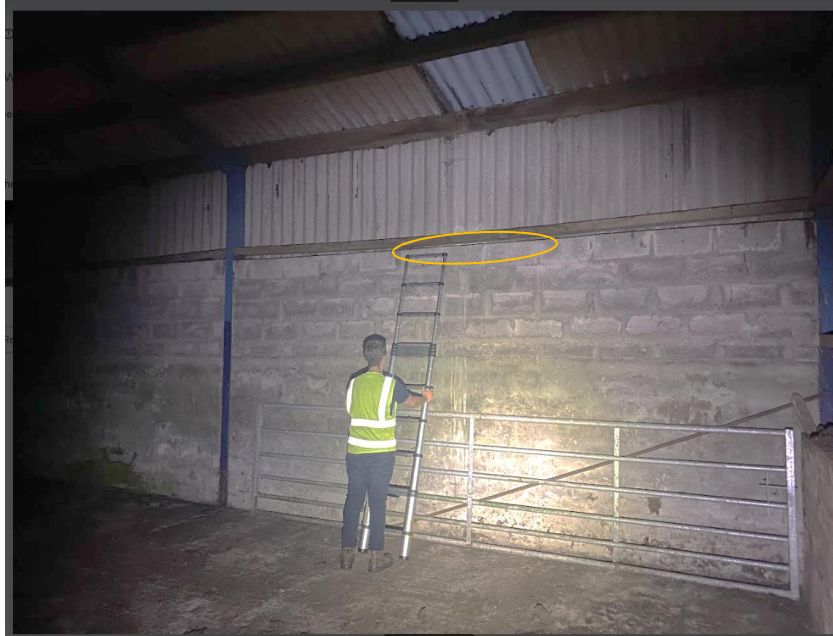
**Bats** - It can be concluded from the above survey results that Brown long-eared, and Common Pipistrelle bats are roosting in the south elevation of the breezeblock wall (hollow) inside the 'Modern Prefabricated Barn'.

**Plate 6:** A photograph of an ecologist inspecting the roost location of the Brown Long-eared and Common Pipistrelle bats seen emerging from their roost (orange outline) inside the 'modern prefabricated barn'.

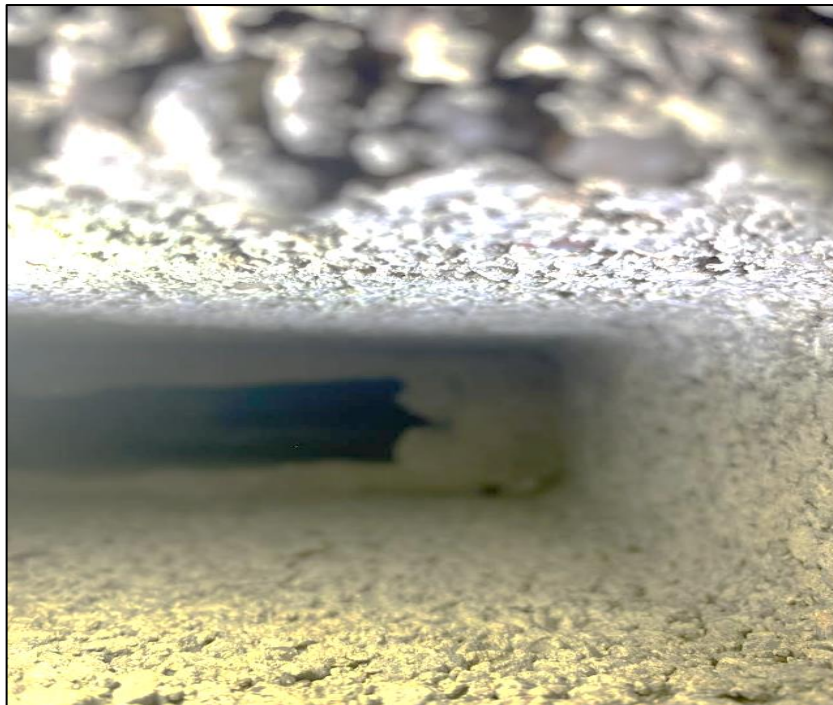
**Plate 7:** A photograph of the roost inside the hollow breeze block wall.

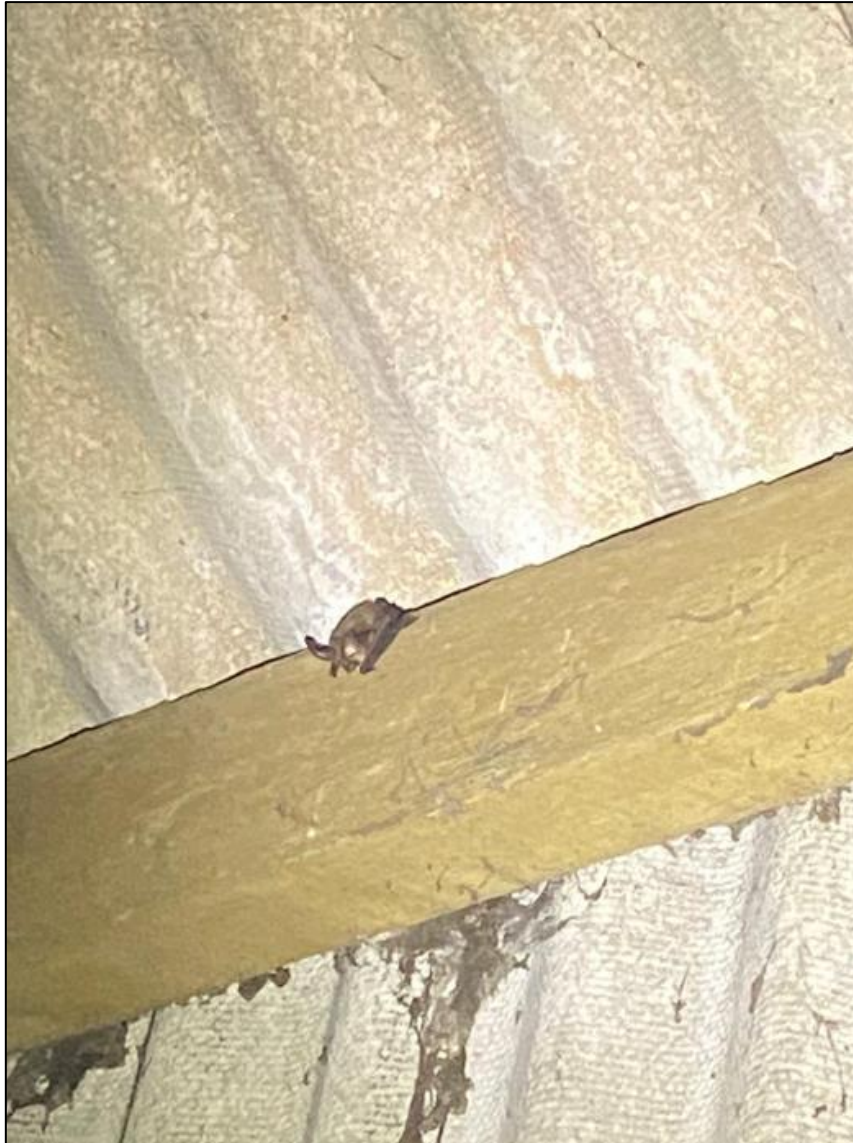
**Plate 8:** A photograph of a Brown Long-eared bat seen emerging from the roost and then perching on a roof beam inside of the 'modern prefabricated barn'.
