## Rudyard Memorial Hall, Rudyard

## Bat Activity Survey Report

**June 2023**

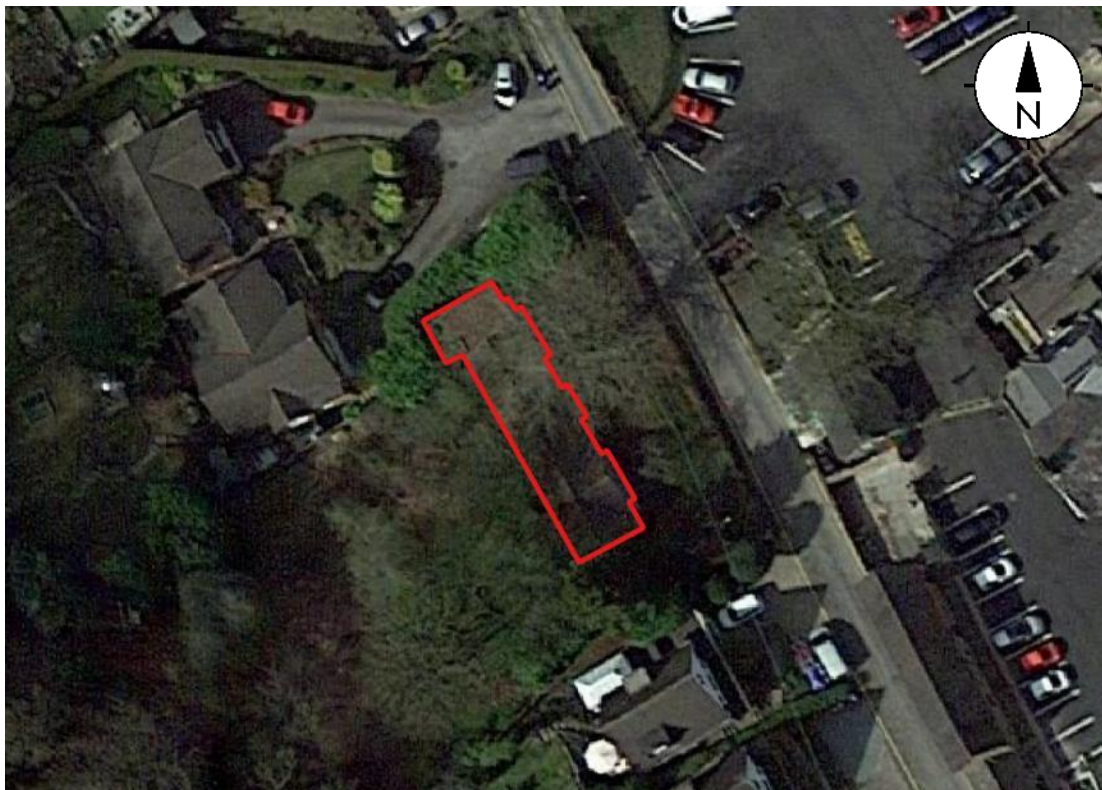
**Figure 1:** An aerial photograph of the surveyed structure at Rudyard Memorial Hall, Rudyard (as shown by the red outline).

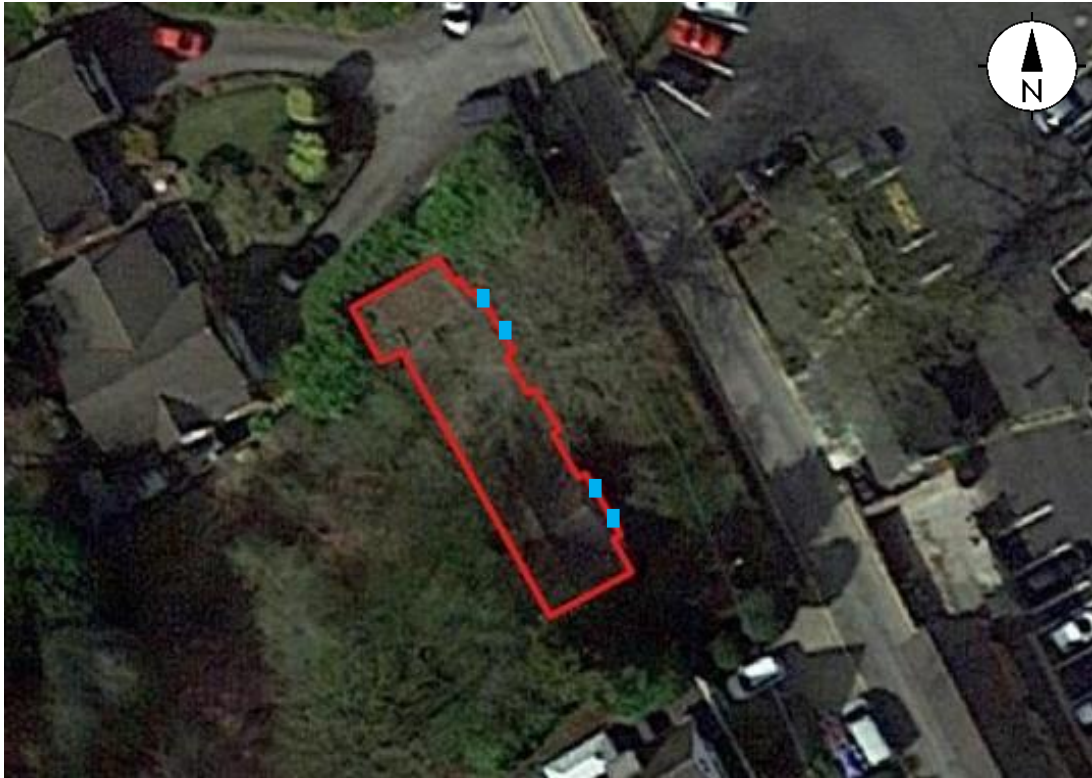
**Figure 7:** An aerial map showing where the integrated eco bat boxes (shown by blue shapes) are to be installed on the structure.

Due to the presence of roosting bats and foraging and commuting bats around the site, no artificial lighting is preferred on the structure. If artificial lighting is necessary, a sensitive lighting scheme is required to ensure that no impacts occur on foraging and commuting individuals. This will involve downward pointing lights and motion-sensor lights (please see **Appendix G** for more information on bats and artificial lighting).

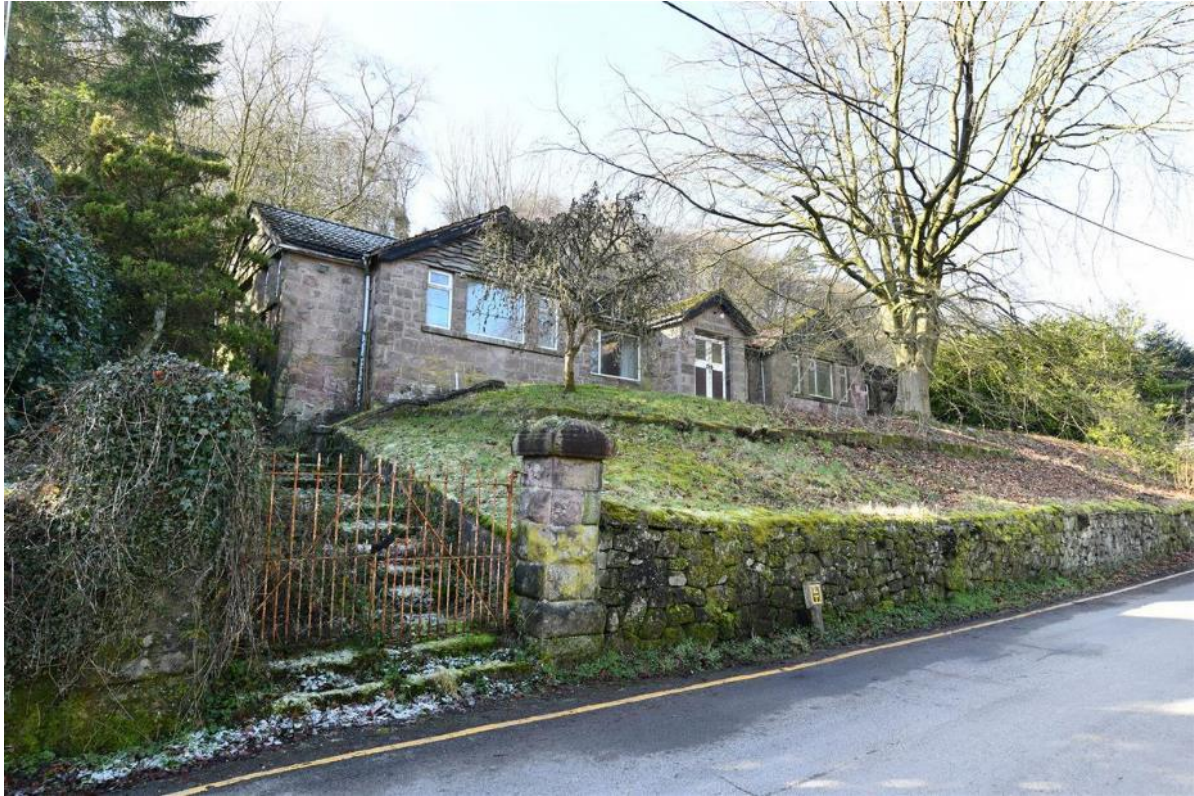
**Appendix D: Photographic Records****Plate 1:** A photograph of north-eastern elevation of **B1**.

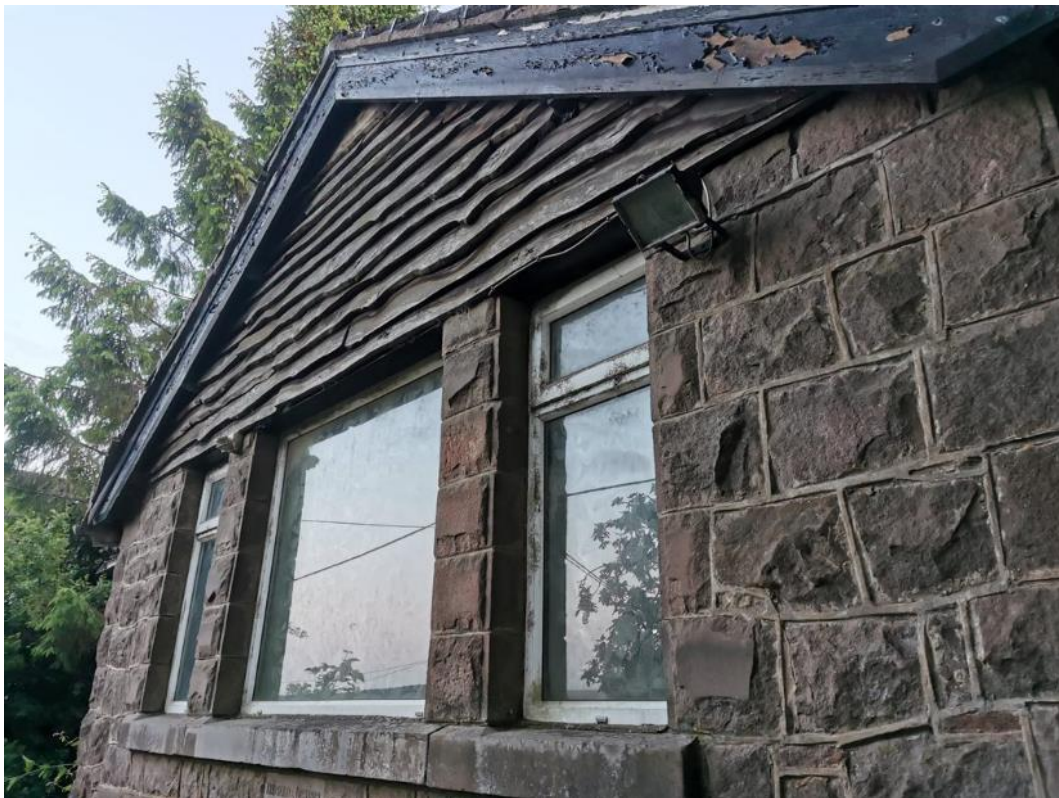
**Plate 2:** Photograph of the rendering present on **B1**.

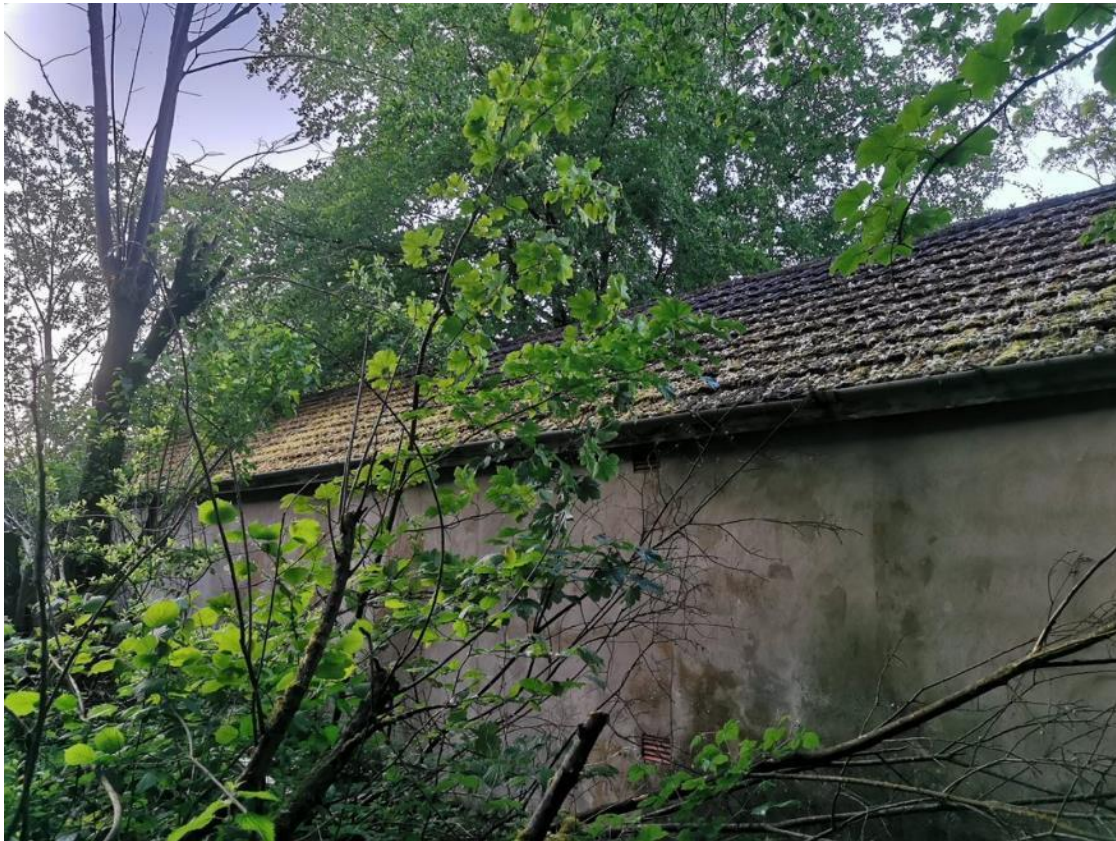
**Plate 3:** Photograph of the south-western elevation of **B1**.

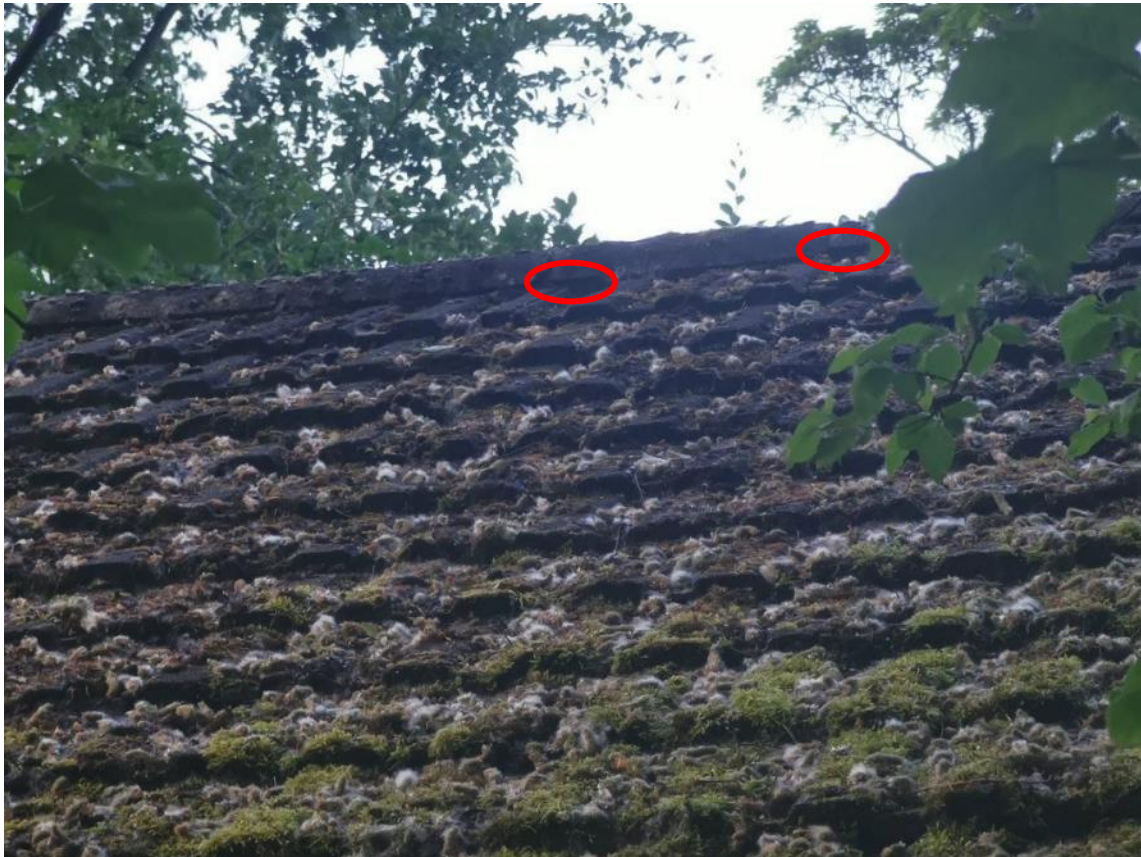
The roof of the majority of the building is cross-gabled, constructed of concrete tiles, with concrete ridge tiles. Due to there being a thick covering of moss on the roof of the structure and topography of the site, it was difficult to make a full assessment of the roof's condition. Nevertheless, gaps were observed across the roof where the mortar is missing, creating crevices that could potentially be used by protected species.

**Plate 4:** Evidence of the gaps at the ridge of **B1** (circled in red).

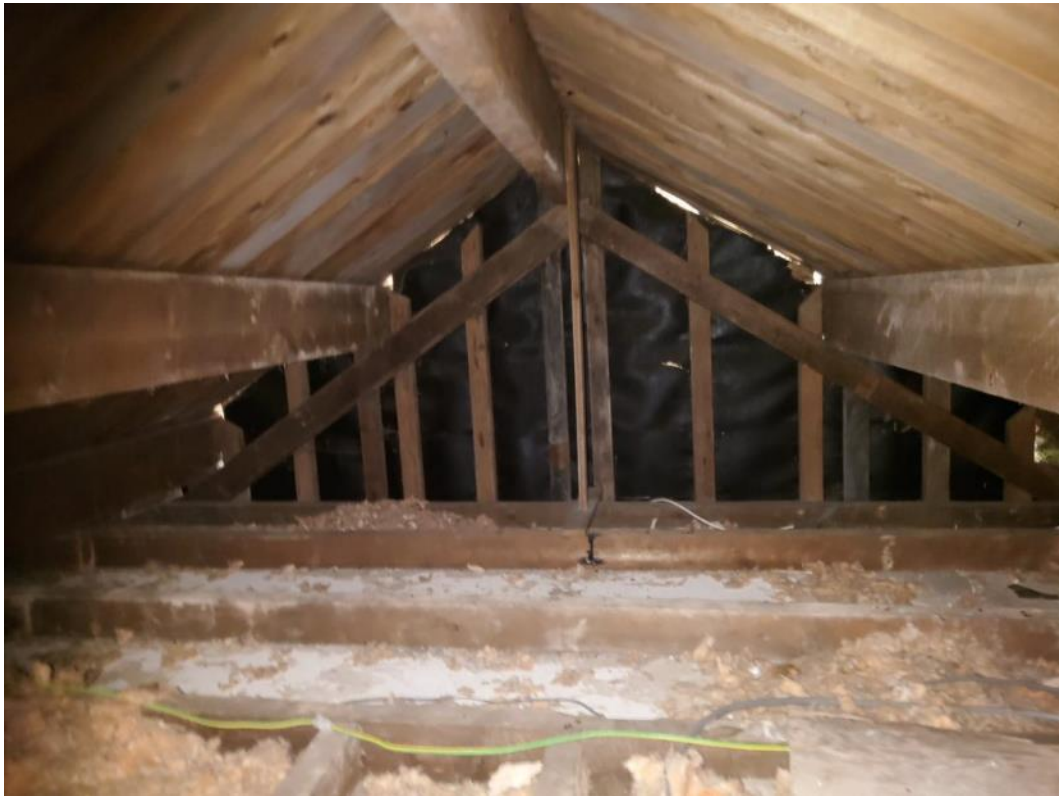
However, bat droppings were discovered within the internal void space of the loft. A large accumulation of old bat droppings were identified at both the southern and northern sections of the loft void, indicating that the building used to contain a maternity roost of bats. However, these were very old, and it is suspected that the structure was re-roofed a number of years ago without any regard for the bat roost being considered. These droppings were deemed to be too old for DNA analysis, due to the deterioration of DNA matter likely to lead to an inconclusive result. Despite this, one fresh, shiny black bat dropping was identified within the void. This was also not sent for DNA analysis due to the small sample size found. However, these sample droppings were analysed in the office by licenced bat ecologists and were thought to pertain to pipistrelle bat species (*Pipistrellus sp.*).

**Plate 5:** Photograph of the internal void of **B1**.

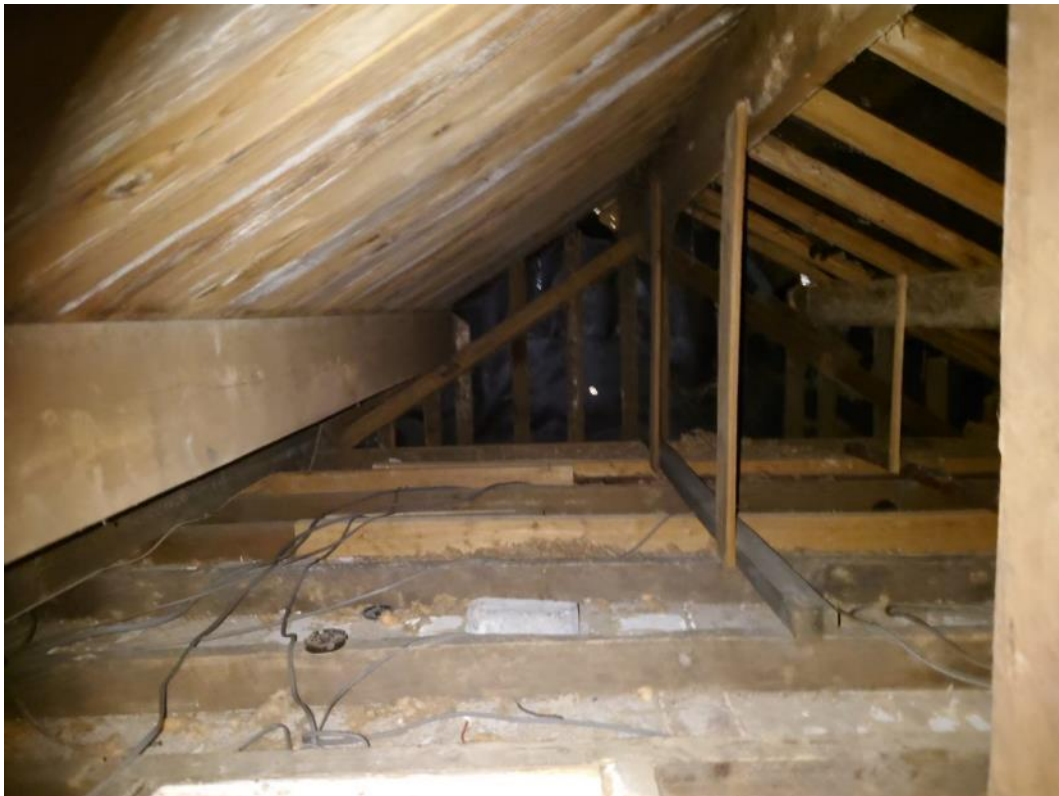
The loft revealed that the roof is supported by timber beams, with one half of the void being lined with bitumen felt, and the other side having timber sarking. The bitumen felt is largely in good condition, with only small sections falling away. The timber sarking is in excellent condition, providing very little access to the void. However, due to the good condition of the underlining materials, it is possible that any bats roosting under the tiles would not be visible, and evidence potentially trapped between the tiles and the underlining.

**Plate 6:** Further image of the internal void of **B1**, showing how one half of the roof is lined with bitumen felt (right), and the other with timber sarking (left).
