## RE: Ecology Walkover and Assessment Note – Newfields Farm, Stoke-on-Trent

On 28<sup>th</sup> April 2023, Enzygo were commissioned by Newfields BESS Ltd for an Ecology walkover survey and assessment in relation to proposals for a Battery Energy Storage System (BESS) at Newfields Farm. It is understood that a site walkover was needed to assess current site conditions and update the previous Preliminary Ecological Appraisal conducted by Phlorum in December 2021.

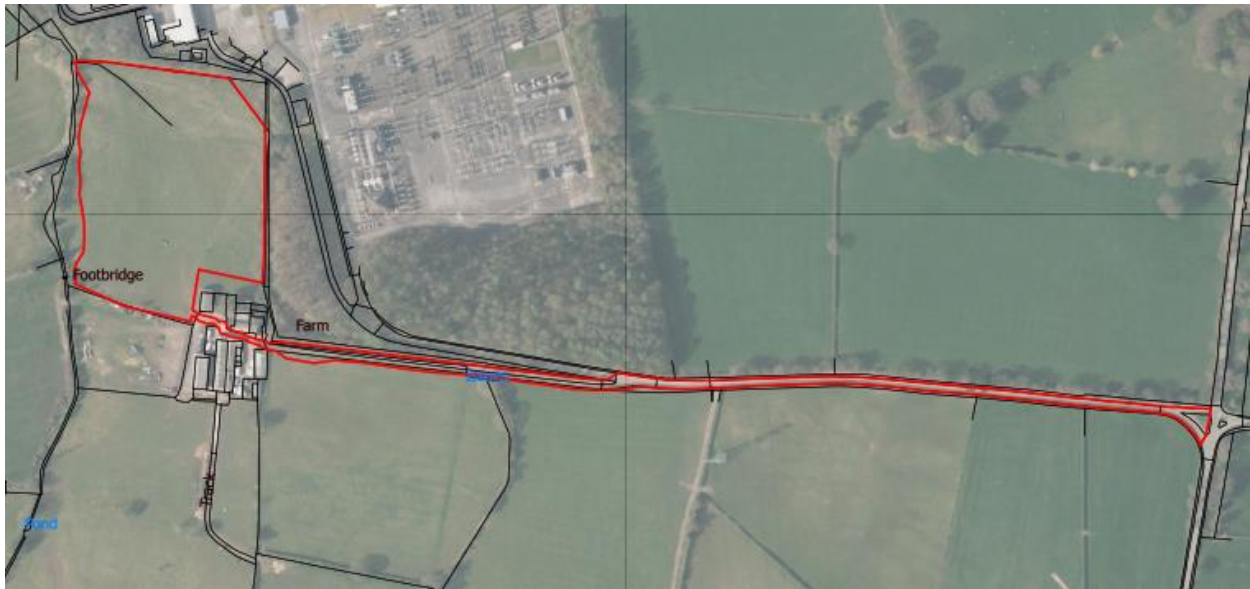
### **Insert 1: Survey Area**

The survey area was found to be predominantly comprised of modified grassland presumably used to graze livestock, with a strip of woodland to the north, hedgerow and woodland to the east, a farmhouse and fields for pasture to the south, an immature hedgerow to the southwest, and intermittent hedgerow with trees and a stream beyond the western boundary.

The access road leading to the farmhouse and associated buildings is hardstanding, as are areas within. The road is lined on one side (to north) with mature Beech, Oak and Silver Birch trees. A public right of way was observed in the northeast corner of the site, which is surrounded by dense mixed scrub, and a public footbridge is located to the southeast.

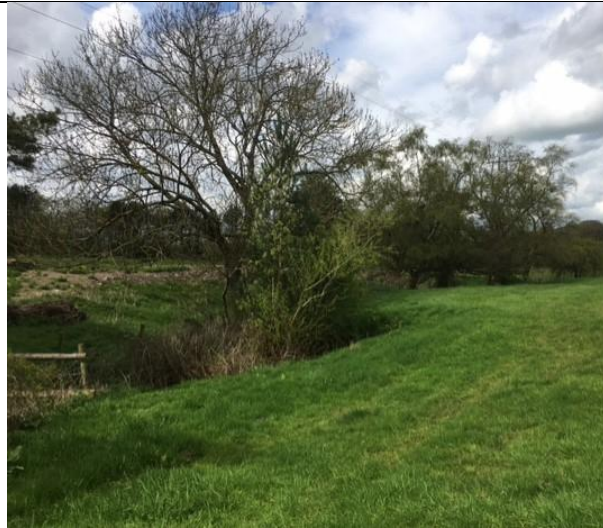
There is a watercourse that runs along field boundary to the west of the site and was identified in the 2021 PEA as a feature of notable value. A minor ditch also runs along the eastern boundary between the site and adjacent area of woodland.

*Western boundary watercourse with trees and footbridge*

To avoid potential pollution and run-off impacts on blue infrastructure, a large undeveloped buffer of a minimum of 20m has been incorporated into the site layout. In addition, all construction works will be undertaken in accordance with best practice and the through adoption of the appropriate Environment Agency guidance (refer to updated 2019 Environment Agency guidance “*Pollution prevention for businesses*” [Pollution prevention for businesses - GOV.UK \(www.gov.uk\)](https://www.gov.uk/guidance/pollution-prevention-for-businesses)). This includes appropriate storage of chemicals, controlled refuelling of vehicles, spill kits etc.

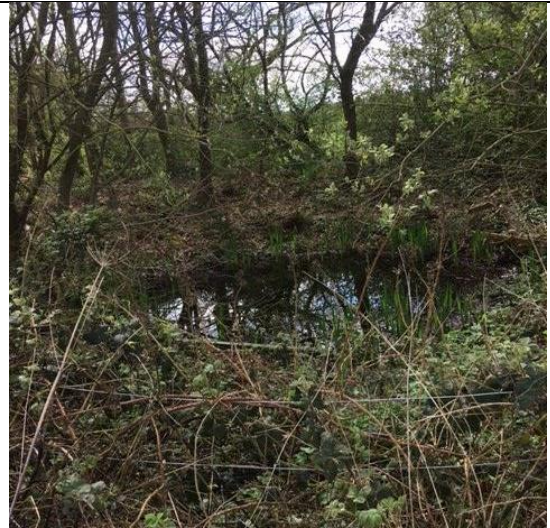
A small pond was identified within the area of woodland immediately to the east of the site that was not identified in the 2021 PEA. The pond contains a limited amount of vegetation and is relatively deep, with a sign nearby warning of its deep waters. The existence of the pond raises concerns regarding the potential for Great Crested Newt (GCN) (*Triturus cristatus*) to be impacted by the development.

*Offsite Pond within adjacent woodland to the east*

It is considered reasonable and appropriate in this instance to recommend non-licensed avoidance measures to mitigate the significantly low risk of encountering GCN during the works. In accordance with best practice, Reasonable Avoidance Measures (RAMS) will be followed.
