# Preliminary Roost Assessment (inc. Bat Emergence Survey)

Yew Tree Farm

Final Report

Report no. HE 2040823

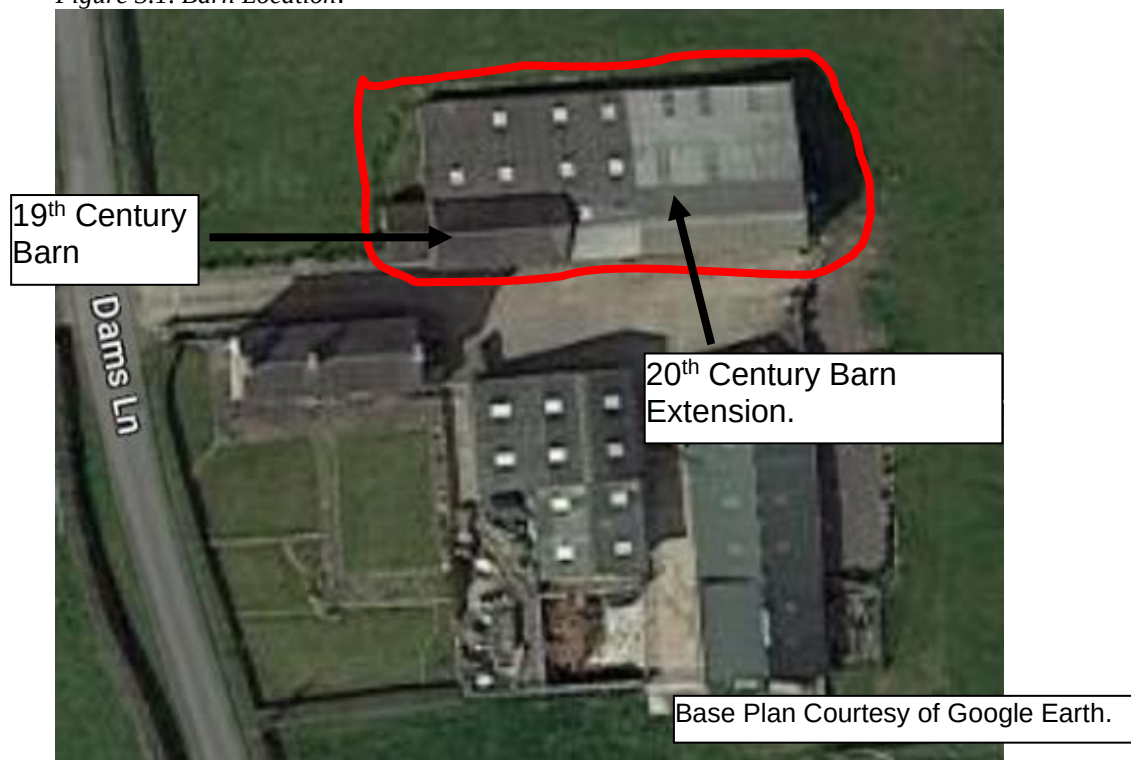
Figure 3.1. Barn Location.

The figure below indicates the location of the barn within the site.

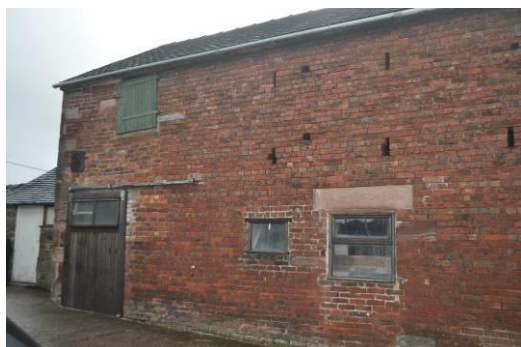
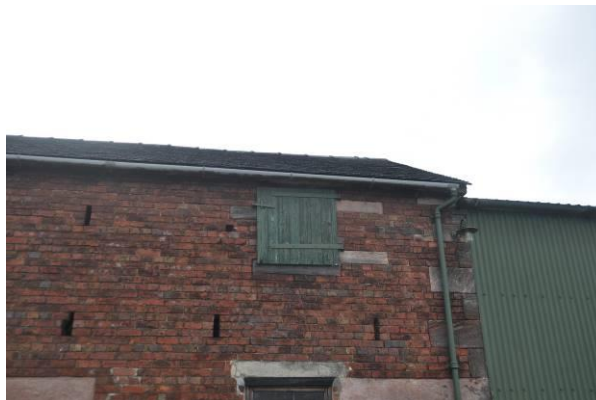
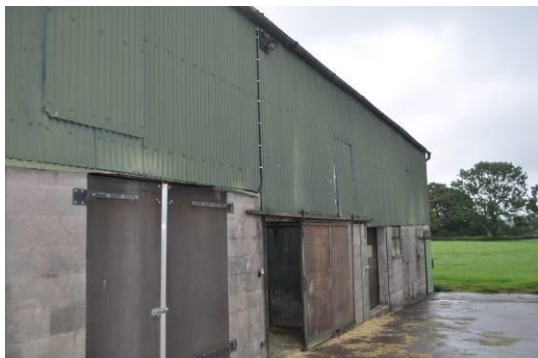
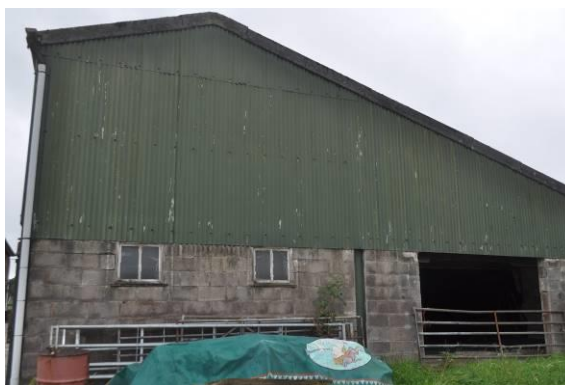
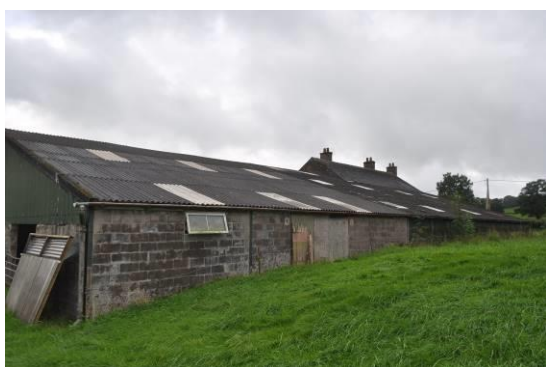
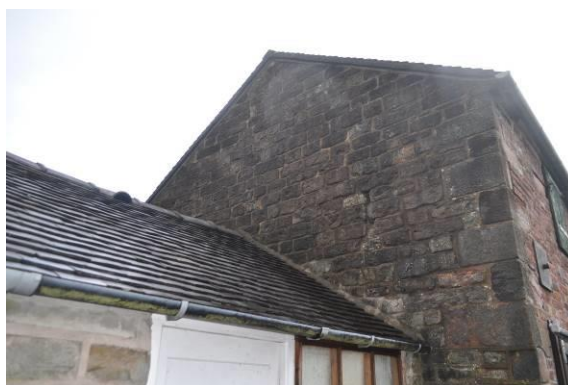
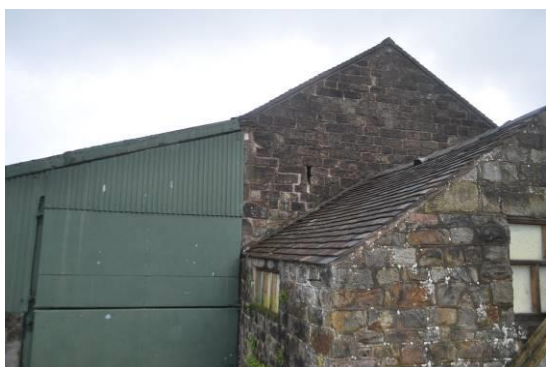
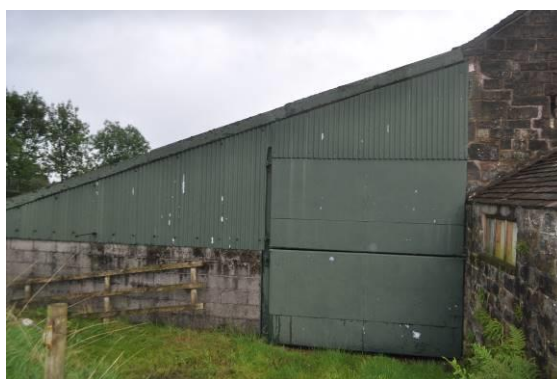
*Plate C.1      Barns (exterior)*

| Preliminary Roost Assessment – 19 <sup>th</sup> Century Barn |
|---|
| <b>Description:</b><br>A well-maintained brick and stone built barn with a pitched clay tiled roof. The |

ground floor is former animal housing whilst the upper floor is a hay loft. The roof is predominately unlined except for the northern lower part where it joins the modern barn which is lined. There are loose fitting loft hatches along the southern elevation facing to the farmyard with ventilation holes along the southern elevation and western gable.

The tiles and ridge tiles are intact with no gaps and the tile ends are sealed with cement on each gable. The beam slots and wall tops are sealed.

Adjoining the barn on the western gable is a brick built single storey outhouse with pitched clay tiled roofs. These are well maintained with no gaps and all doors and windows sealed. There are no missing tiles but there is a central ventilation ridge tile.

A modern construction of concrete block half walls with corrugated metal sheeting on a wooden and metal frame. The roof is shallow pitched composed of corrugated sheeting with frequent light panels.

The barn abuts the 19<sup>th</sup> Century barn with all joins sealed with no cracks or spaces suitable for bats to access the building interior.

| Avoidance (A), Mitigation (M), Compensation (C) & Enhancement | |
|---|---|
| <b>Bats (potential roosts)</b><br>(A) | <p>Although bats are likely to be absent from the barns, the implementation of Reasonable Avoidance Measures (RAM) (see below) are advised when demolishing the barns to reduce the chance of committing an offence with respect to bats. Ideally works should be carried out between <b>October and February</b> when bat activity is low.</p> <p><b>Reasonable Avoidance Measures</b> to be implemented include:</p> <ul style="list-style-type: none"> <li>– Ensuring all workers are familiar with bat (and protected species) legislation at site induction and agree to work in accordance with and fully follow these best practice measures.</li> <li>– Careful check of any cracks/crevices/cavities in the roof prior to tile removal. Typical signs of usage by bats are droppings, urine stains,</li> </ul> |

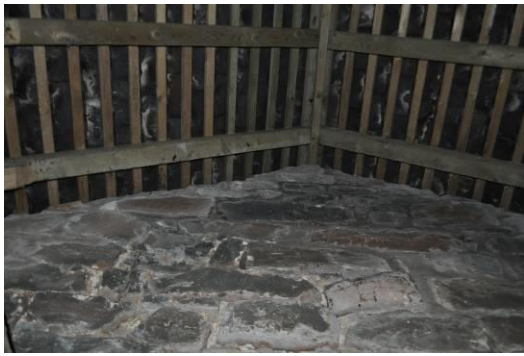
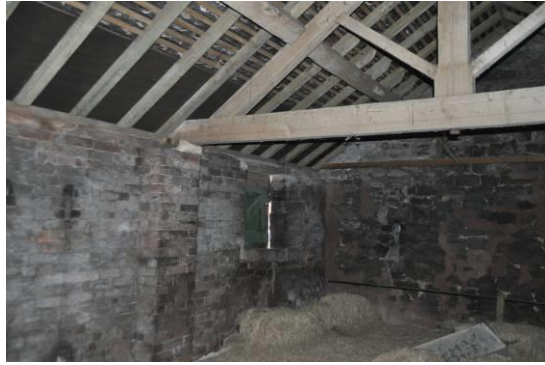
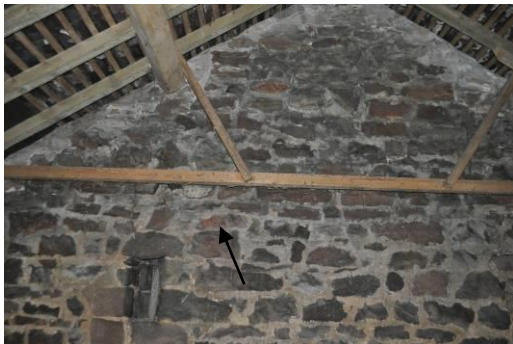
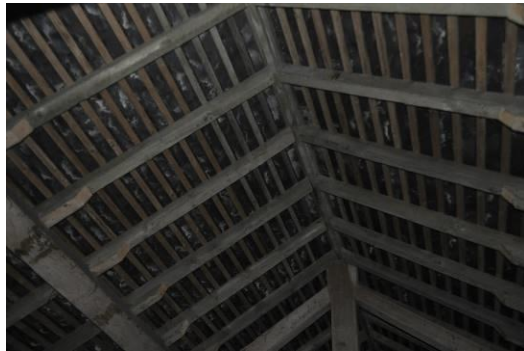
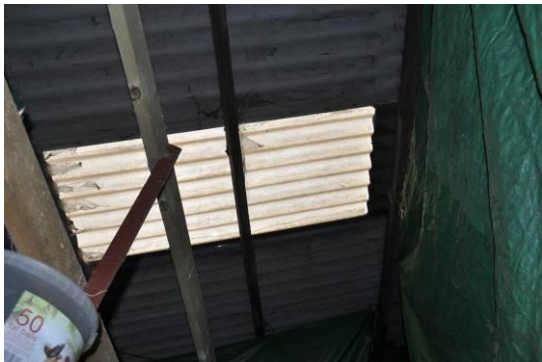
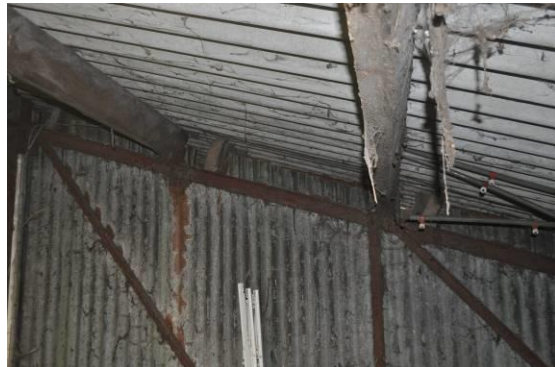
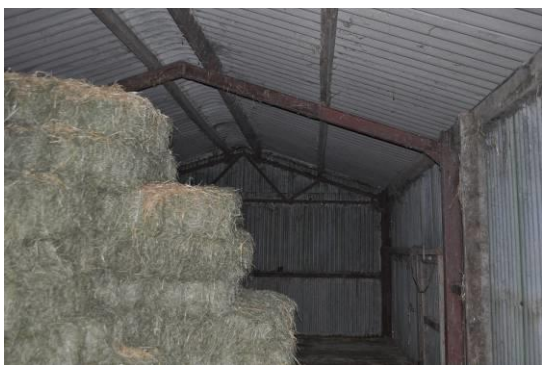
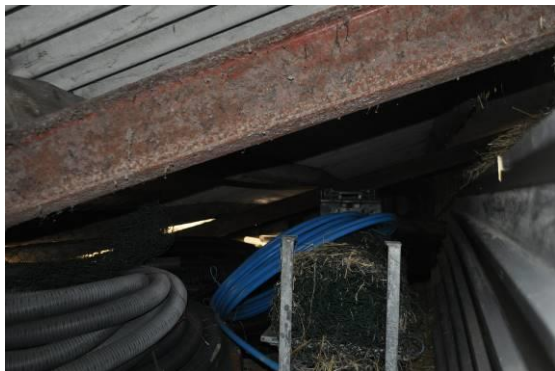
Plate C.2      *Barns (Internal)*

**Beneath air vent of ridge, around ridge beam in hay loft**

**Potential feeding remains (butterfly and moth wings) in hay loft.**

The barn is used for storing fodder crops (hay, straw).

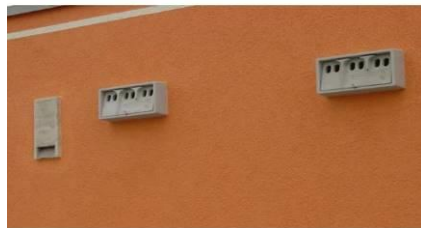
This Sparrow Terrace has been made in WoodcretePLUS™ by Schwegler, it provides insulated accommodation for up to three families. The sparrow nesting box is designed for fixing on (or in) walls, 2 meters or more above ground level.

- height 16 x width 10.5 x depth approx. 15 cm
  - Overall: 245H x 430W x 200D mm
  - Weight: 13kg
- Colour options: Brown or Stone.

Considering the scale of the proposal (single barn in farmyard) and the presence of foraging pipistrelle bats, it is recommended that 3 bat boxes suitable for crevice dwelling species and a house sparrow terrace are installed on the eastern elevation (preferable) of the new building.
