# Phase 1 Habitat Survey and Protected Species Assessment

Sugar Street,  
Rushton Spencer,  
Staffordshire

Report Reference: CL831/005/001

Prepared by  
Clear Environmental Consultants Limited  
July 2011

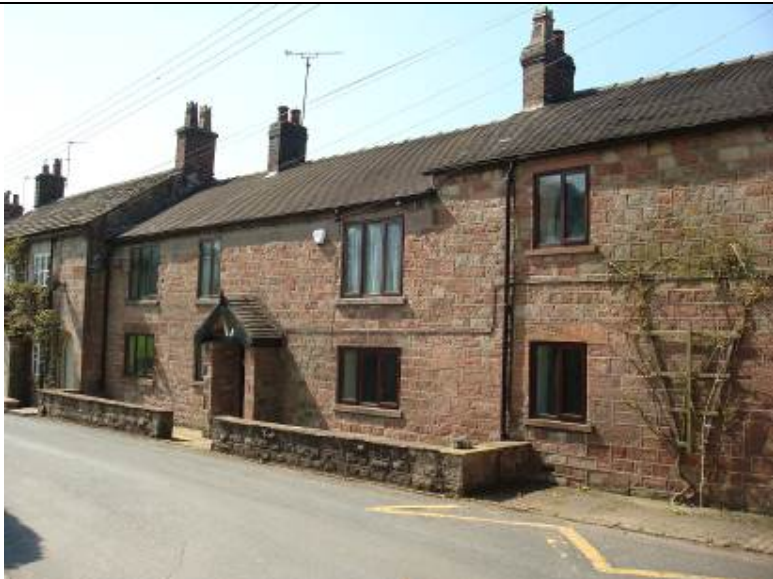
<p>Photograph 1.</p> <p>Front of the B1 facing the road.</p>

B1 was a two storey; brick built end of terrace residential dwelling which is currently unoccupied. The roof was pitched with a number of single storey single-pitched extensions to the rear. A conservatory was also present to the rear. Skylights could be seen in the rear aspect of the roof implying part of the roof void had been converted. Wooden framed windows and uPVC guttering were also present, along with barge boards on the extensions. The northern elevation of the building has a gable end.

Potential access points for bats were identified through gaps in the mortar at the ridge and several slipped roof tiles.

Internally two roof voids were present which were separated by fire walls. Wooden beams and under-felting were present within both roof voids and insulation covered in carpet was also noted on the floor. No visible gaps were observed in the under-felting which would provide potential access points for bats into the main area of the roof void.

It was considered that there is potential for bats to roost between the roofing tiles and under-felt and due to the sealed nature of the under-felt any potential evidence may have been concealed.

Vent bricks were noted in the gable end of the second roof void which was present over the northernmost section of the building; however it was considered the ventilation holes were too small (~5mm diameter) to enable bat access.

No evidence of bats was recorded during the survey, but there remains low to moderate potential for bats to be roosting in the building, between the roofing tiles and under-felt.

The bat building assessment found potential bat access points and the surrounding area provided potential for foraging bats; furthermore the desk study highlighted records of bat species within 1 km of the proposed development. Internally, no evidence of bats was observed however due to the sealed nature of the under-felt it is possible that bats were roosting between the tiles and under-felting. It was concluded that B1 and B2 have low to moderate potential for supporting roosting bats, however as B1 is to be partially demolished under current proposals and B2 is to be completely demolished a suite of nocturnal surveys is recommended to be carried out.

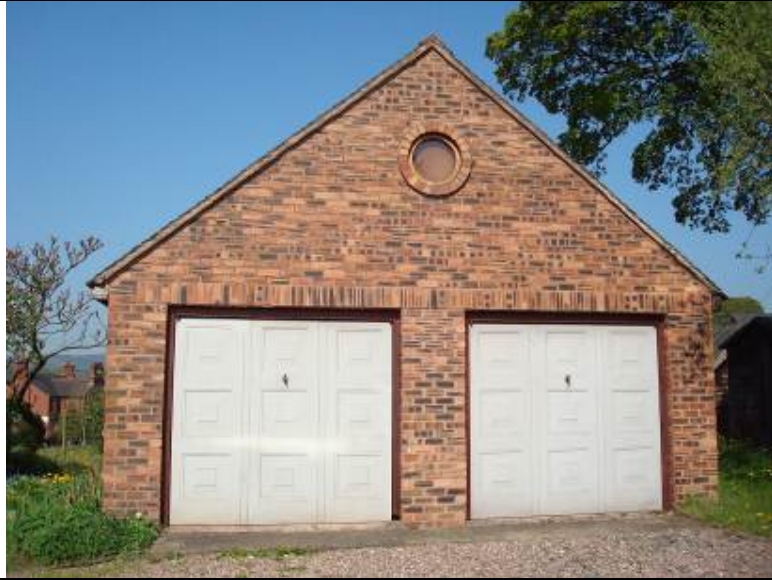
Photograph 3.

B2 was a detached single storey, brick built double garage with a small metal single pitched lean-to on the north western aspect. The garage had a pitched, clay tiled roof with overhanging eaves. Gables, barge boards and flashing were also present.

Potential access points for bats were identified under the over hanging eaves where there were gaps between the wooden frame and the wall plate. There were also several areas of missing mortar and gaps in the roof tiling.

Internally a roof void was present which had been used as part of the living accommodation. The roof void was boarded out with plasterboard and two skylights were present in the roof. Two storage areas were located running lengthways along the room within which Tyvek under-felting was present. This brand of under-felt is smooth to the touch and therefore does not enable bats to gain necessary purchase reducing the likelihood of bats roosting on the internal face of the felt.

Open access was available between the main roof void area and the storage areas in the eaves. Dead peacock *Aglaia io* and tortoiseshell *Aglaia urticae* butterflies were observed within the main (living accommodation) area however these were considered not to be associated with bats as they were intact on the floor, rather than showing signs of being bat foraging remains.

Front of B2, a double garage.

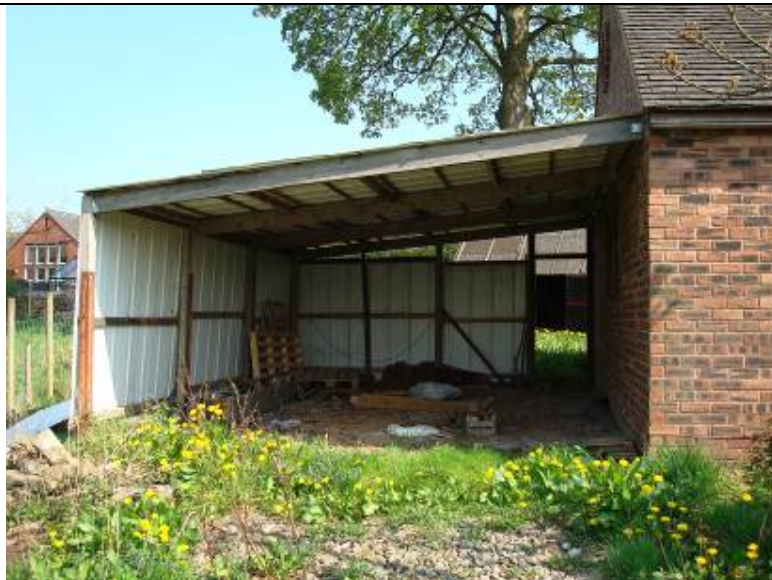
Photograph 4

Lean-to, to the rear of B2

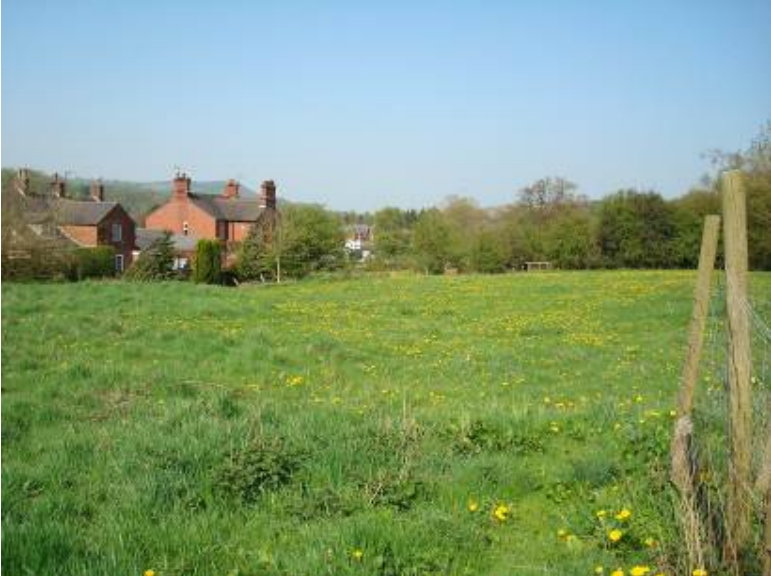
<p>Photograph 5</p> <p>The previously grazed pasture</p>

The site was dominated by one large field compartment which was previously grazed pasture, with a water course running along its south west boundary. Towards the northern end of the field species

composition became more diverse. Plant species present included perennial rye grass *Lolium perenne*, meadow foxtail *Alopecurus pratensis* and Yorkshire fog *Holcus lanatus*. Herbaceous species included dandelion *Taraxacum officinale*, common nettle *Urtica dioica*, creeping buttercup *Ranunculus repens* and daisy *Bellis perennis*.

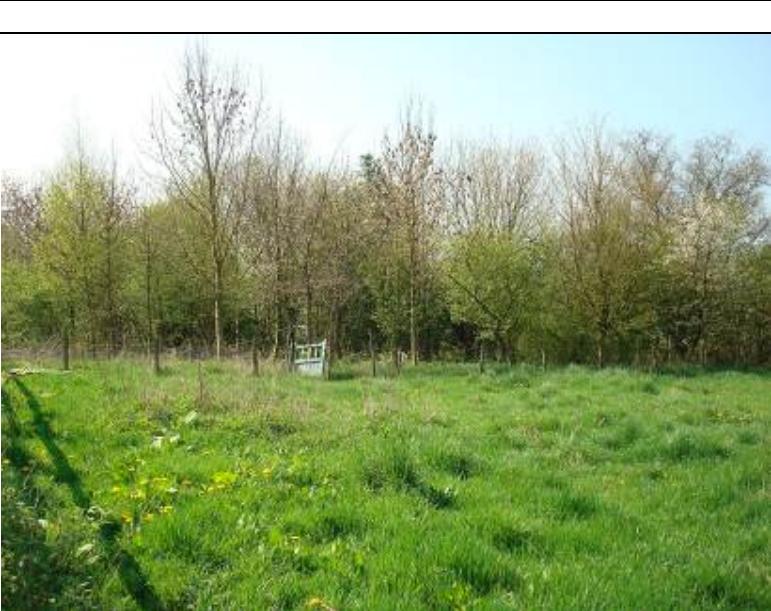
Located on the southern end of the field was a small fenced area of immature broadleaved plantation woodland. Within this woodland canopy species included silver birch *Betula pendula*, field maple *Acer campestre*, ash *Fraxinus excelsior* and cherry *Prunus* sp. The ground layer comprised ground elder *Aegopodium podagraria*, bramble *Rubus fruticosus*, angelica *Angelica sylvestris*, lesser celandine *Ranunculus ficaria* and wood avens *Geum urbanum*.

A small patch of invasive Himalayan balsam *Impatiens glandulifera* was located in the southernmost corner of the site.

<p>Photograph 6</p> <p>Broadleaved woodland.</p> <p>Himalayan Balsam was located in this area.</p>

Tree removal where necessary, should be undertaken outside of the bird-breeding season (mid-March – September inclusive) as all birds, their eggs, nests and dependant young are protected under the *Wildlife and Countryside Act 1981 (as amended)*. Where this is not possible an inspection of the trees prior to removal by an experienced ecologist should be undertaken. This will ensure that any active nests found are suitably protected until the young have fledged.

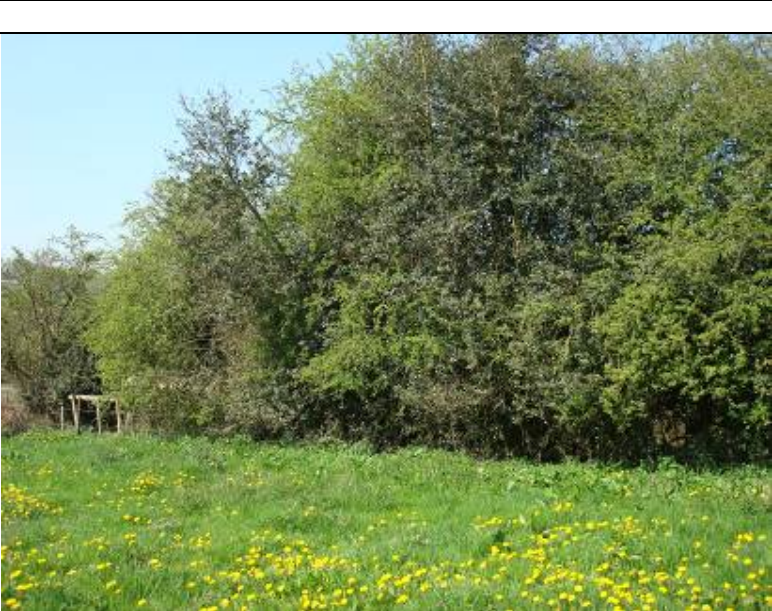
<p>Photograph 8</p> <p>A section of hedgerow 2</p>

H2 was approximately 4m+ in height and 3m+ in width with 10-0% gaps. The hedgerow was also dominated by hawthorn, with abundant holly, elder and blackthorn and standard trees of silver birch, ash and sycamore.

Following HEGS assessment H1 scored a conservation value of low (4+). H2 scored a conservation value of high (2+) the hedgerows were not classified as 'Important' under the Hedgerow Regulations (1997) ecology criteria due to a lack of associated features and species diversity.

Both hedgerows qualify as UK BAP Priority Habitats due to the presence of over 80% native canopy species.

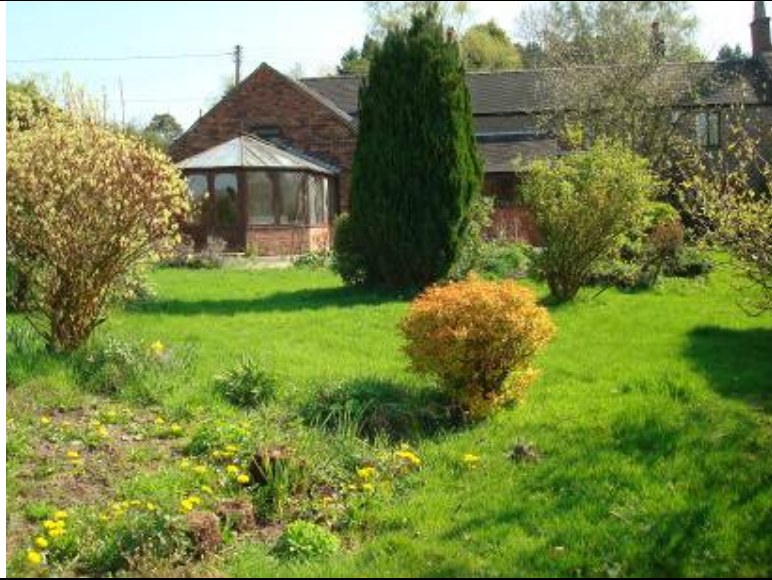
Photograph 9

Ornamental planting was present within a garden area associated with the house on the eastern boundary. The garden had been neglected since the house was vacated. Species present included tulip *tulipa* sp., forsythia *Forsythia* sp., magnolia *Magnolia officinalis*, honeysuckle *Lonicera japonica*, geranium *Geranium* sp., and oxlip *Primula elatior*. Located within the garden in the north west corner was a neglected vegetable patch with species such as rhubarb *Rheum rhaponticum*, blackcurrant *Ribes nigrum*, gooseberry *Ribes* sp. and raspberry *Rubus* sp. present.

Ornamental  
planting  
adjacent to  
B1.
