## 2 Site Conditions and Identified Contamination

## **3 Relevant Pollutant Linkages and Outline Strategy**

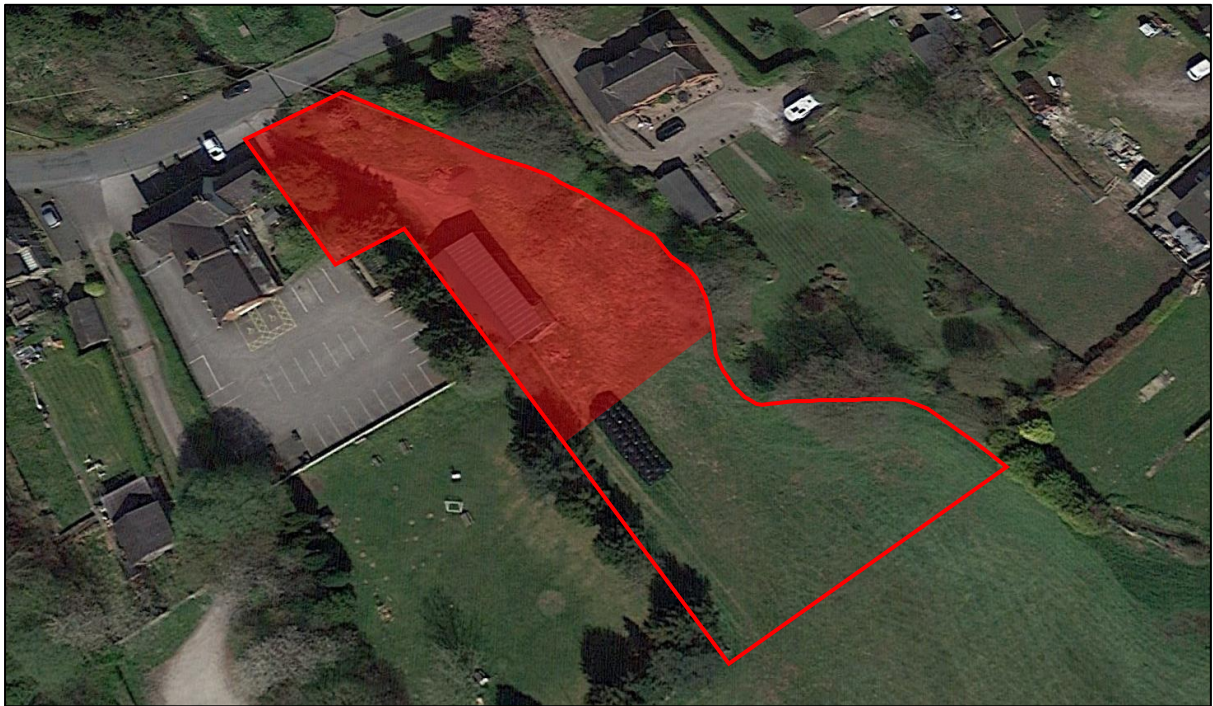
Figure 3-A: Remediation Zone Plan

- 3.2.2.3 No exceedances of any GAC values were recorded in WS05 and WS06 in the proposed southern garden area and therefore the risk to human health receptors is considered low and no clean cover is required in that area. The remedial requirement for a clean cover is required for the northern half of the site only, as indicated in the zoning plan overleaf.

- 3.2.2.4 The delineation of the remedial area is based on a combination of the placement of exploratory boreholes, field observations of the ground conditions and surface materials, and time-lapse aerial imagery between 2003 to the present day showing the use of the site and different vegetation growth patterns.

- 3.2.2.1 Where present, the provision of hardstanding areas will sever the pathway to end-users of the site, and no action is considered necessary.
- 3.2.2.2 In all soft landscaped areas that fall within the remediation zone, a cover system of chemically and physically suitable imported soils should be placed to sever the pathway between PAH and metal contamination and end-users, thus breaking the pollutant linkage and reducing the risk to acceptable levels.
