# Tier 1 Hydrological Impact Assessment

**St John the Baptist Church, Wetley Rocks, Stoke**  
**Mr Andrew Cooper**

Job No. M24-117

## PHASE 1 DESK STUDY

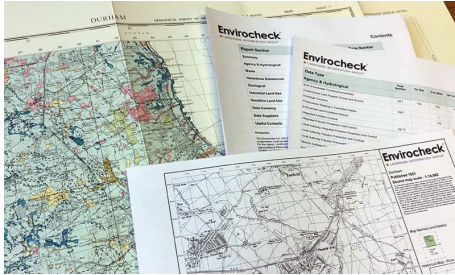
The drift deposits on site are likely to consist of Glacial Till from the Devensian – Diamaticon. This comprises a heterogeneous mix of clay, sand, gravel, and boulders, often unsorted and varying in size and shape (Figure 3). Dependant on depth and local constituents, groundwater flow will increase with lower clay % or reduce with lower clay %.

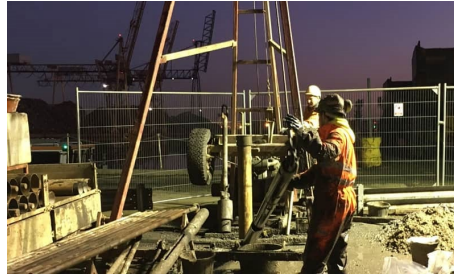
The site is shown to be underlain by solid geology of Pennine Lower Coal Measures Formation and South Wales Lower Coal Measures Formation (Undifferentiated) (PSLCM) most likely comprising interbedded mudstone, siltstone and sandstone with coal seams (Figure 4).
