# BAT SCOPING ASSESSMENT

**Project:** Residential Development

**Address:** Ashlea Farm, Bradley Lane,  
Threapwood, Alton, ST10 4DQ

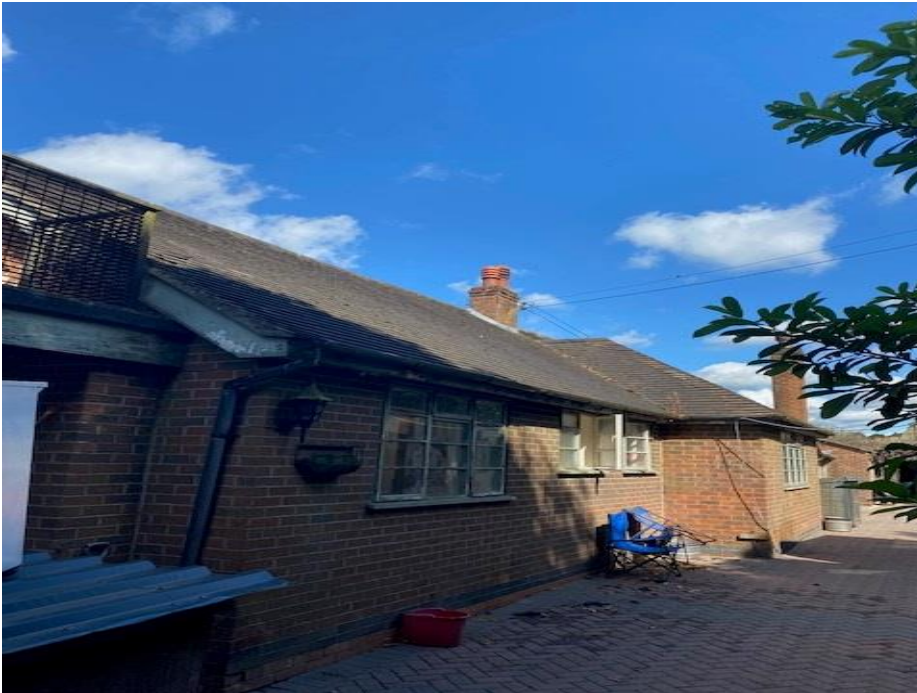
The eastern roof elevation is in good condition with no broken/missing tiles or holes in the soffit. The windows on the eastern elevation are also intact. The southern gable end is also in good condition with no possible entry points. The area surrounding the structure is concrete and no bat droppings or feeding waste was found on this surface.

Figure 5.  
View north from southeast corner of structure (grid ref: SK 04963 42052)

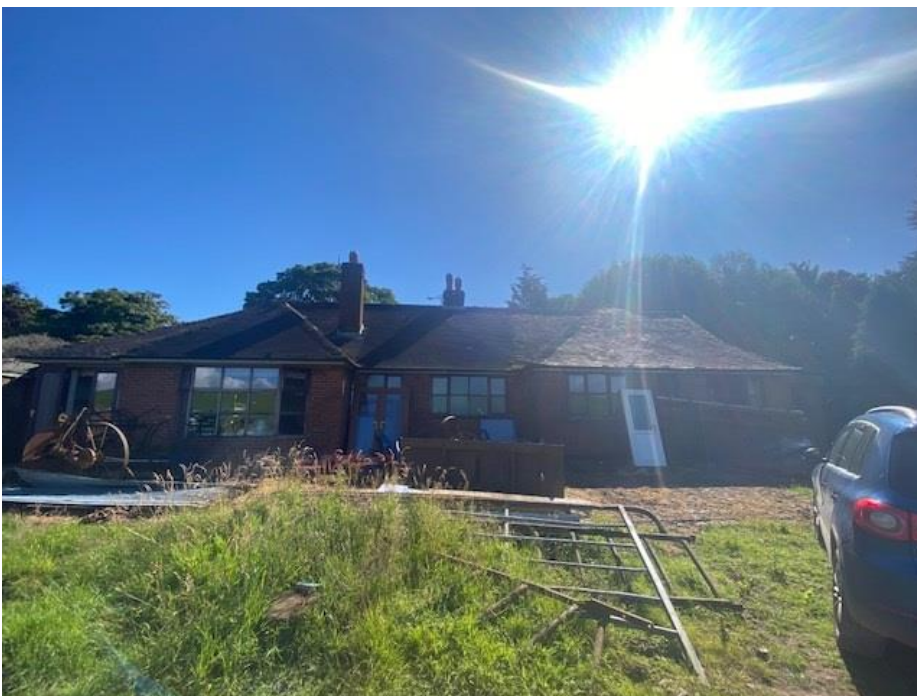
The western roof elevation is more deteriorated with multiple missing tiles but only the northwest corner appears to have potential for accessing the loft void. No signs of frequent use were seen in the area with no grease stains visible between the tiles.

Figure 6.  
View east from western elevation of structure (Grid ref: SK 04939 42052)

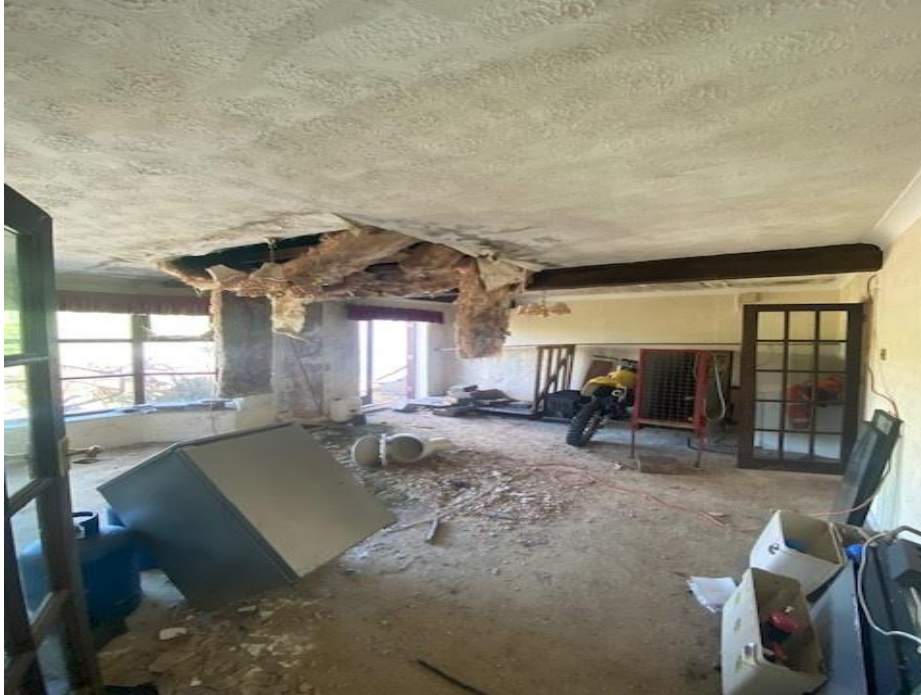
Accessing the structure, a portion of the living room ceiling has collapsed limiting loft access. Light was visible entering the loft from the northwestern corner, confirming the suspected entry point from the exterior assessment.

Figure 7.  
View of living room with partially collapsed ceiling (Grid ref SK 04954 42061)

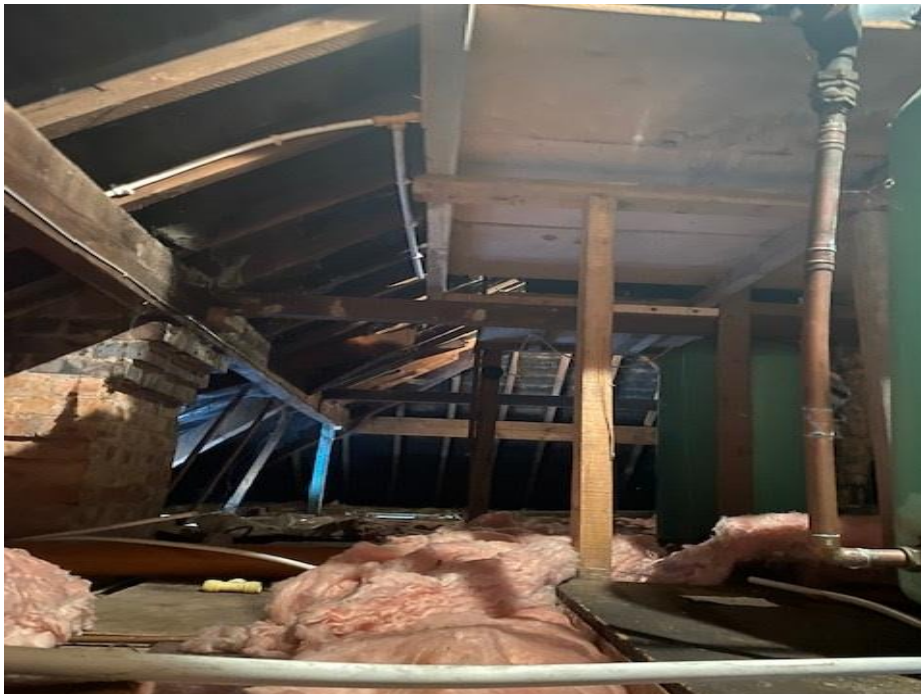
Figure 8.  
View of loft space (Grid ref: SK 04956 42054)

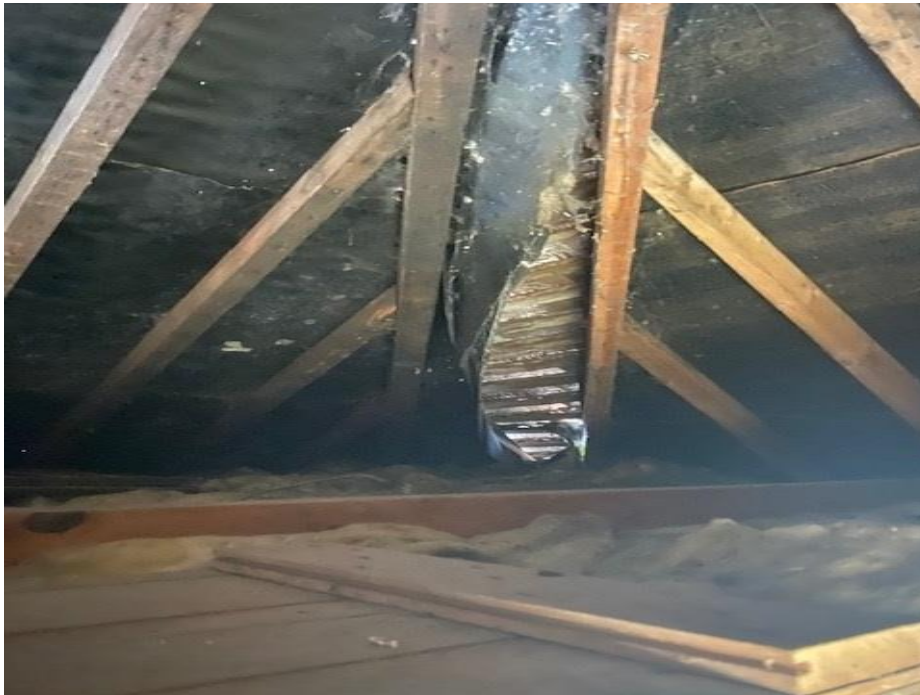
Figure 9.

The region of potential entry for bats in the structure is focussed on the northwest corner and each flank of the northwestern hipped roof over the bay window.

View of the gap in the northwest corner of the roof (Grid ref: SK 04950 42066)

The site contains good foraging habitat for bats. The potential for roosting is confined to the northwestern corner of the structure with gaps in the corner ridge tiles. The tiles have no signs of grease marks from entry and exit but the surrounding habitat is likely to support a significant bat population. This potential roosting feature therefore has moderate suitability for roosting bats and at least 2 surveys will be required within the optimal survey season to determine the presence or absence of roosting bats in the structure.

The ideal habitat and the possibility of entry into the structure leaves the structure with a medium suitability for roosting bats requiring at least 2 surveys to be conducted within the optimum survey season (May-August)

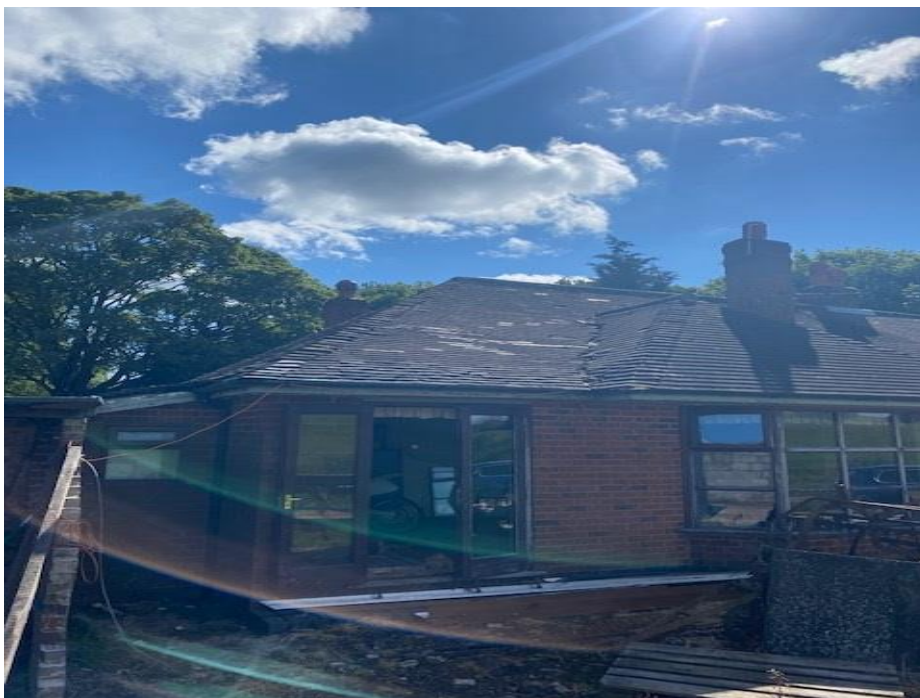
Figure 10.

View southeast of the northwest corner of the structure (Grid ref: SK 04942 42067)

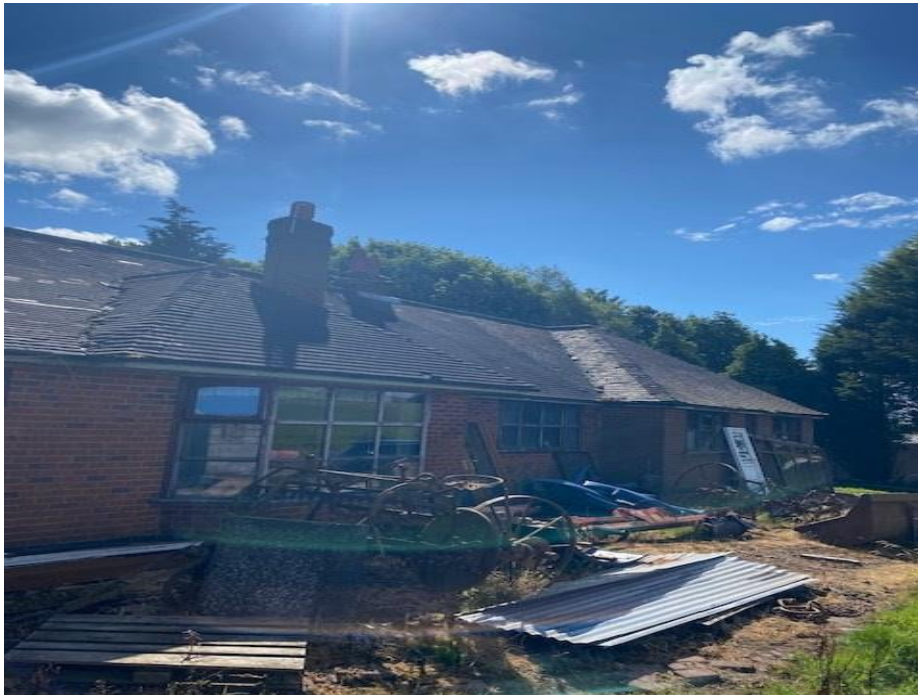
Figure 8.  
Western elevation hipped roof bay window (Grid ref: SK 04944 42064)

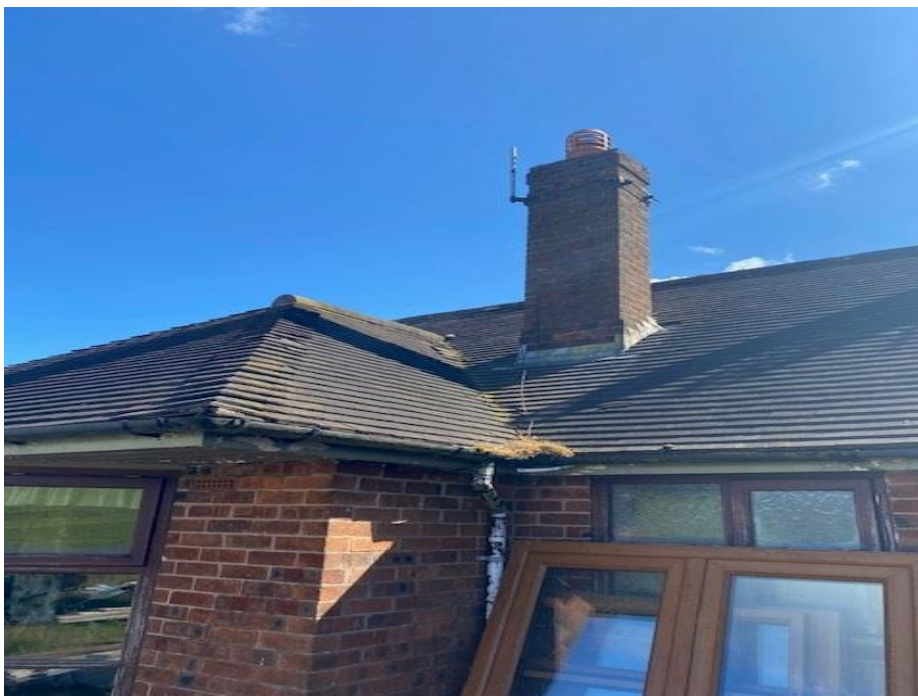
Figure 92.  
View of northern chimney and hipped roof (Grid ref: SK 04948 42058)
