## Rudyard Memorial Hall, Rudyard

## Bat Mitigation Statement

November 2024

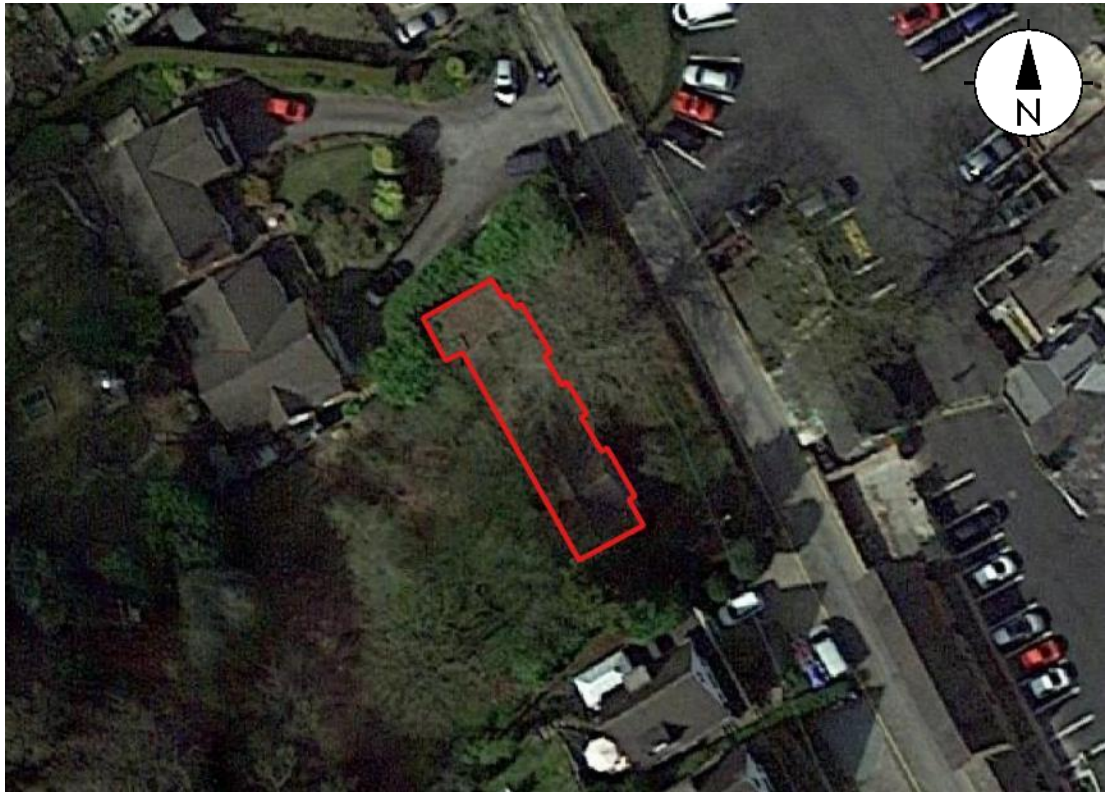
**Figure 1:** An aerial photograph of the surveyed structure at Rudyard Memorial Hall, Rudyard (as shown by the red outline).

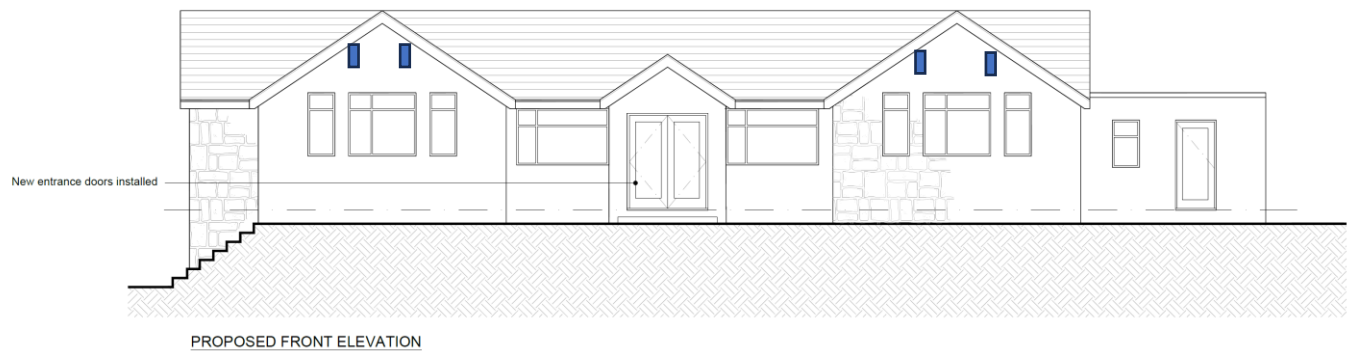
**Figure 3:** Front elevation plans showing the location of the Integrated Eco Bat Box (blue shape).

It will be necessary to compensate for the loss of the common pipistrelle roost. This will be to include six [Integrated Eco Boxes](#) are installed on the structure as close to the existing roost as possible. These should be placed where the timber slats are currently located, with two on each section. In addition to this, two boxes will be installed on the south-western elevation, to provide alternative roosting locations.
