## **Bat and Bird Survey Report**

Marshfield Gate Farm, Marshfield Gate Lane, Gillow Heath, ST8 6RG

| Document Number: | FFE-01094-V2 |
| Project: | Residential development |

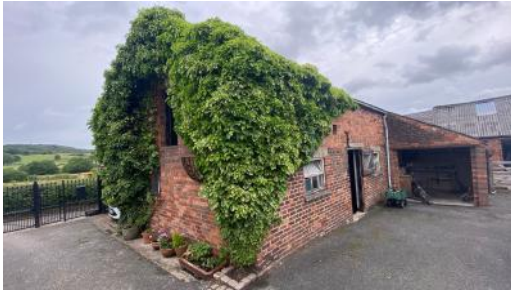
- 3.4 B1 was an irregular-shaped brick-built barn with a timber-framed complex pitched roof structure that was clad with clay tiles and underlined with traditional bitumen felt. There were several doors for access inside the barn. The northern element extended out to form a garage used for vehicle parking. This part of the structure supported a timber-framed pitched roof that was lower in height than that of the main structure. There was also a small brick workshop extension to the southeast corner of the barn which supported a mono-pitched roof that merged with the main roof pitch at eaves level, as well as a separate room at the back of the same workshop along the eastern side aspect, which was small and used as a laundry facility. Internally, B1 was penned off in sections, presumably because it once housed livestock, and there was a ladder leading to a loft area, a first-floor room created by use of boarding set out over the joists. There were two large openings in the brickwork at first floor level on either side of the barn

- 3.5 Externally, many potential roosting features (PRFs) were identified during the survey, most of which were raised, fractured or dislodged roofing tiles which were suitable for use by a variety of bat species, and some of these gaps would likely provide bats with access between the tiles and bitumen felt. Gaps were also noted beneath the ridge tiles and while inside the loft, daylight could be seen shining through into the loft along the ridge line, which also suggests there was ample roosting opportunity along the ridge and ridge board below. Direct access inside the loft for bats was made available via the two large gaps in the brickwork at either side. Other suitable roosting locations were between the roof timbers and in small settlement cracks within the brickwork of the barn. In addition to above, the entire barn provided opportunity for night roosting and perch-feeding, for species such as brown long-eared bat *Plecotus auritus*. No evidence of bats was discovered in B1.

**Photo 1: views of the southwest facing corner of B1**

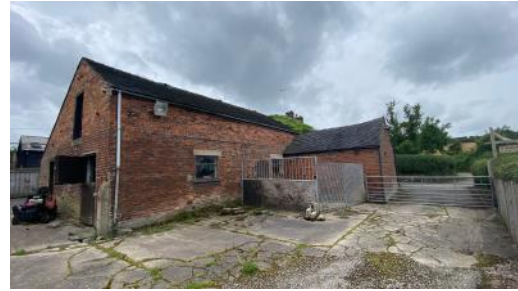
- 3.6 B2 was a rectangular-shaped brick-built barn with a gable end each side. Historically, it would have been designed to serve as two separate (albeit adjoining) barns. It supported a timber-framed pitched roof, half of which was clad with corrugated fibre sheeting (southern half), whereas the other half was covered with clay roof tiles (northern half). The ridge line was marginally stepped up higher along the southern half. Internally, there were two main compartments, although at the time of the survey, access to both could be achieved via a door located at the southern part of the barn. There was no loft void, the underside of the roof was not lined with bitumen felt and the entire roof could be observed from ground level. Concrete ridge tiles were fitted along the northern half of the barn.

**Photo 2: views of the northwest facing corner of B2**

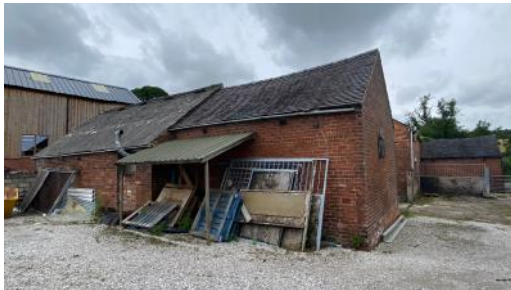
- 3.7 The tile covered section of B2 provided a suitable roosting environment for bats, with opportunity for roosting made available between very many tiles that had become raised or slipped over time. There was ample access for bats to enter inside the building given the roof was not underlined with felt. The corrugated fibre sheeting was less suitable for use by roosting bats, as it lacked crevices for bats to roost between, although the internal elements of the entire barn provided night roosting and perch-feeding opportunity for species such as brown long-eared. During the survey, small concentrations of moth wings were discovered in the northern half of B2 as well as the occasional relatively fresh medium-sized bat dropping typical of those deposited by brown long-eared.

**Photo 3: views of the east facing side aspect of B2**

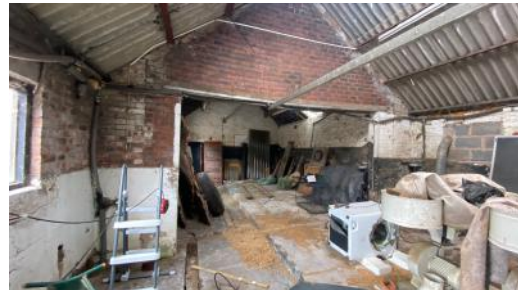
**Photo 4: internal elements of B2**

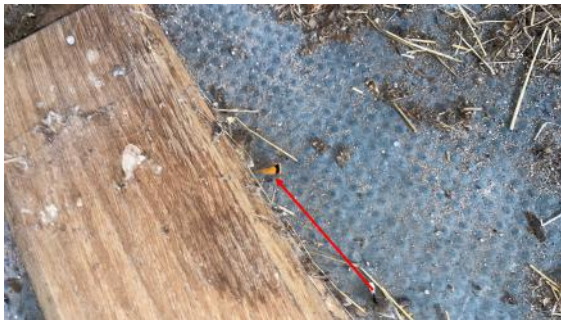
- 4.8 During the PRA, presence of discarded moth wings (and occasional droppings) found in B2, suggests the barn was used as a feeding roost by brown long-eared bat, a species which is known to carry moths into buildings before feeding.

**Photo 5: red arrow points to discarded moth feeding remain in B2**

4.12 Bats are protected by law. If a bat roost exists in a building, it would be a criminal offence to impact the roost without a bat mitigation licence which would be issued by Natural England prior to works commencing and after planning permission and/or other relevant consents have been granted. All survey work must be complete before a licence application can be made. The licence application is usually supported by a method statement that includes mitigation measures aimed to safeguard bats and their Favourable Conservation Status (FCS). Natural England expect three tests to be satisfied before a bat mitigation licence can be issued. These tests are as follows:

4.14 Works must not commence until the bat mitigation licence has been granted by Natural England. There will be no timing constraints associated with the licence because no breeding or hibernating bats will be affected by the proposed works.

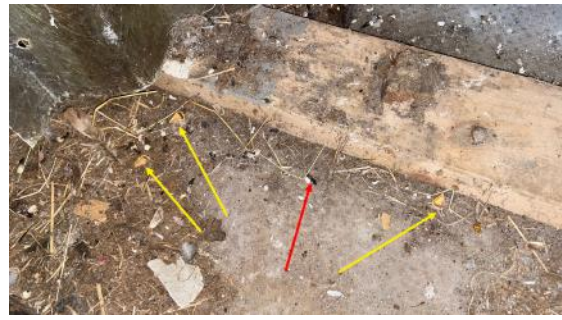
**Photo 6: Red arrow points to bat dropping and yellow arrows point to discarded moth feeding remains in B2**

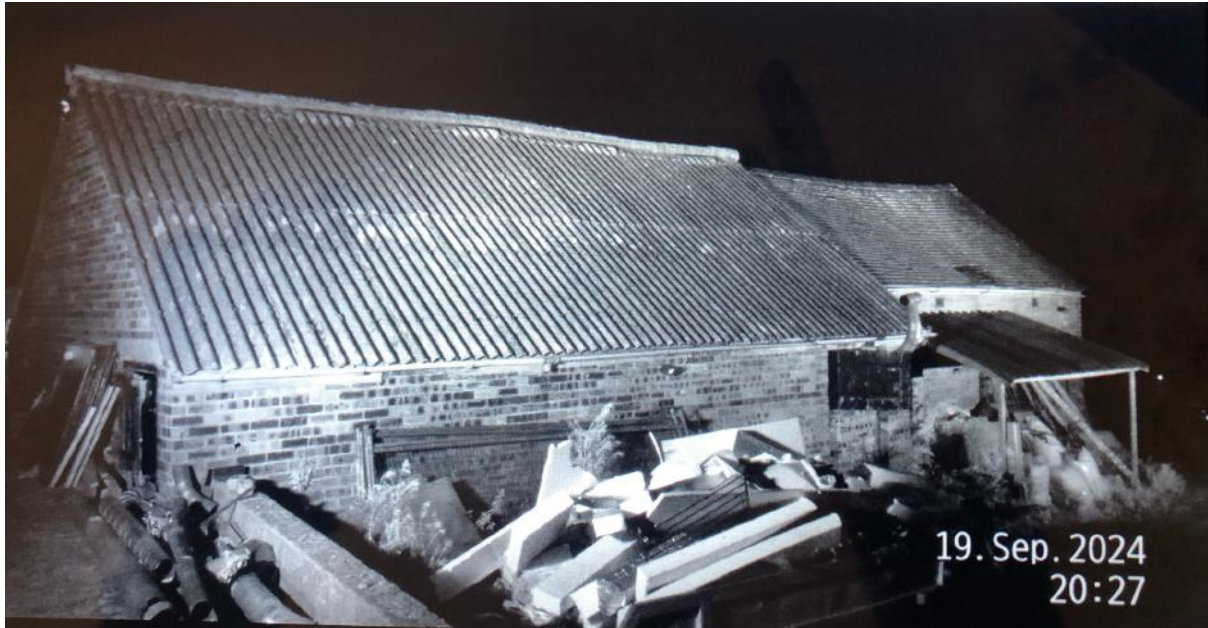
**Photo 7: NVA image covering rear east facing roof pitch of B2**

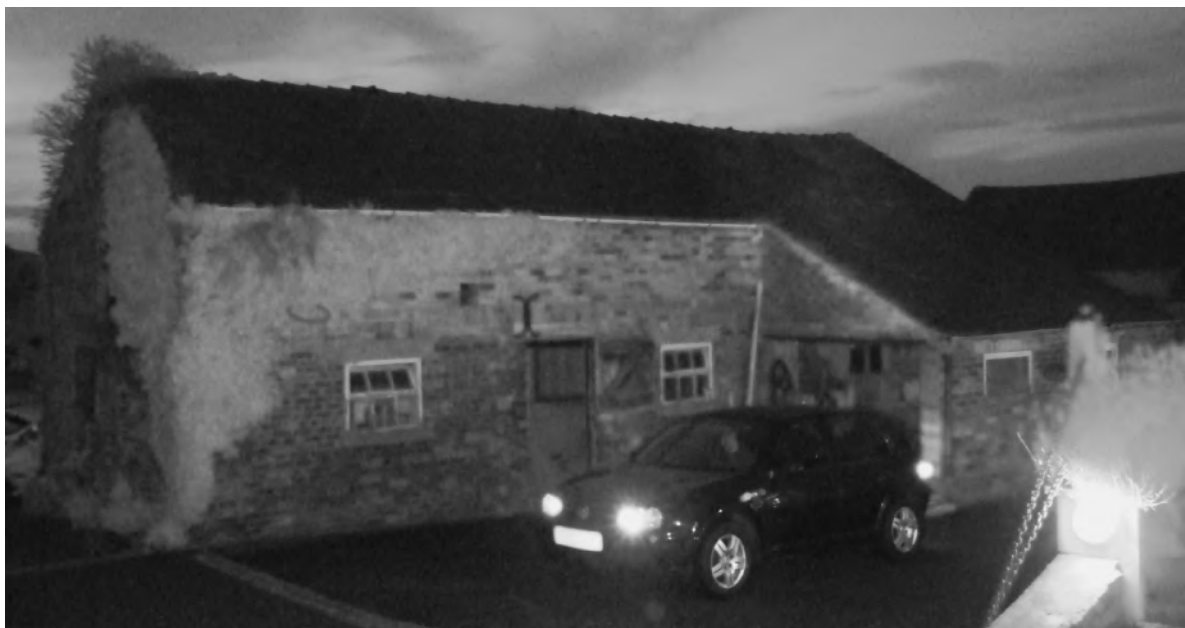
**Photo 8: NVA image covering southwest corner of B1**
