TREE REPORT AND SURVEY AT Albion Mill, Biddulph

Albion Mill, Station Road, Biddulph

Arboricultural Implications Assessment

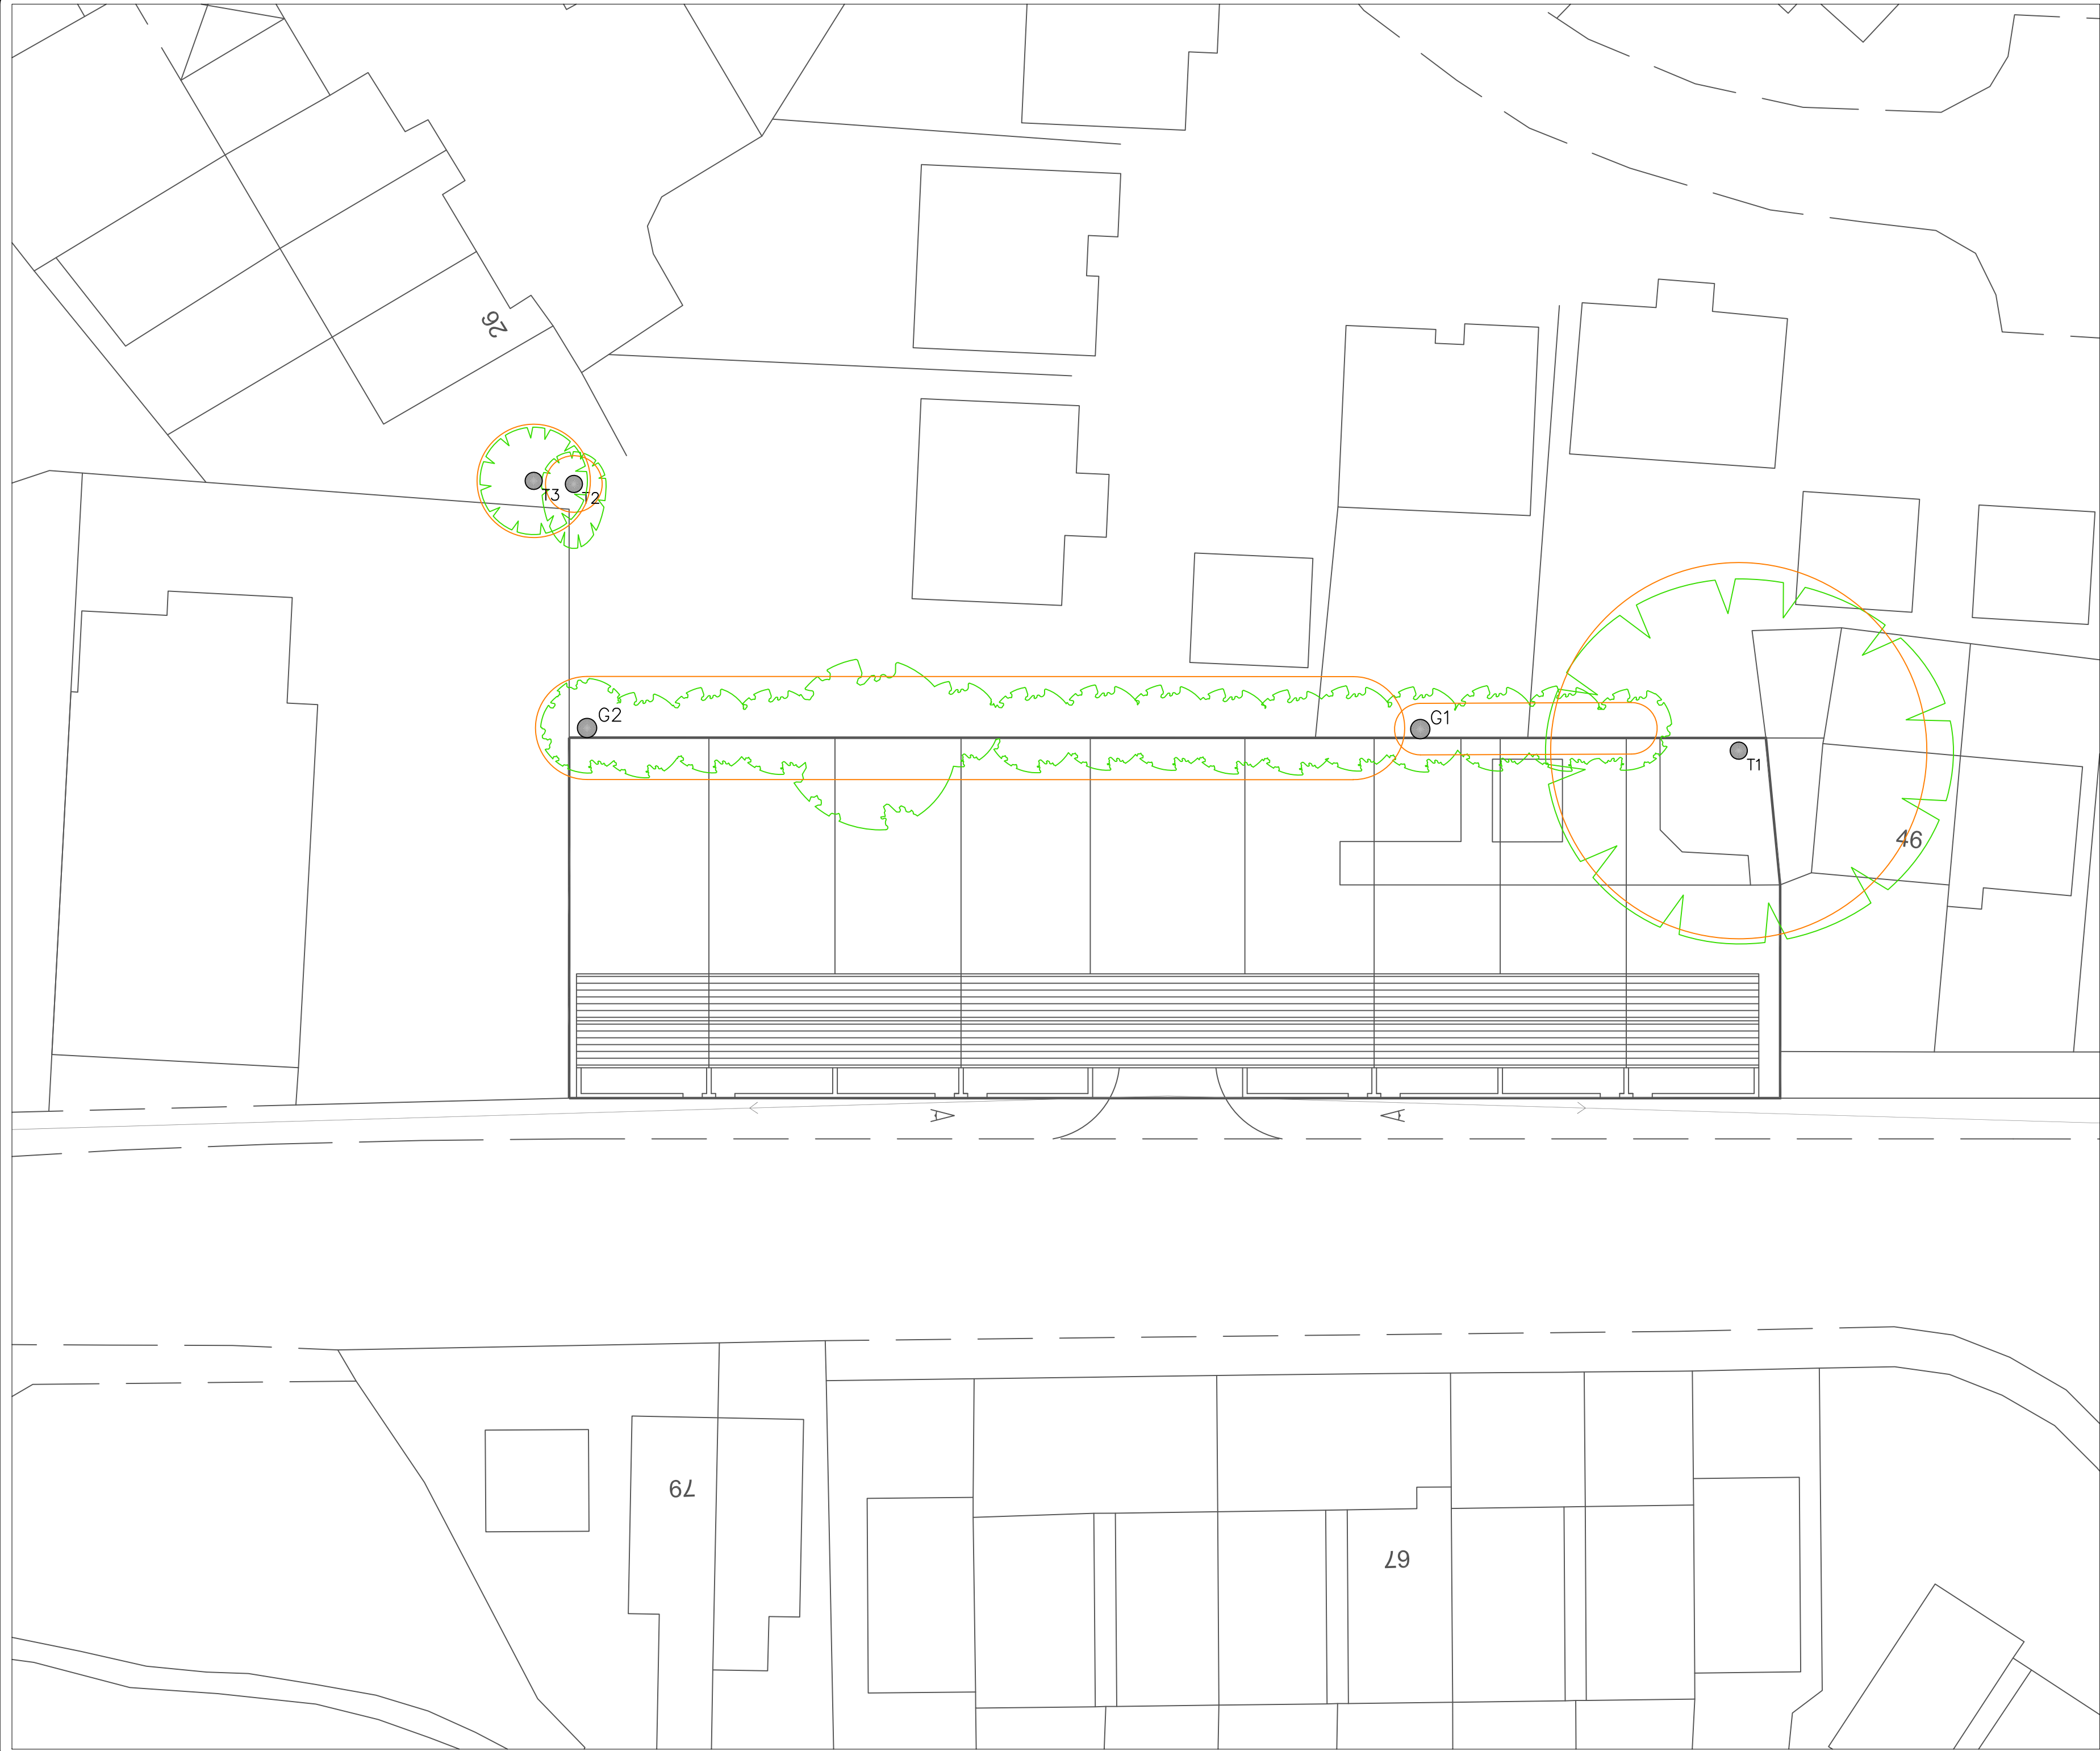
Scale: 1:200	Paper Size: A2	Date Created: 28/07/10
Drawing Number: THL/JW100	Drawing Revision: 1

The trees are shown on the Arboricultural Implications Assessment drawing THLJW100.

T1 is a large Ash located to the rear of the property within a raised bed along the boundary wall. The tree has some major dead wood in the crown and has been heavily pruned by the neighbours. A large part of the stem and crown is also covered by ivy. There appears to be a 'lean to' type structure and retaining wall adjacent to the tree. If this structure is removed during the construction stage then there may be some stability issues with this tree. I would suggest that the tree is removed if the scheme is implemented.

T2 and T3 are sufficient distance away as not be affected by the development and will be protected by the existing boundary fence and wall.

G1 and G2 run along the rear of the property and are located outside of the boundary wall. These trees will not be affected by the development but will provide a suitable screen from the properties behind. These trees would benefit from having the sides trimmed to create a better quality screen.

It is not necessary to use protective fencing as the trees are off site and protected by the retaining walls.
