## APPENDIX I

### IVY HOUSE FARM, ROWNALL - SUPPLEMENTARY PHOTOGRAPHS

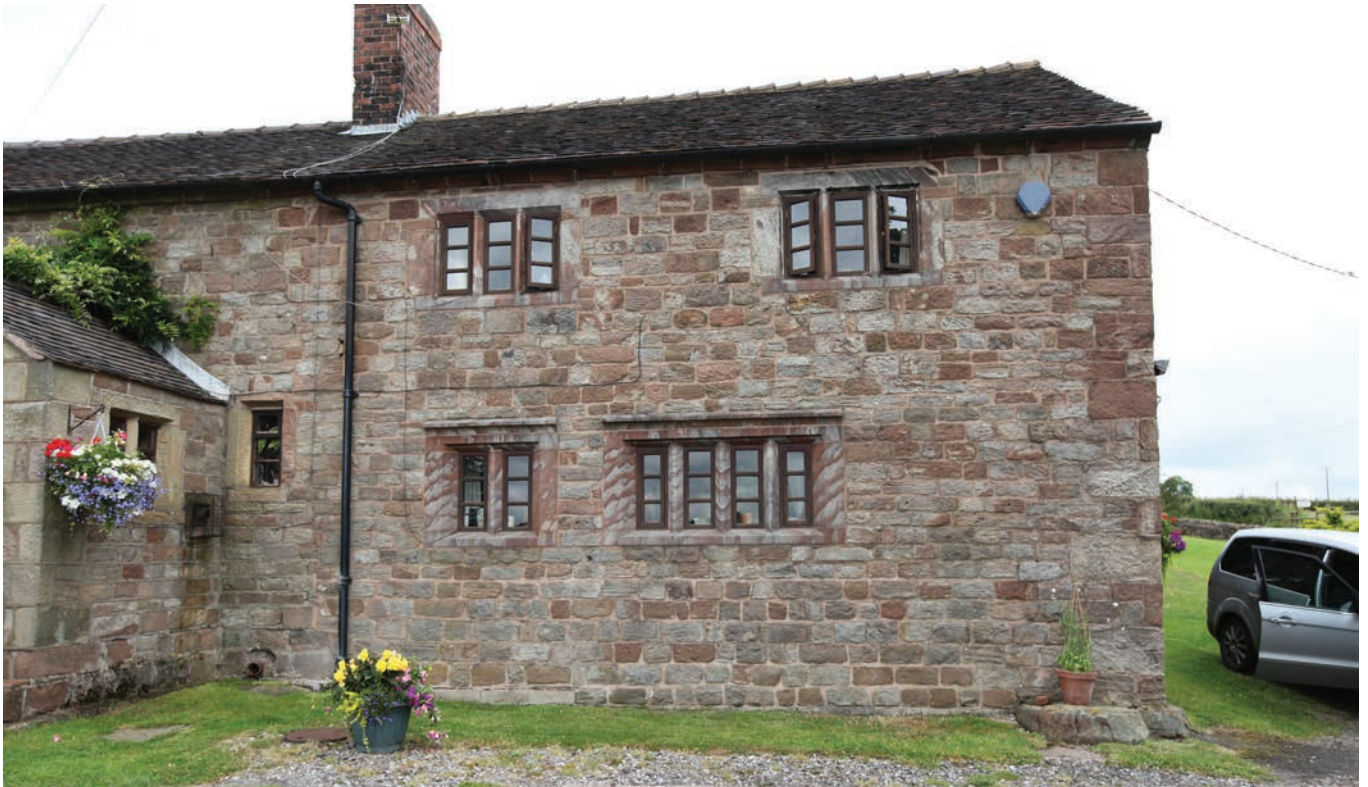
Pl. 1 Eastern bay with four-light window and small mullioned and chamfered window to the left, approved in 1992

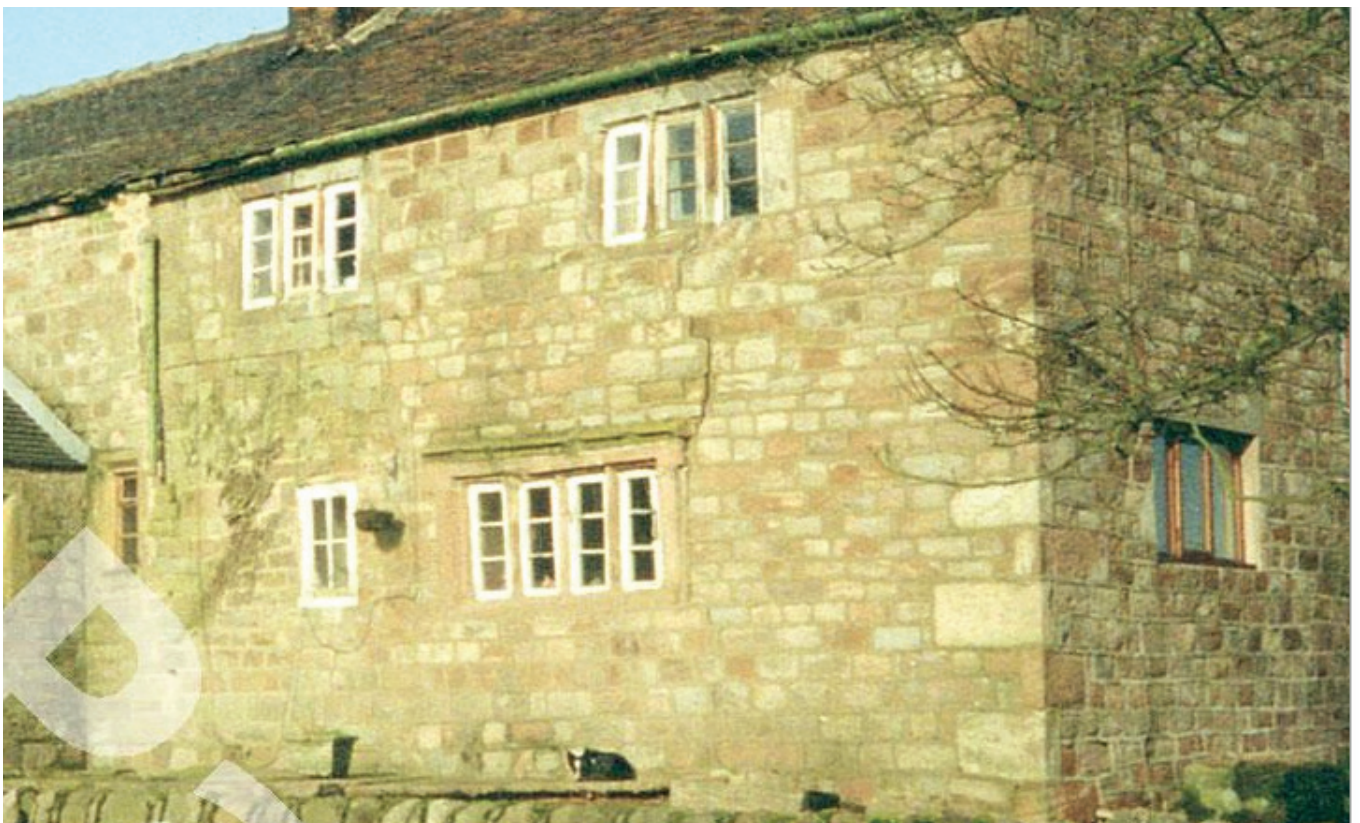
Pl. 2 The same elevation photographed circa 1984. Although the mullioned windows are eroded in this image, their buff colour is distinct. The position of the first floor windows relative to those on the two western bays of the farmhouse, and subtle differences in the masonry (no longer evident) are two indications that the upper floor windows may have been part of an adaptation to raise the building from a single storey wing to a two-storey structure, at which time the staircase window in the gable end would have been added.

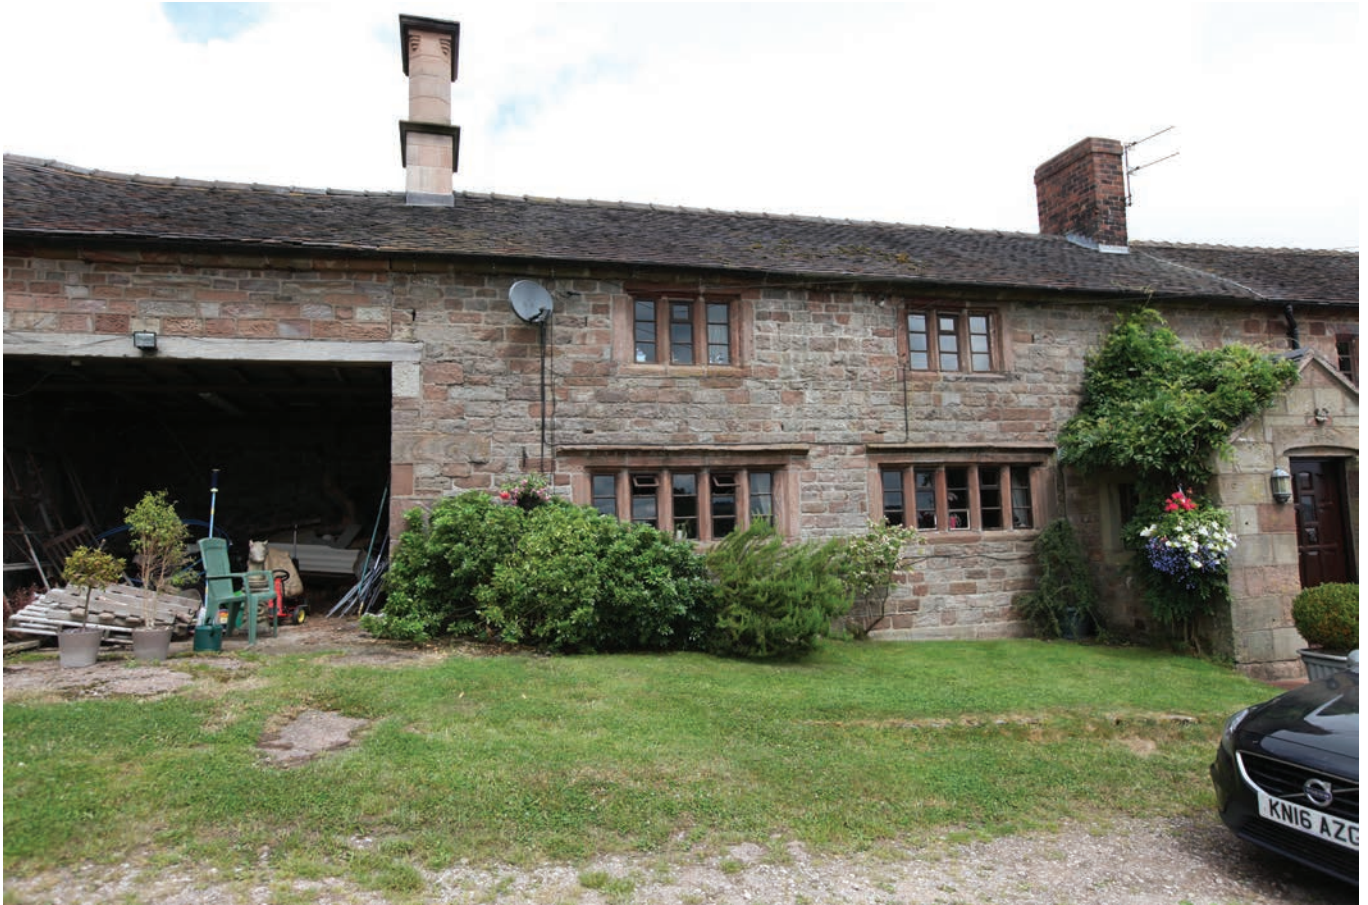
*Pl. 3 View of the south-facing elevation. The modern porch of 1984 covers the original entrance doorway into the Houseplace or Hall. The open cartshed to the left is a later 19th century alteration and may relate to the documented presence of a 'carter' at Rownall in the 1861 and 1871 census returns.*

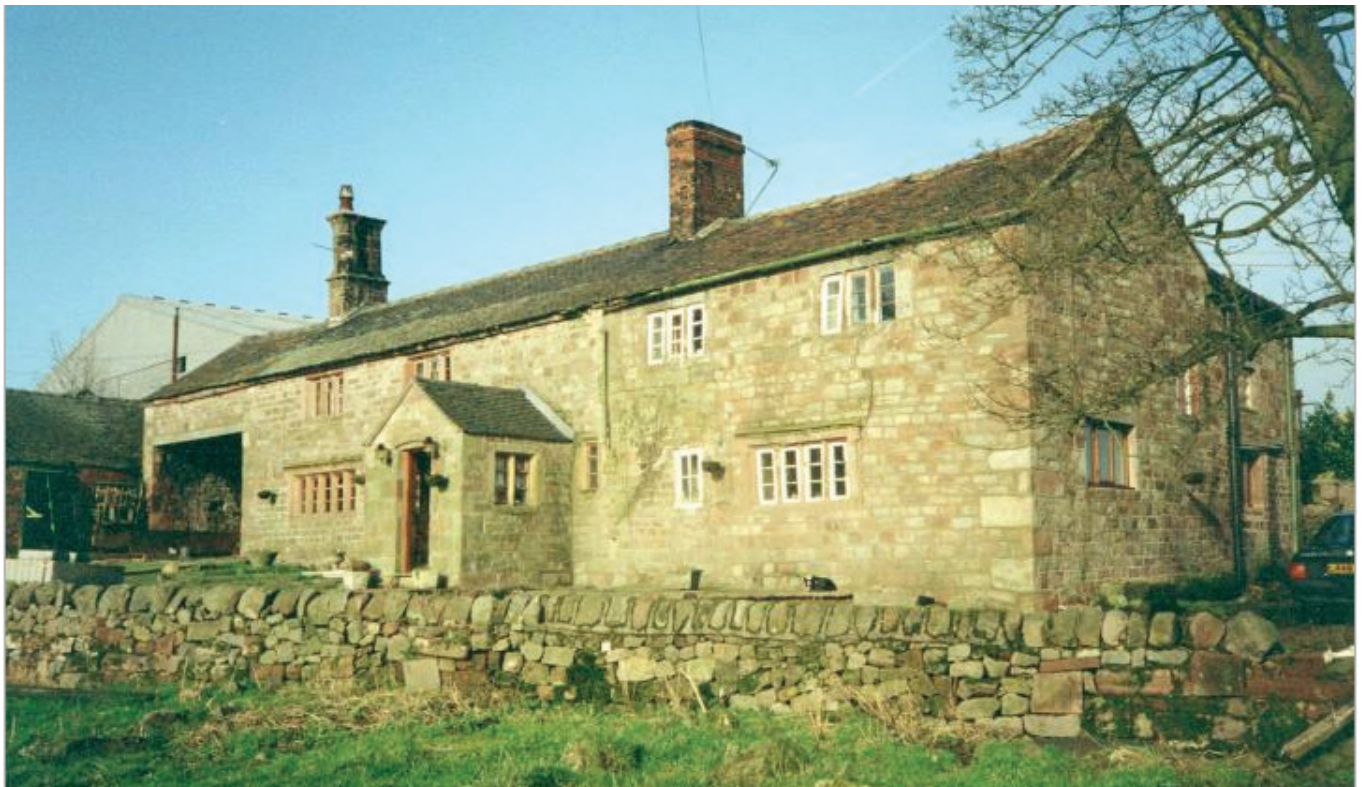
*Pl. 4 Photograph of the entire south-facing elevation taken circa 1984 prior to alterations.*

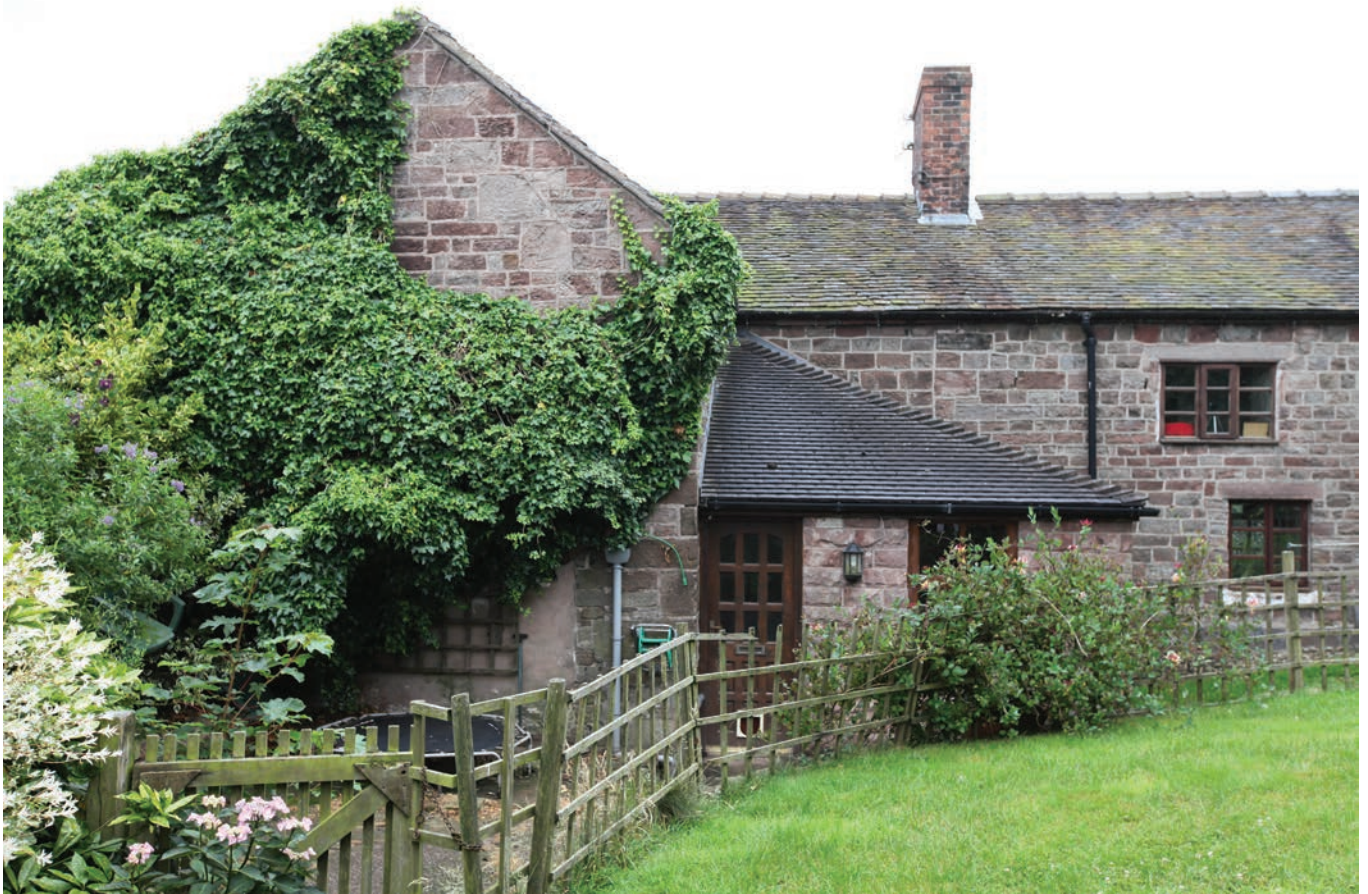
Pl. 5 (above) Rear elevation looking south from the raised and embanked lawn.

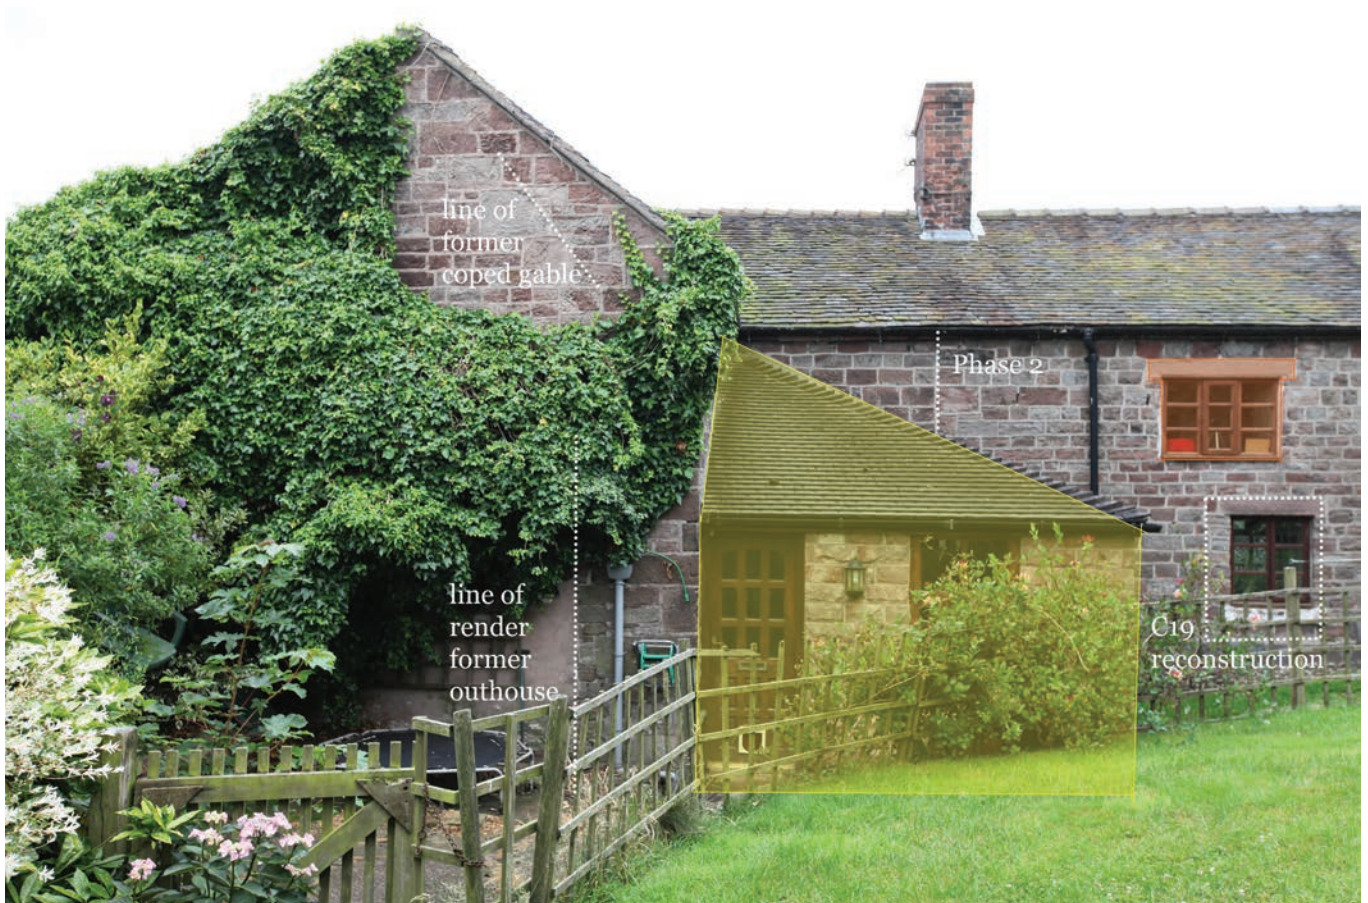
Pl. 6 (below) The orange highlight represents a 20th century alteration to insert a window with a concrete lintel, the yellow highlight is the reconstructed utility, on the footprint of an earlier 20th century rear porch.

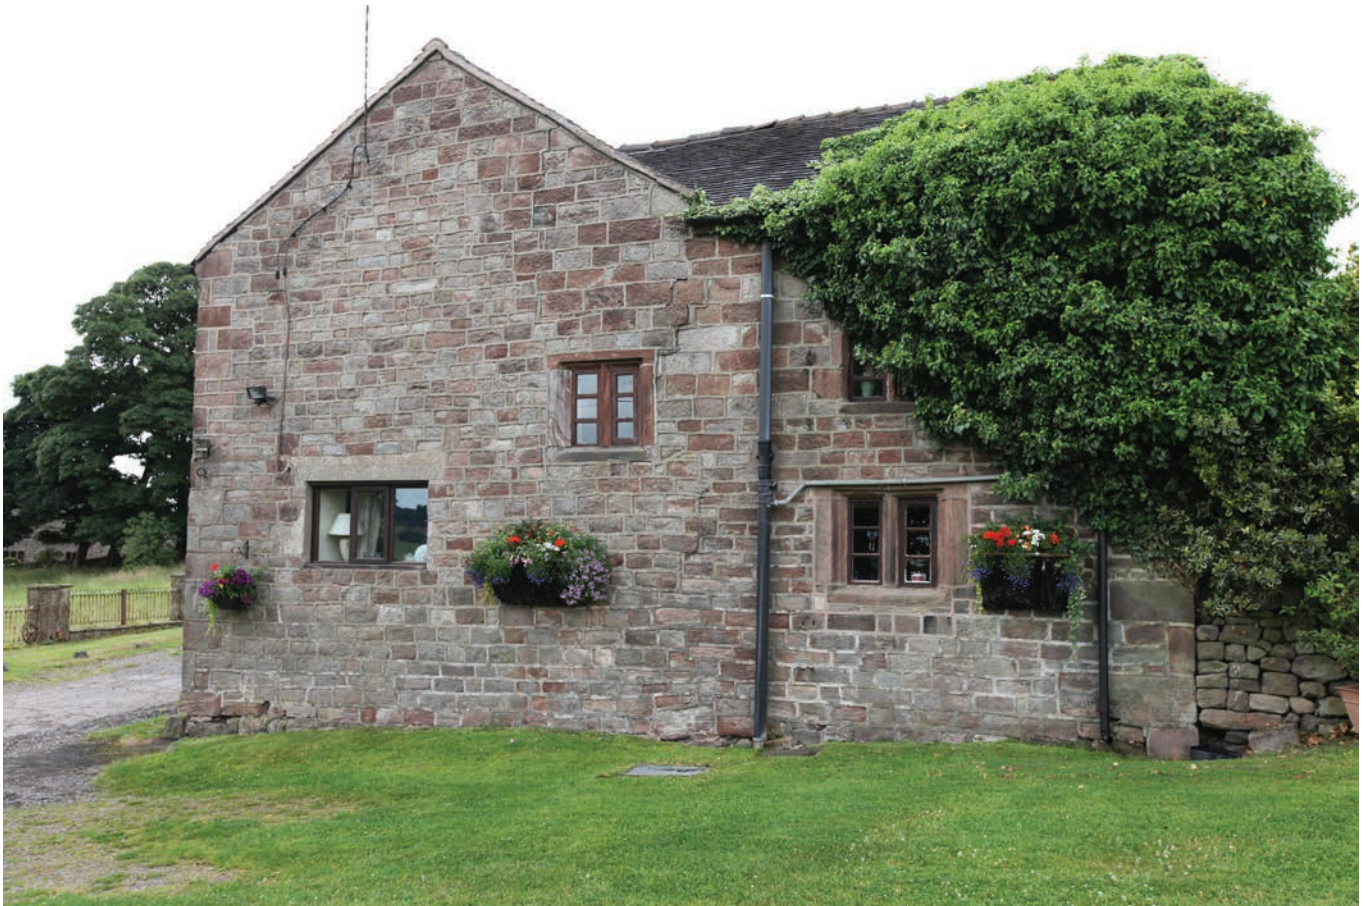
Pl. 7 Eastern gable end. This elevation has undergone considerable alteration. The larger masonry courses towards the gable suggest a large area of reconstruction, possibly undertaken in the 18th century. The original stone coped gable has also been removed. There are indications that this part of the building may have originally been a single-storey kitchen wing using the earlier cruck trussed frame, which would account for the change in masonry. When it was altered in the later 17th century and raised to two storeys, a staircase window was inserted.

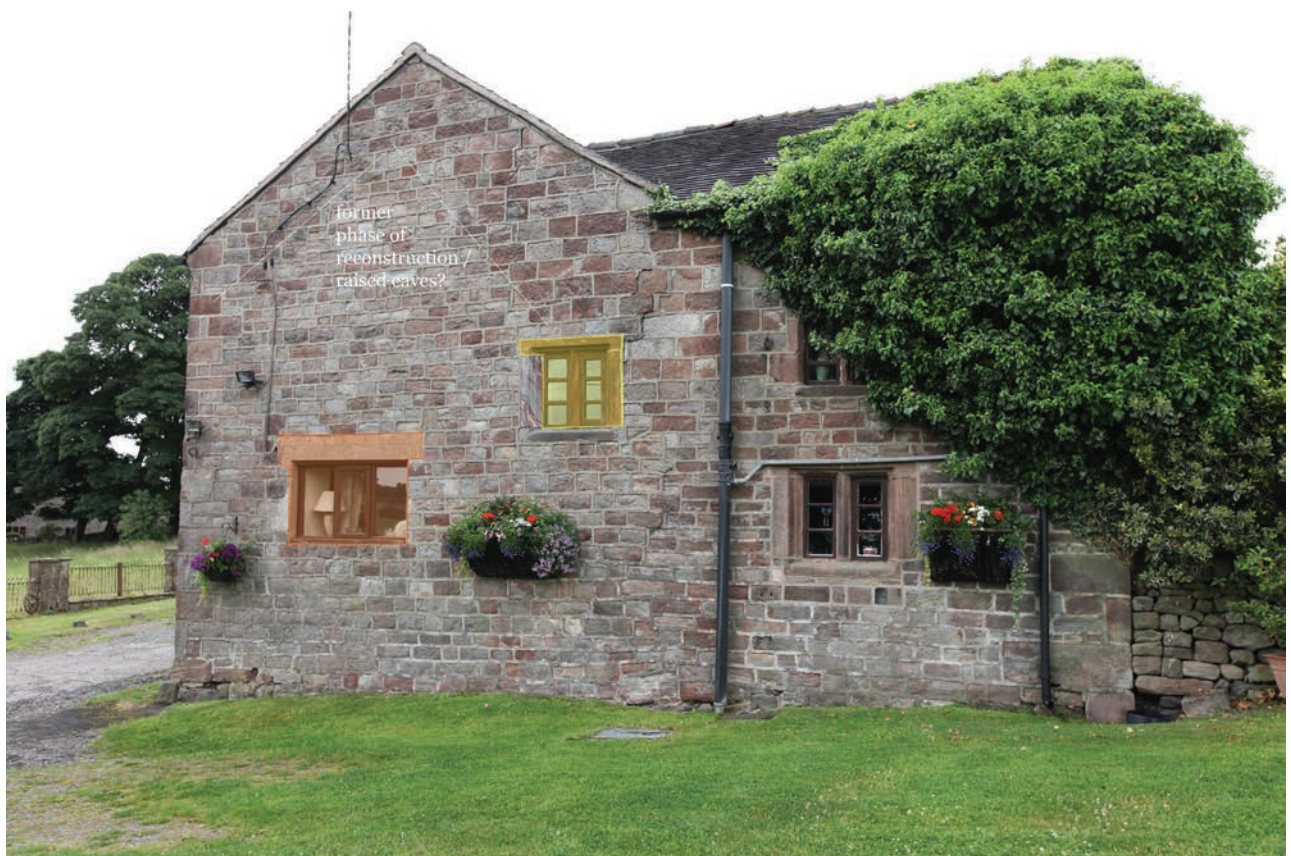
Pl. 8 yellow highlighted masonry dates from the 1992 repair, whilst the orange highlight is a 20th century alteration

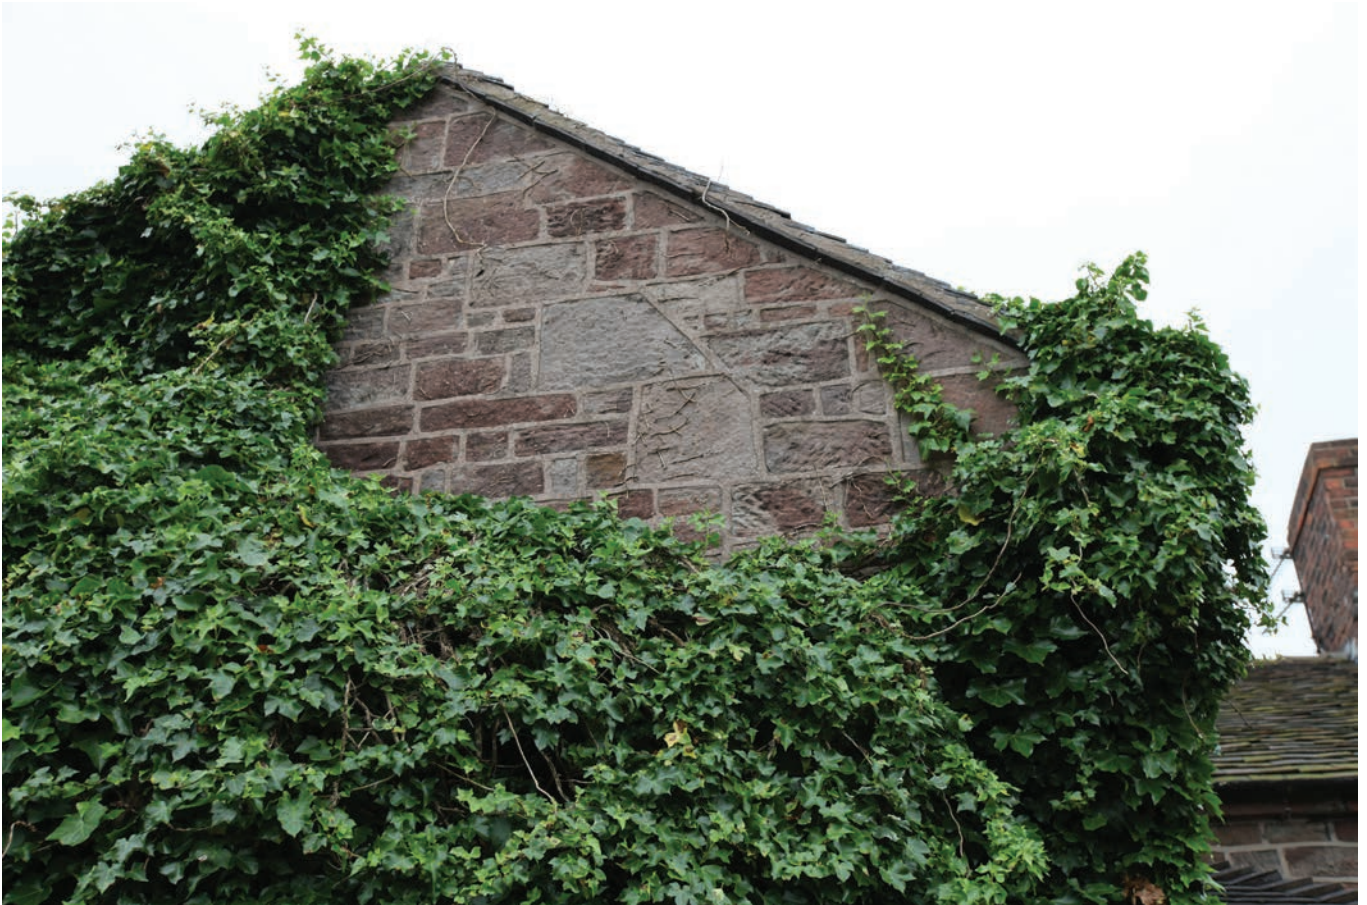
Pl.9

*Northern gable to the dairy / kitchen wing. The presence of large blocky stones, cut and dressed, reveal that this gable was once much narrower with a raised coped gable.*
