# Historic Environment Desk-Based Assessment

## New House Farm BESS

### YLEM Energy Ltd

SLR Project No.: 415.064529.00001

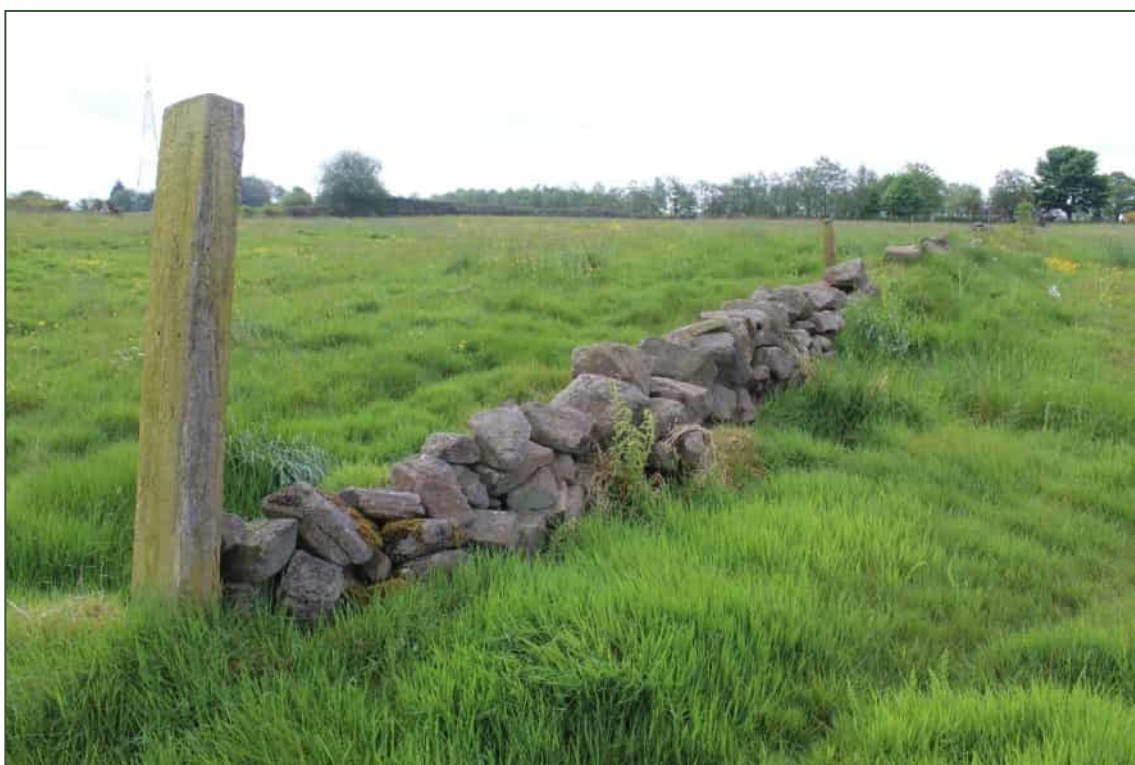
Photo 2: Looking southeast from center of the northern Site boundary, central dividing sandstone wall in foreground

The central sandstone wall is in a poor condition and given its low heritage significance, it is anticipated that the impact caused by its partial removal could be somewhat offset by a brief photographic record documenting its condition and form (as provided within Section 2.1 of this report).

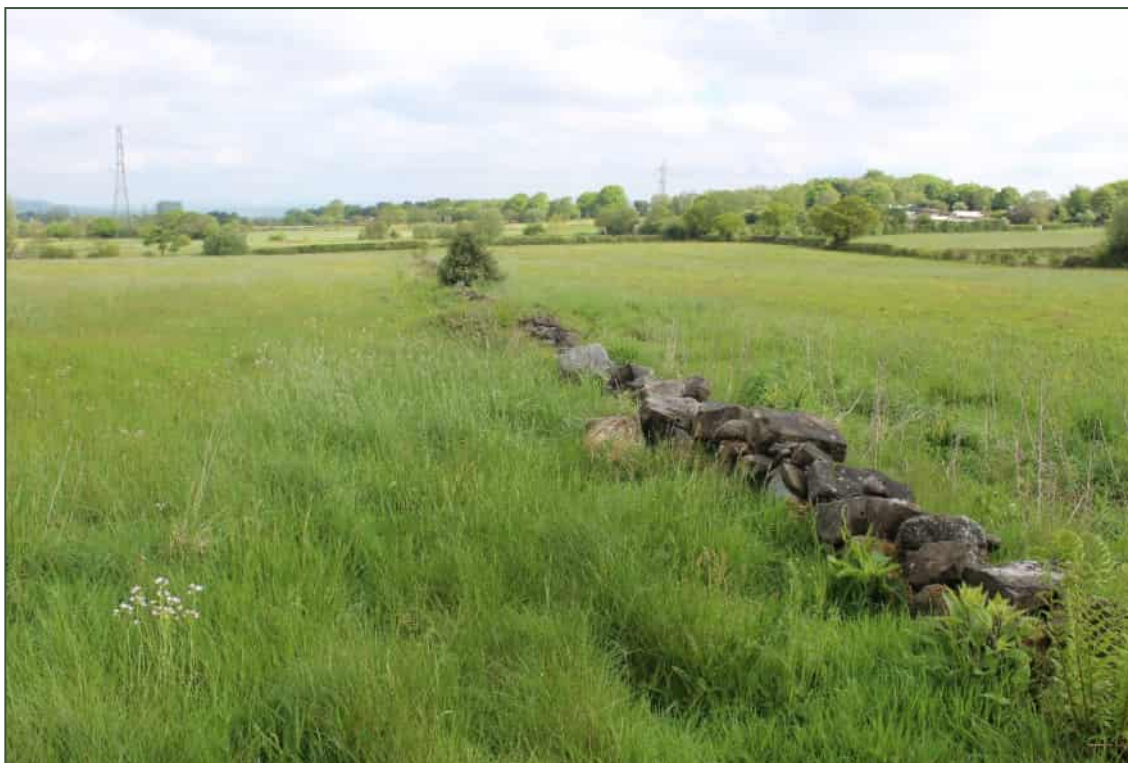
Photo 5: Looking north from center of the southern Site boundary, central dividing sandstone wall in foreground

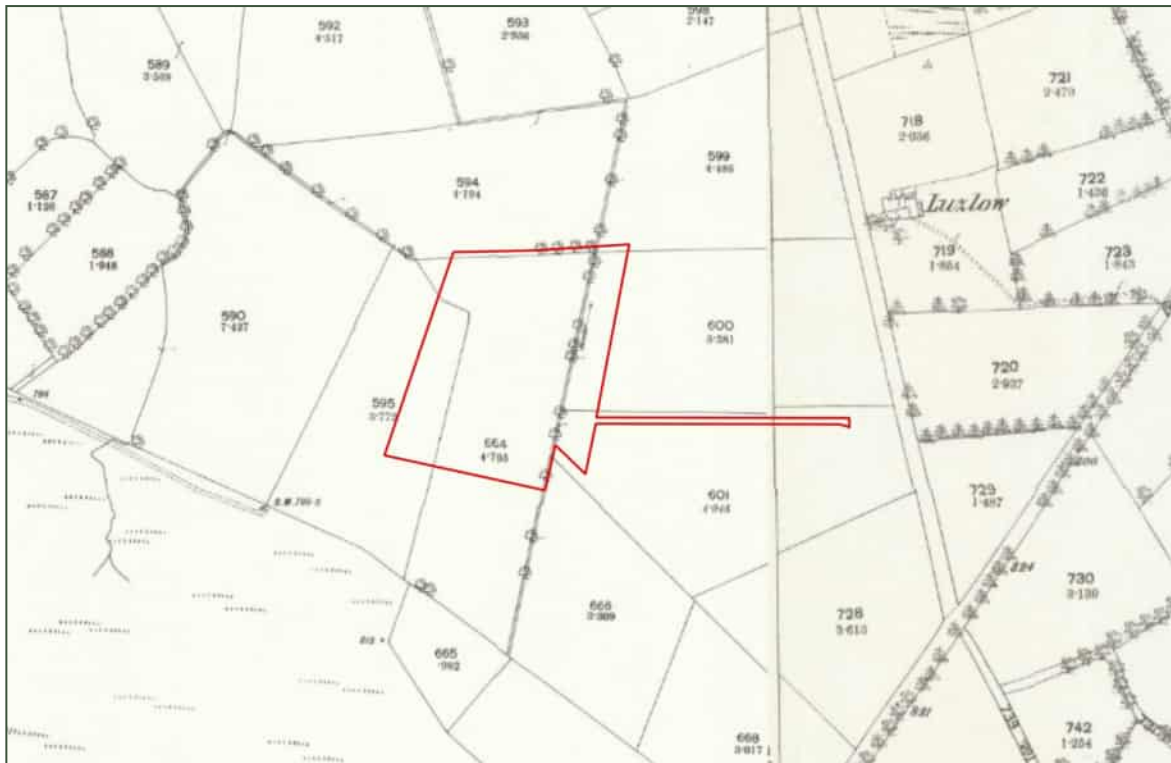
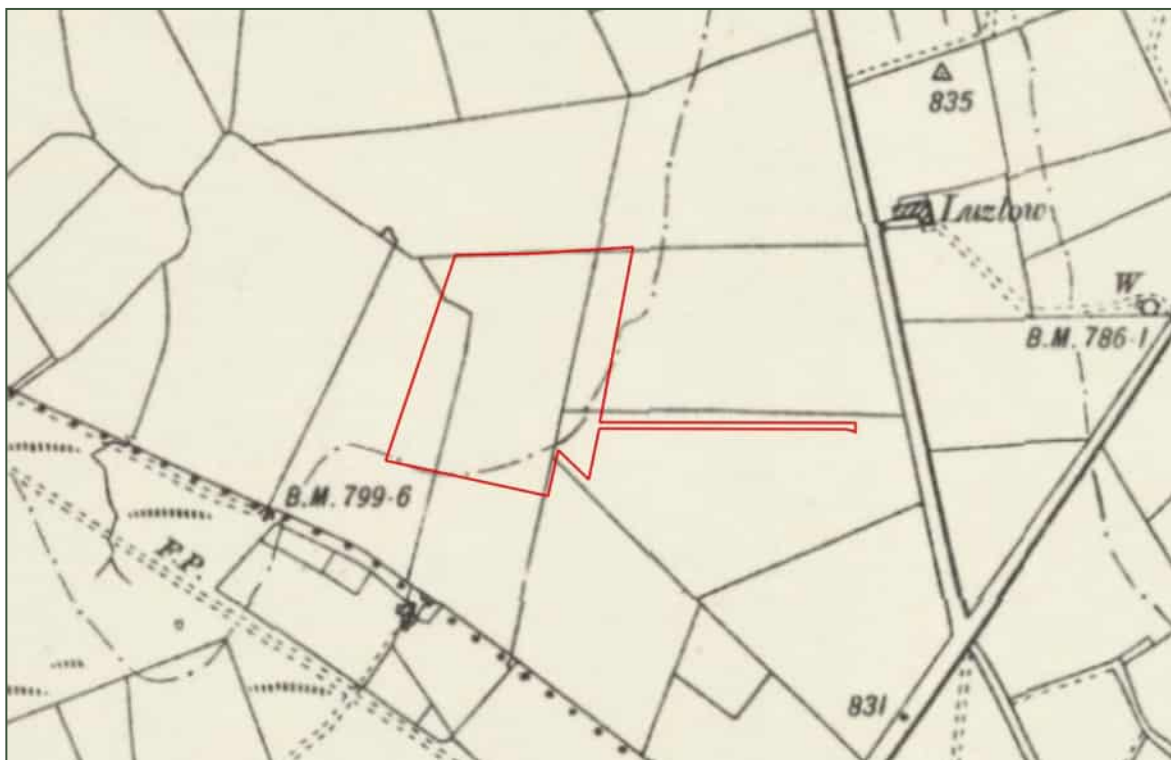
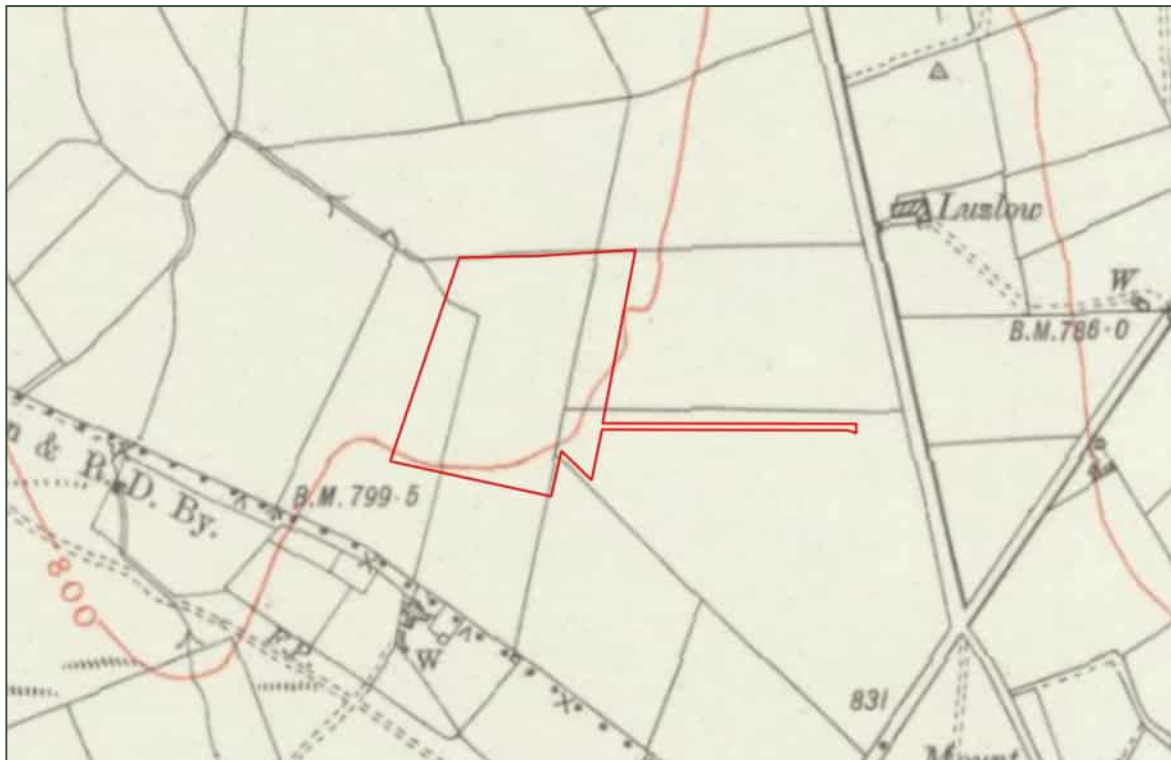
Plate 5: OS Map of Staffordshire XII.11 & 12, 1877. Retrieved from NLS online, 08/05/2024

Plate 6: OS map of Staffordshire Sheet XII.SE, 1898. Retrieved from NLS online, 08/05/2024.

Plate 7: OS Map of Staffordshire Sheet XII.SE, 1922. Retrieved from NLS online, 08/05/2024

Plate 8: OS Map SJ94NW – A, 1967. Retrieved from NLS online, 08/05/2024

No material changes are visible within the Site on subsequent historic mapping (**Plate 5-Plate 8**). The most notable changes to the surrounding landscape comprise the partial enclosure of the land to the south of the Site throughout the second half of the 19<sup>th</sup> century for use as plant nurseries, the construction of Little Armshead Farm to the immediate south between 1877 and 1898, and the construction of New House Farm to the north of the proposed access road route during the mid-20<sup>th</sup> century. Otherwise, the general landscape use of agricultural fields and farmsteads to the west, north and east of the Site, and heathland/plant nurseries to the south, has remained consistent until the present day. No notable changes are evident from historic satellite imagery over the past two decades (**Plate 9**).

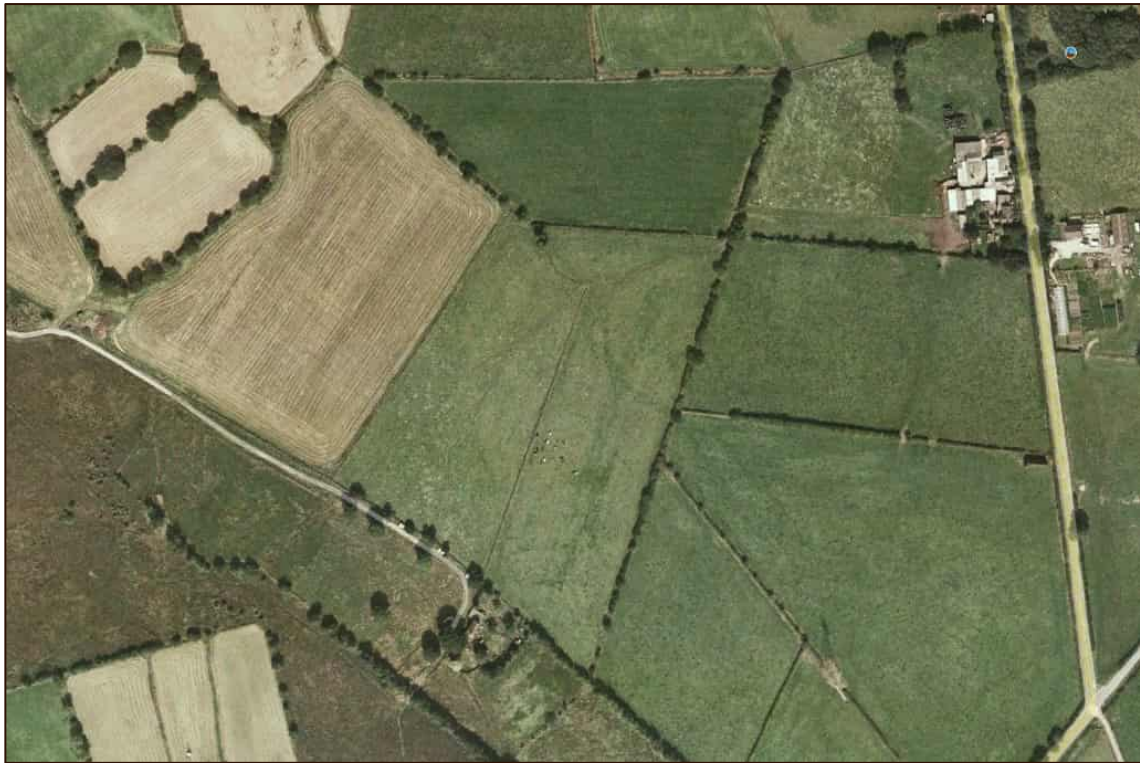
Plate 9: Satellite Image of the Site and surroundings, c.2003. Retrieved from Google Earth Pro, 14/05/2023
