**Cumberledge Farm, Huntly Road, Denford, Leek, Derbyshire,  
ST13 7JU.**

This document provides an overview of current ecological bat activity/survey findings. The bat scoping survey was undertaken on the 18<sup>th</sup> of June 2024 by Roy Leigh ACIEEM, a licensed bat surveyor, number 2015-15883 –CLS.

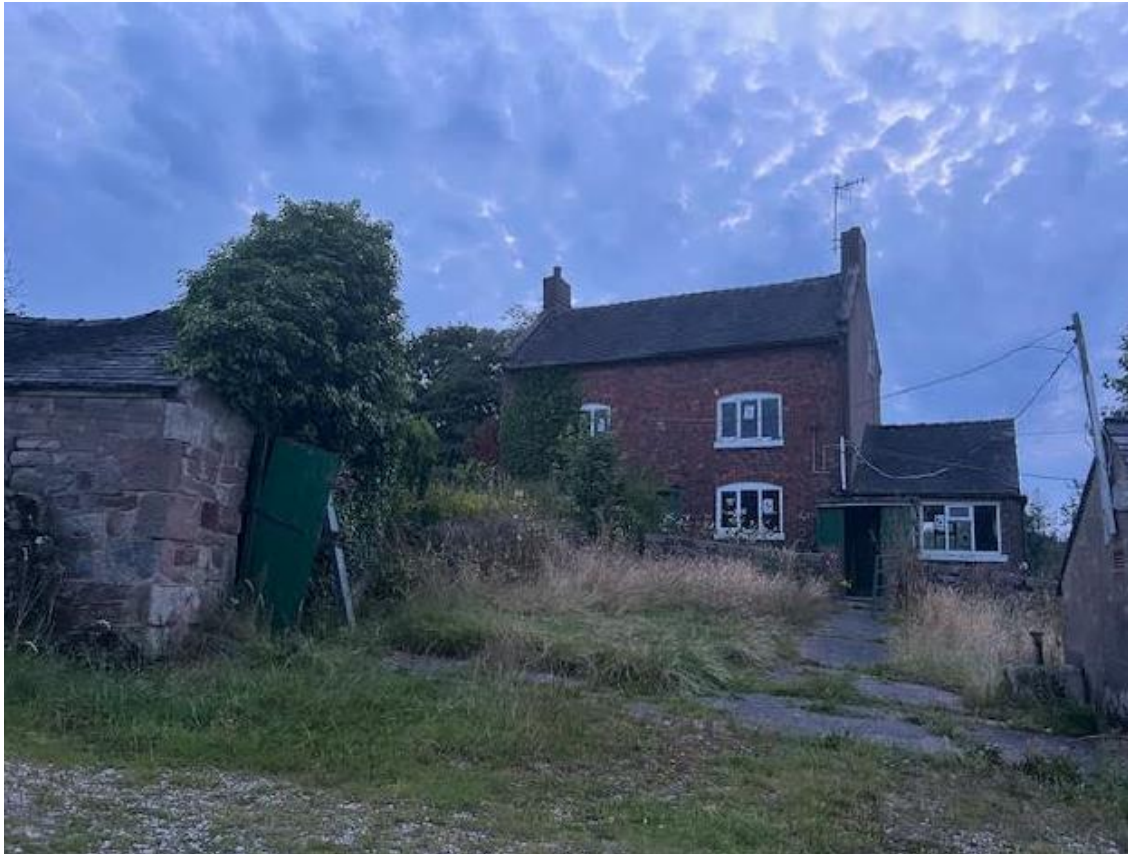
Therefore , the output from the bat scoping survey, the farmhouse was categorised as having a high potential for roosting bats, given the gaps in the coping stones, ridge tiles and flashing.

The target farmhouse.

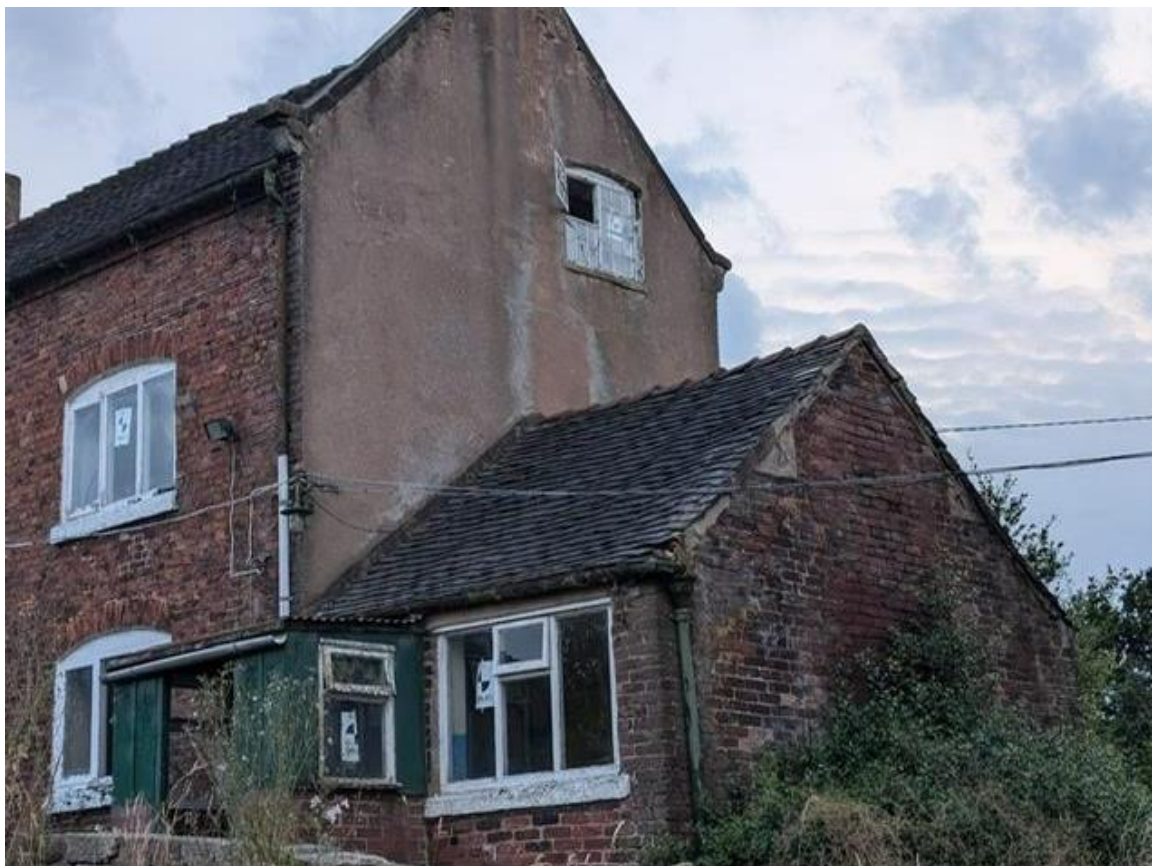
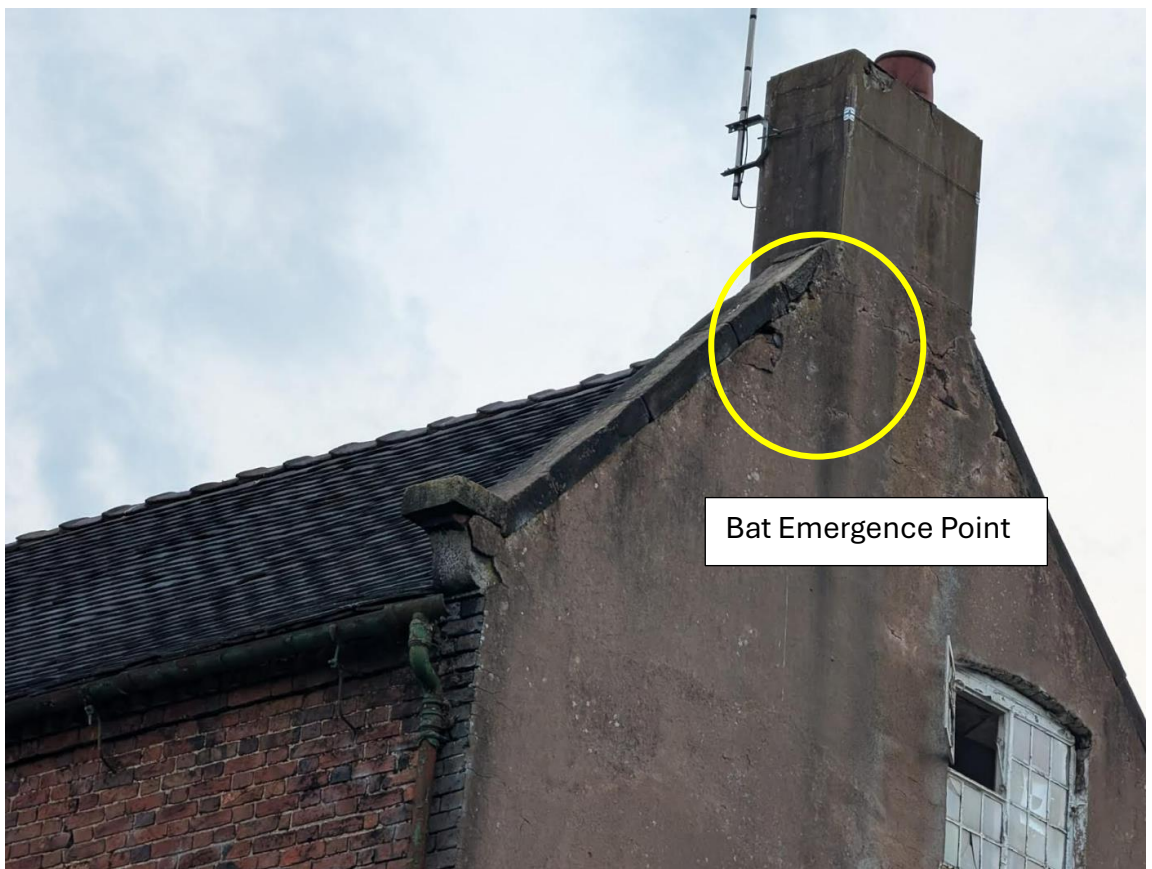
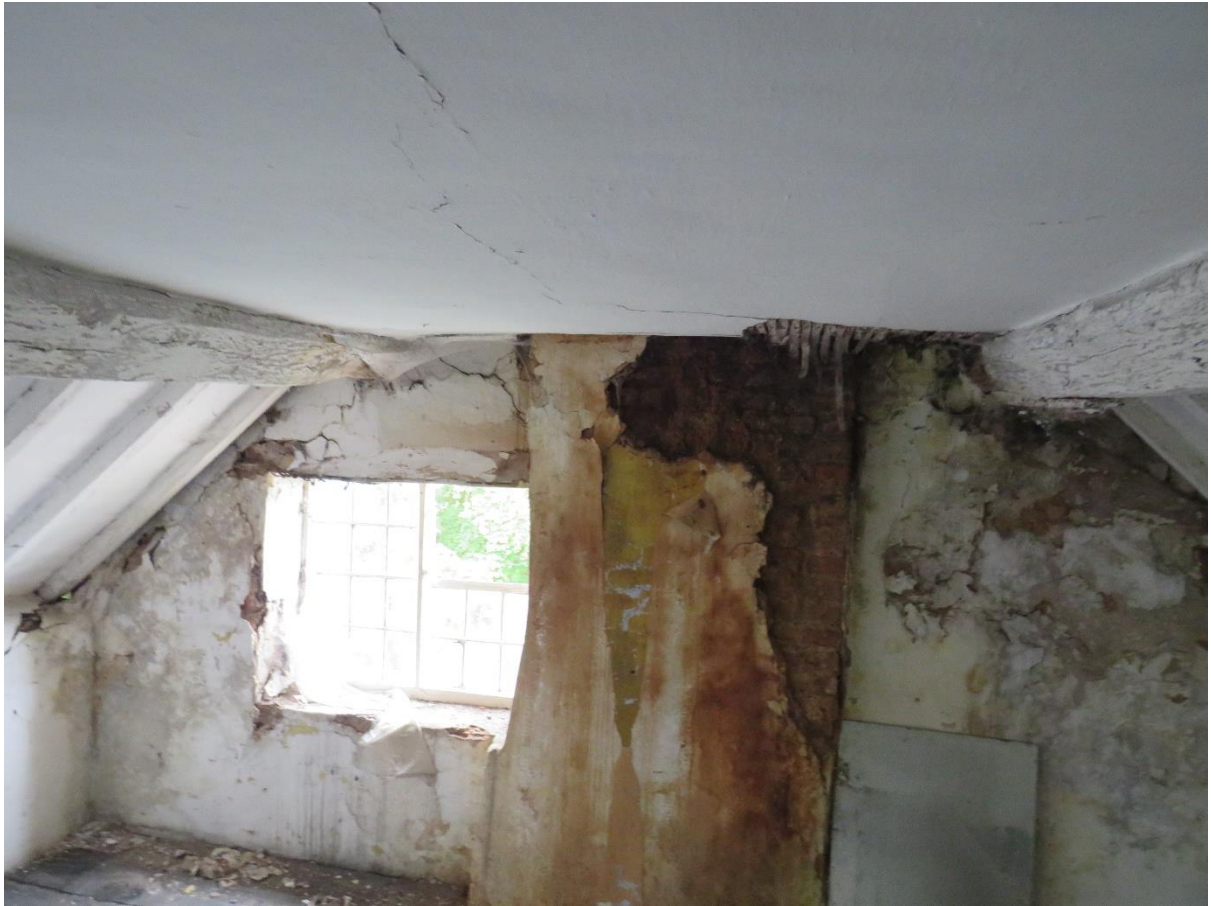
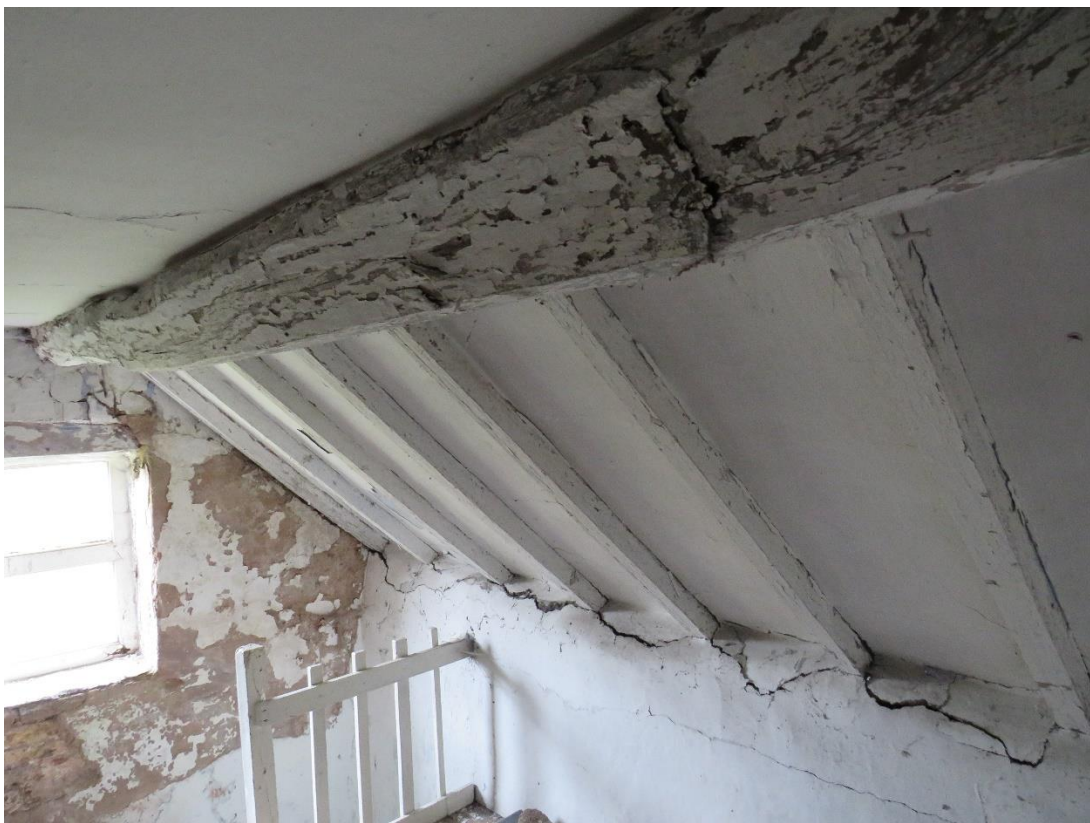
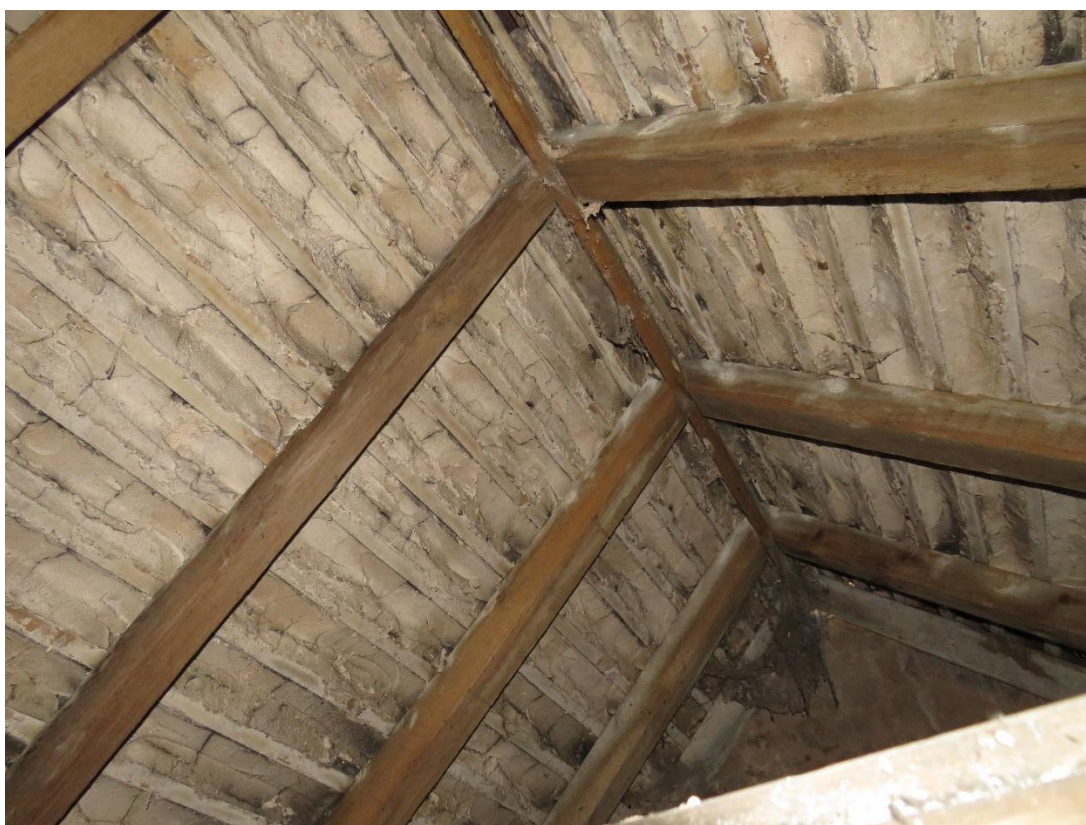
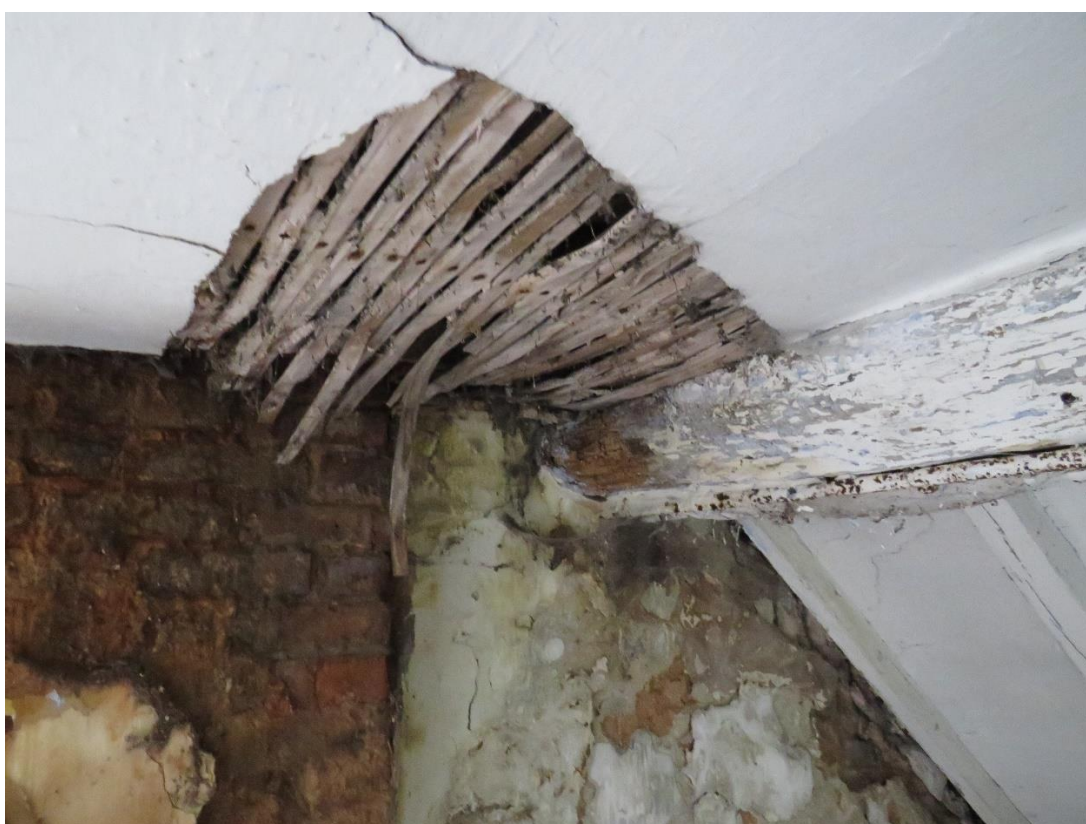
The house has a vaulted ceiling, therefore no loft space see pictures below:

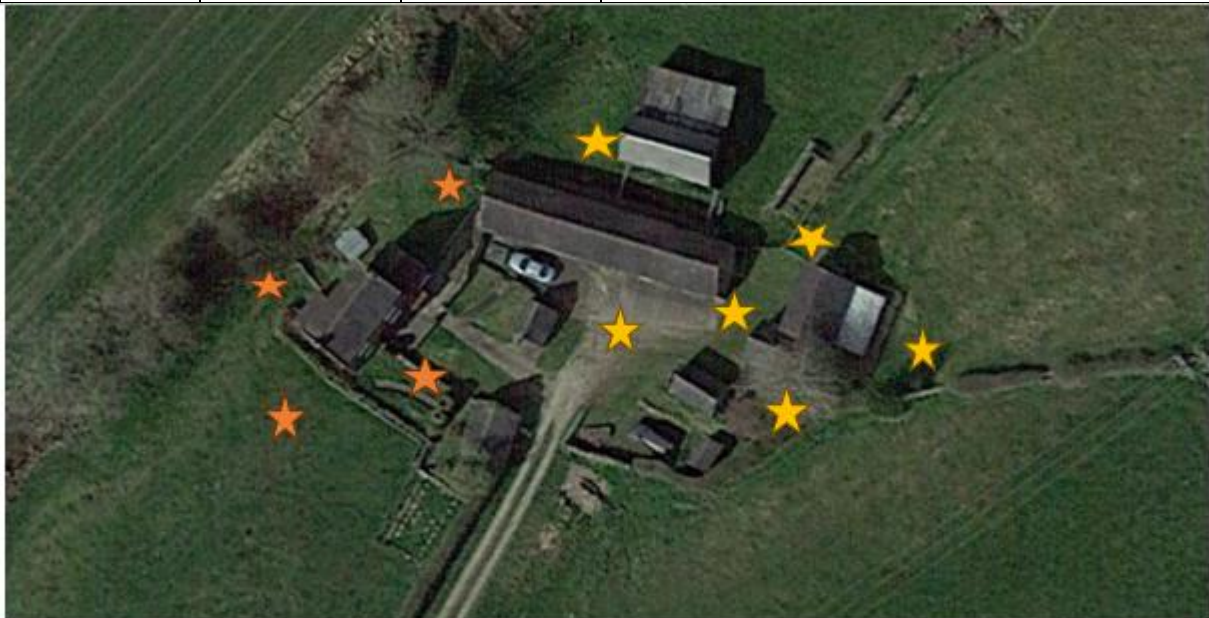
**Figure 1; Site extent and surveyor locations.**

The surveys began 25 minutes before the recorded dusk time and continued for 90 minutes after. The surveyors used Wildlife Acoustics Echometer/IPAD 4 and EMT pro bat detectors to record the echolocations of active bats. The surveyors were positioned at each corner of the target buildings in order to view the elevation and roofs and to gain full coverage simultaneously (see surveyor location plan below).

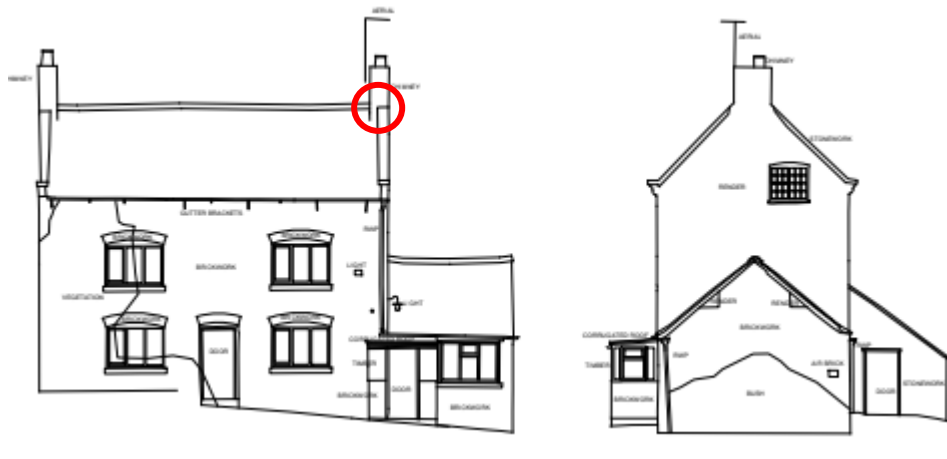
Brown Long Eared Emergence Point – from flashing near chimney and lifter ridge tiles.

Post development mitigation will consist of the provision of bat tiles on the roof, using felt roof liner, and leaving gaps in the mortar between the coping stones.

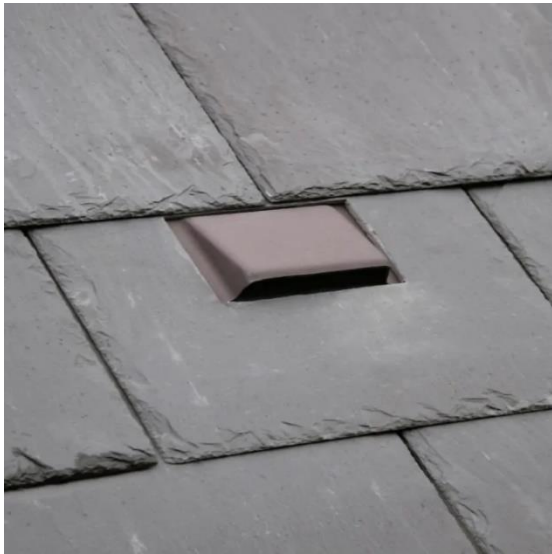
Example of a bat tile.
