## **Bat and Bird Survey Report**

Bath House, Basford Hall, Basford Green, Leek, ST13 7ER

Prepared for Basford Properties

April 2025

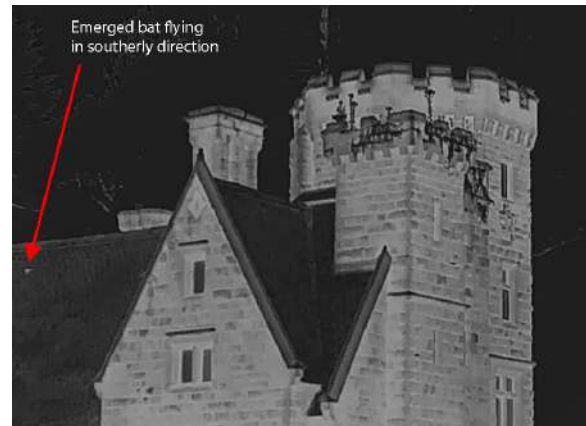
- 20:42 – 21:40: a further 18 common pipistrelles emerged from the dormer roof, either from the north or south facing pitches (see image 1 below).
- 21:01: three common pipistrelles emerged from beneath a tile on the main southwest facing roof pitch below the ridge line of the building (see images 2 and 3).

Image 2: common pipistrelle emerging from beneath a tile on the main southwest facing roof pitch of the building

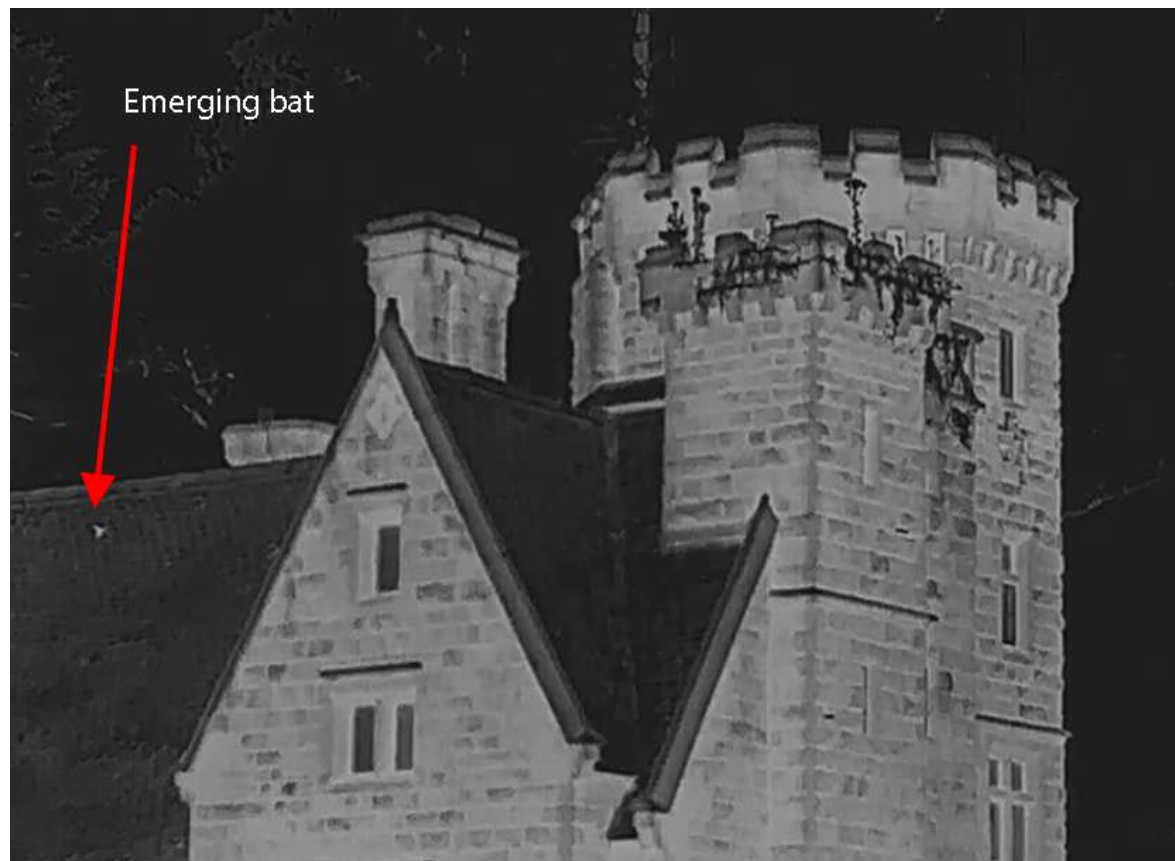
Image 3: another common pipistrelle (in addition to the bat featured in Image 2) emerging from beneath a tile on the main southwest facing roof pitch of the building

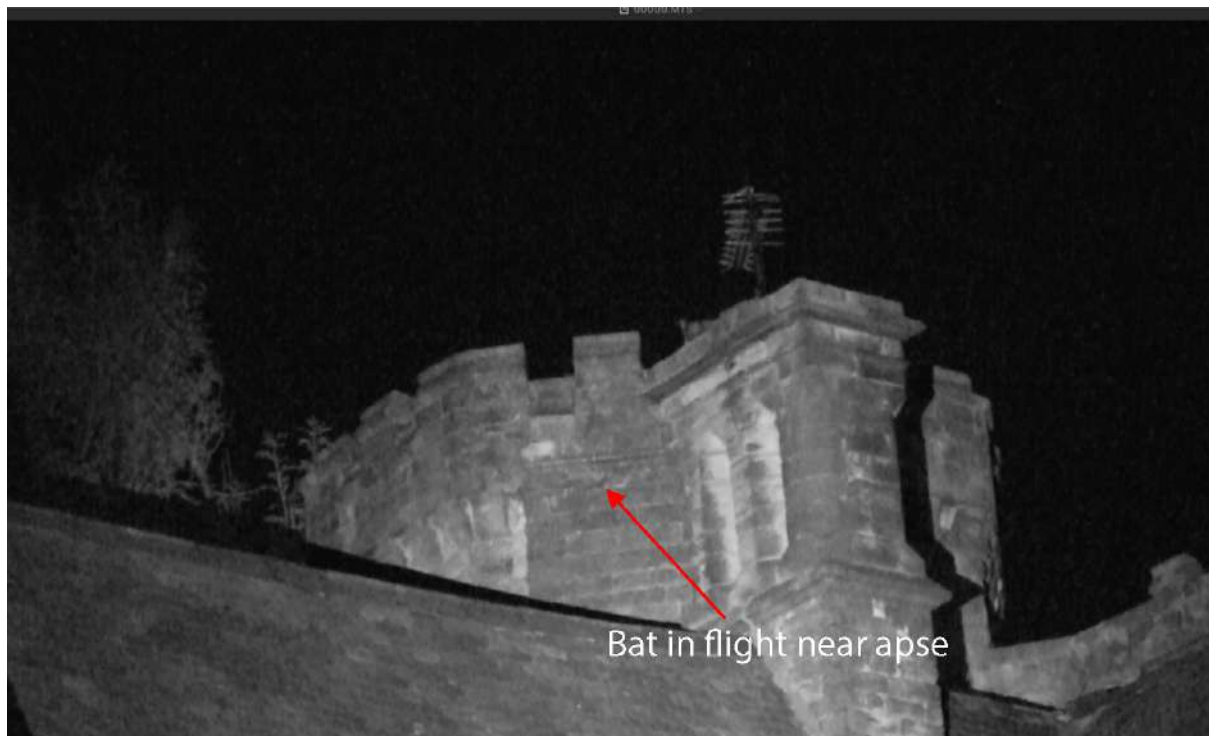
3.16 Bat activity was high during the survey. Species recorded included common pipistrelle, soprano pipistrelle, noctule and *Myotis*. Most activity during the survey was that of common pipistrelles which in addition to foraging locally, also expressed particular interest in the apse area, where several individuals flew in pairs, often exhibiting chasing behaviour. During this period, bats frequently landed on the east-facing stone wall of the apse, as well as entering a small gap in the stonework where mortar has failed. The amount of time spent in the gap ranged between several seconds up to ten minutes. On some occasions as many as four bats were roosting between the stonework (see images 4-7).

Image 4: red arrow points to one of many bats recorded in flight near the eastern side of the apse on 16<sup>th</sup> September 2024

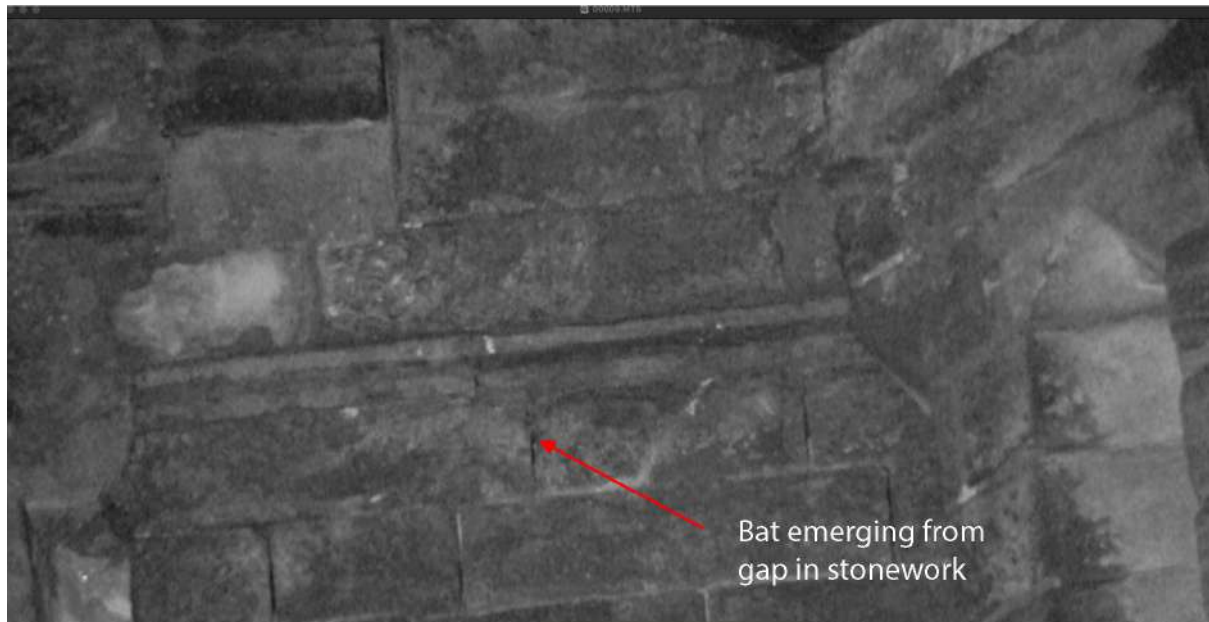
Image 6: red arrow points to bat emerging from narrow gap between stonework on eastern side of apse during the survey on 16<sup>th</sup> September 2024

- 4.11 Based on the hibernation survey results, it must be assumed the behaviour described as 'explorative' was merely bats investigating other roosting sites during the late summer period. It should be noted that Natural England will not issue a mitigation licence unless a roost has been confirmed present at a site (in this instance we refer to hibernation). Based on this, any work associated with the stonework in the apse region (such as pointing and other repairs) should be undertaken with due care and diligence and only if necessary. Such work should also be carried out during summer months when temperatures are above 10 deg. C., when most bats will be at summer sites. An ecologist must be present while work to the apse is carried out.

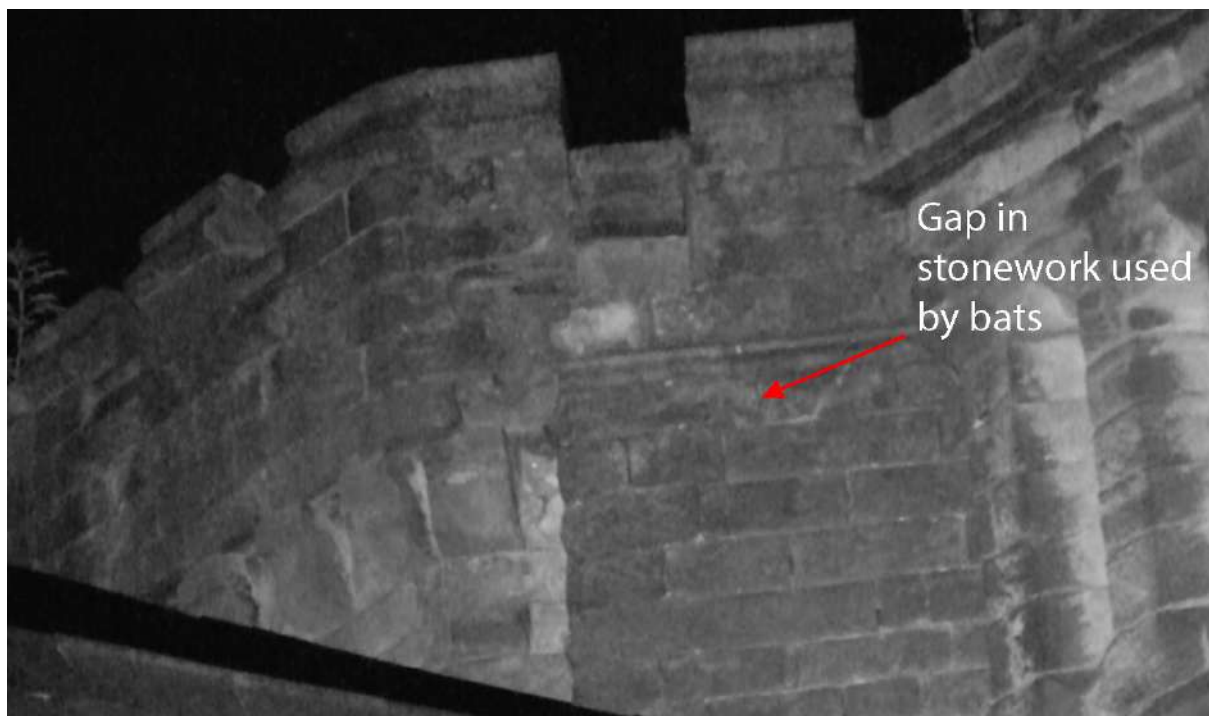
Image 7: red arrow points to area in which access between stonework used by bats is located on eastern side of apse

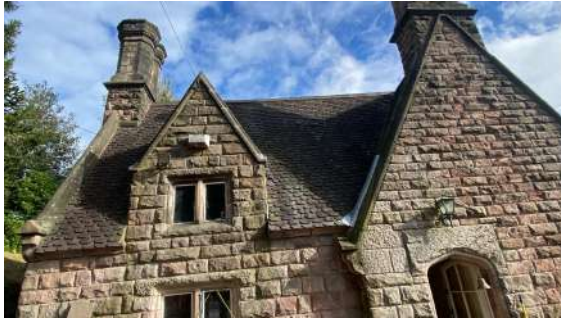
Image 8: side southwest elevation

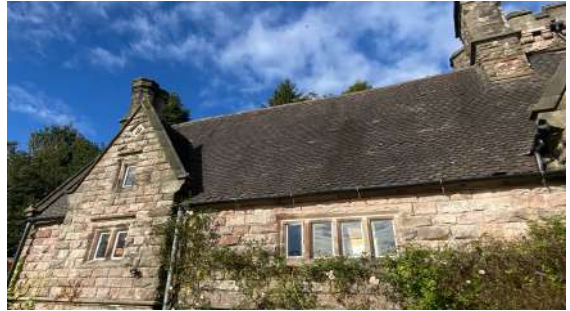
Image 9: front southeast elevation

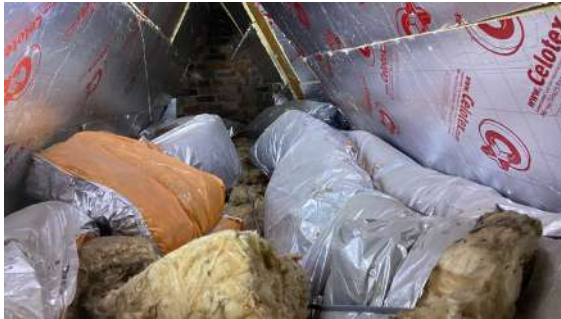
- 3.7 Internally, there were two main floors plus a third set above eaves level, leaving a relatively shallow loft void that in recent years had been lined with Kingspan. The internal elements of the loft regions were not considered safe to enter, although brief inspections from ladders were carried out. From the areas that could be assessed, the roof timbers, such as ridge boards and rafters, were suitable for use by void-dwelling species such as brown long-eared.

Image 10: loft area (viewed from hatch)

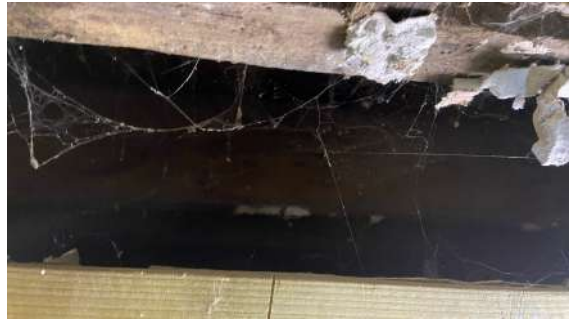
Image 11: narrow loft cavity at northern end of building (viewed from hatch)
