# BAT SCOPING ASSESSMENT

**Project:** Proposed Conversion of Partially  
Derelict Agricultural Building to Residential with  
Parking and Amenity Space

**Address:** Land off Brund Lane, Cheddleton

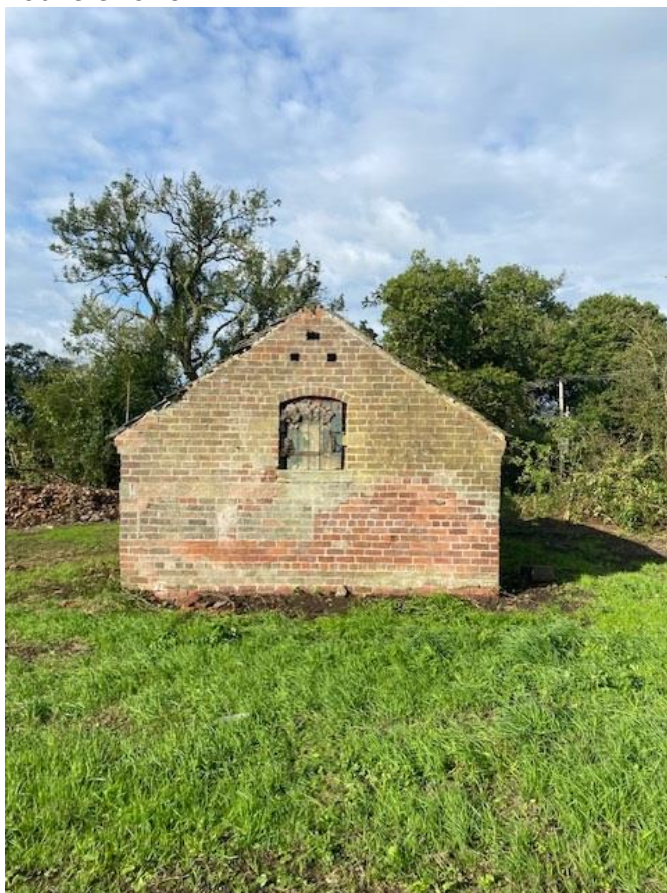
Figure 6.  
East elevation

The agricultural building is partially derelict with the roof partially collapsed from the centre outwards. The tiles remaining on the roof are loose and backed by felt creating access and a void between the tiles that could be used for roosting by crevice roosting species. Within the area of the structure still covered by the roof, bat droppings were searched for and none were found. Feeding waste was also absent from the site. The gable end features 3 vents that allow access to a small room on the eastern side of the structure.

The site contains multiple potential roosting features on the eastern and western elevations where the roof remains standing, these elevations will require at least 2 emergence surveys at each end and take place within the optimal survey window for bat activity (May-August). These surveys will establish presence or absence of roosting bats within the structure prior to any works commencing on the site to prevent harm or disturbance to any potential bat roost.

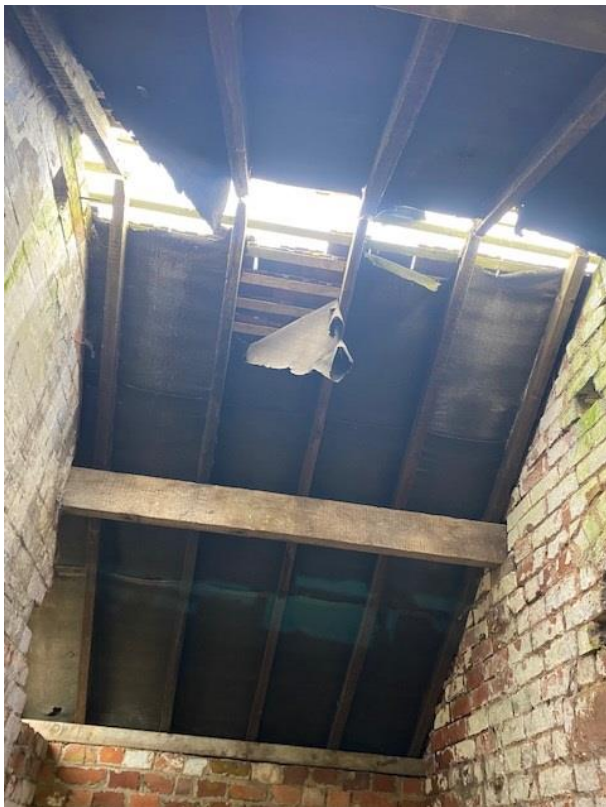
Figure 9.  
*East elevation interior roof*

A search of all crevices on the roof tiles found no signs of frequent use such as rubbing and scratch marks indicating along with the lack of droppings that the structure was not used frequently or used by a large bat population at the time of the survey, but this may be due to the time of the year the survey took place in being sub-optimal for bat activity and the structures internals being open to the elements which could have disturbed bat signs within the building.

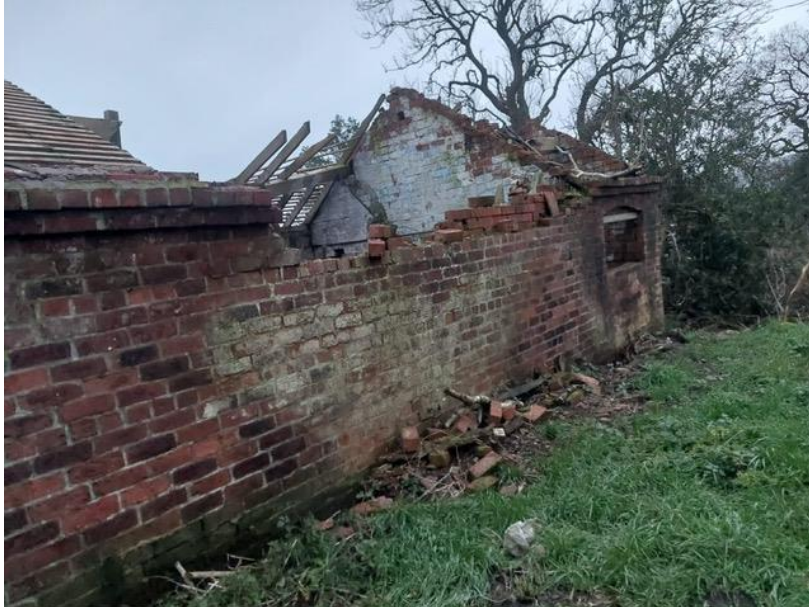
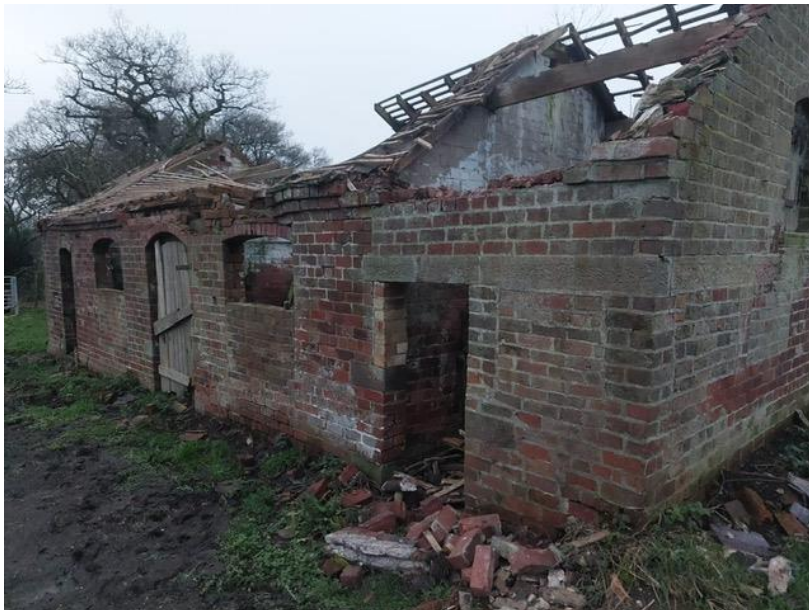
Following the scoping survey conducted on 10/09/2024, Hewitt&Carr Services was informed by Mr K A Carr that all the roof tiles had fallen off during storm Darragh. Below are images provided by Mr K A Carr following storm Darragh:

As a result of this, all Potential Roosting Features (PRF's) identified during the survey have been destroyed. Consequently, further bat emergence/ re-entry surveys advised in this report are no longer required.
