Statement of Significance

Hollington House, Main Road, Hollington Mr

SoS/hollingtonhouse/AH1039/17/12/24V3

December 2024

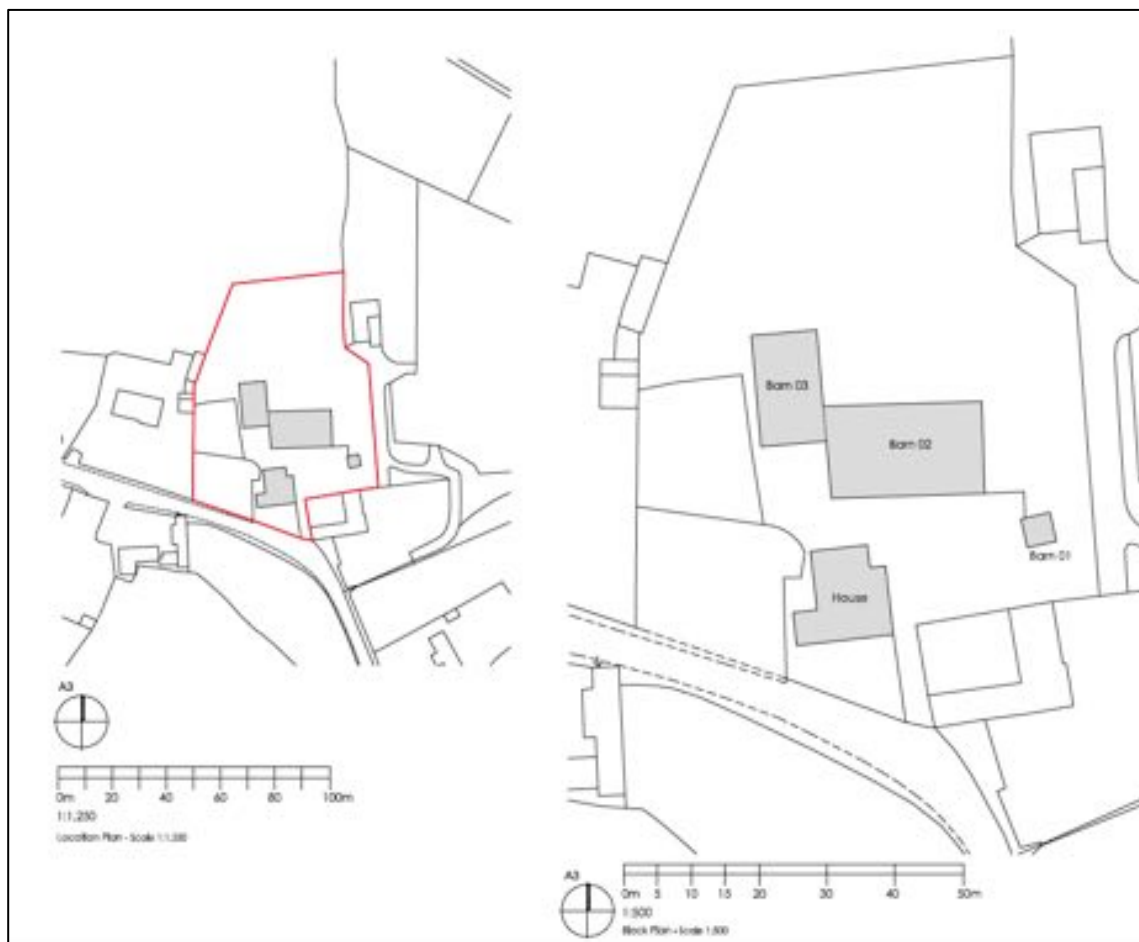
Figure 1. Plan of the site.

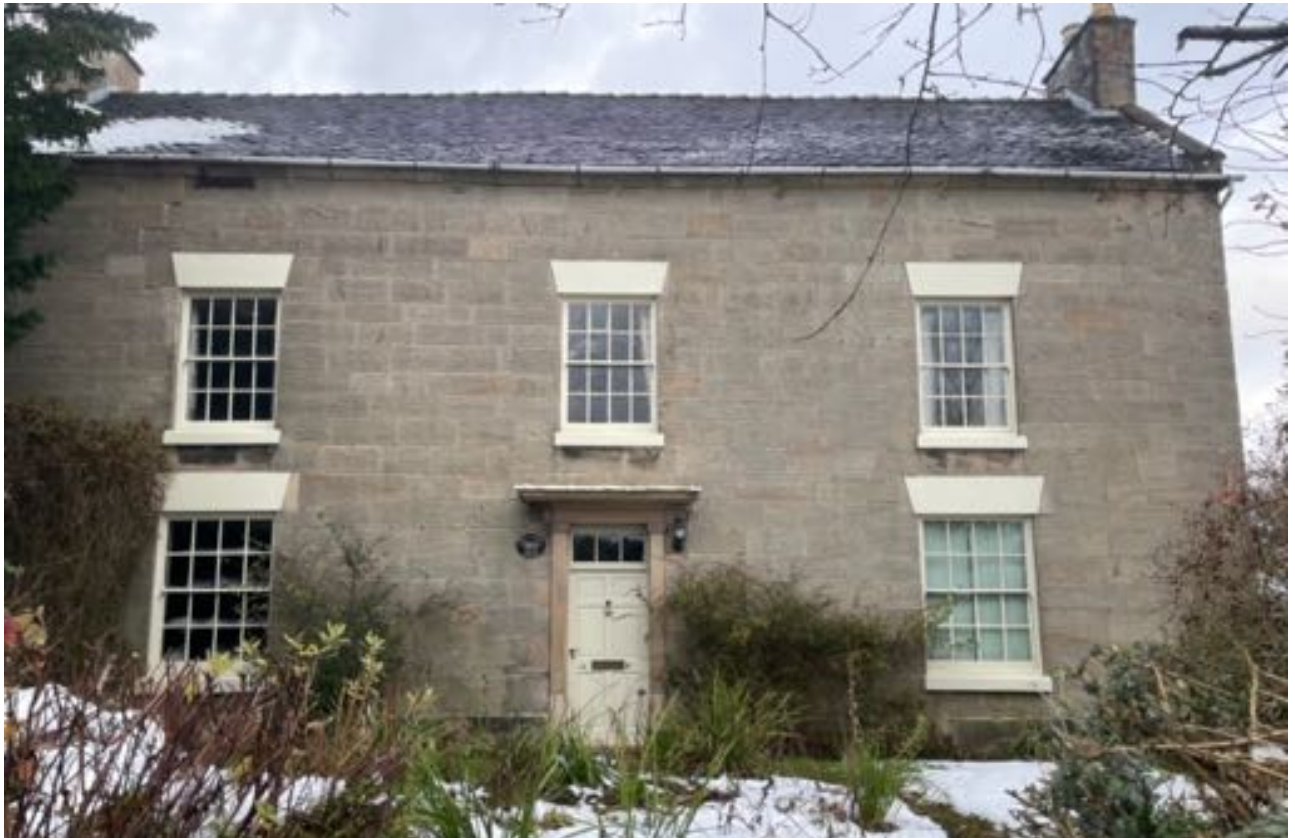
- 3.3.1 All three ranges of the AB are constructed in finely coursed dressed and squared Hollington sandstone with clay tiled roofs. Range 1 has verge parapets and two end chimney stacks, both constructed in brick. The front, south facing elevation of Range 1 (Plate 1) is symmetrically arranged with windows to the ground and first floors flanking a central window above the entrance. Each window opening is surmounted by splayed stone lintels whilst the doorcase comprises plain squared pilasters below a flat hood. Above the door is rectangular fanlight. Each window opening houses sash windows with horns to the bottom rails of the upper sashes. The presence of the horns suggests that the sashes are historic rather than original given horns appeared on sashes post 1850.

Plate 1. The front, south facing elevation of Range 1.

- 4.2.1 The application for LBC relates to structural work to the attic and front elevation of Range 1, the main farmhouse. A structural survey (GCA, 2024) noted that the eaves spread to the western side of the front elevation of Range 1, presents a notable risk where the ridge has dipped and the eaves in this location have moved out significantly with the stonework below pushing out from the masonry above the westernmost window.

- 4.2.2 The defect in the external masonry of the front elevation of Range 1 was noted during AHL's site visit. Internally evidence of the structural defect was also noted by AHL in the form of cracking to the front wall in Room 16, and displacement of the floor in relation to the base of the walls. In Room 14, the front wall is in very poor structural condition, having leant significantly outwards and cracks are present throughout the wall, consistent with the external eaves spread. At some point it appears that attempts were made to rectify this by the installation of a tie bar across the room. The structural survey noted that the significant lateral displacement in this location represents a major defect with requires urgent attention.

- 4.2.6 On the external front elevation of Range 1, the existing dislodged stone blocks above the window should be pushed back with all care and any pointing should be in keeping with the traditional appearance of the AB.

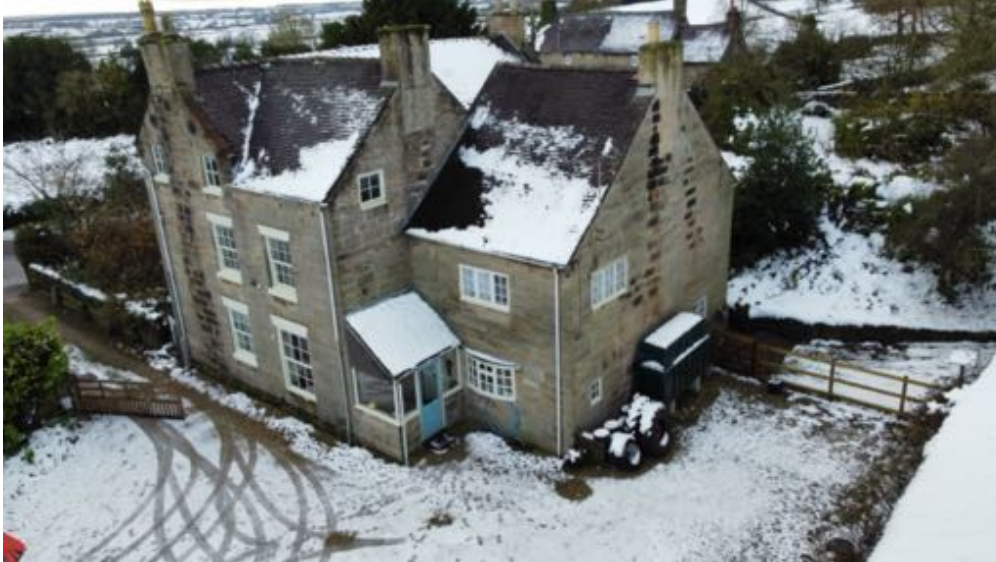
- 3.3.2 The eastern elevation of the AB, comprising Ranges 1 and 2 is characterised by sash windows under splayed lintels (Plate 2). Two small attic windows are present at the top of this elevation in Range 1 whilst the larger sash windows are confined to the northern side of Range 1 elevation and to Range 2. The sash windows in this elevation are the same style as those in the front elevation but those in the Range 2 east facing elevation appear to be recent/modern replicas. The attic windows are modern. There are circular, iron wall ties located at the apex of the Range 1 eastern elevation, just below the base of the chimney stack.

Plate 2. Eastern elevations of Ranges 1, 2 and 3.

- 3.3.3 Range 3 is offset from the northern elevation of Range 2 and its east facing elevation is adjoined by a small stone and glazed porch of modern date (see Plate 2 above). The windows in this elevation are modern hardwood. A straight joint in the stonework between Ranges 2 and 3 suggests that Range 3 was constructed at a later date than Range 2. The north facing elevation of Range 2 is surmounted by an end chimney stack which has been rendered and houses a single modern attic window. The north facing elevation of Range 3 (see Plate 2 above) houses modern windows and patching/discolouration in the stonework suggests that the range has undergone phased building activity in the past. There is an end chimney stack also rendered on this elevation of Range 3.

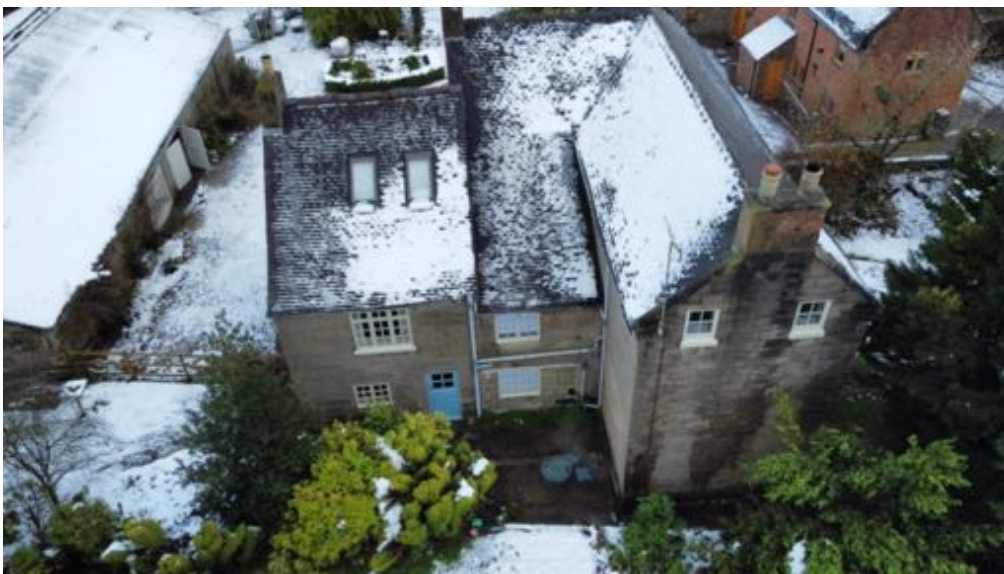
- 3.3.4 The western elevations of Ranges 2 and 3 (Plate 3) house modern timber windows and entrance door. A straight joint in the stonework between the ranges again suggests that Range 3 is unlikely to be contemporary with Range 2. There is patching in the stonework around the ground floor window of Range 2 suggesting that this window opening is a recent/modern insertion.

Plate 3. The western elevations of Ranges 2 and 3.

- 3.3.5 The western elevation of Range 1 is largely devoid of any openings apart from two attic windows which are modern timber insertions (see Plate 3 above). Like the eastern chimney stack the western stack is constructed of brick suggesting that both are later additions (or rebuilds) to Range 1.

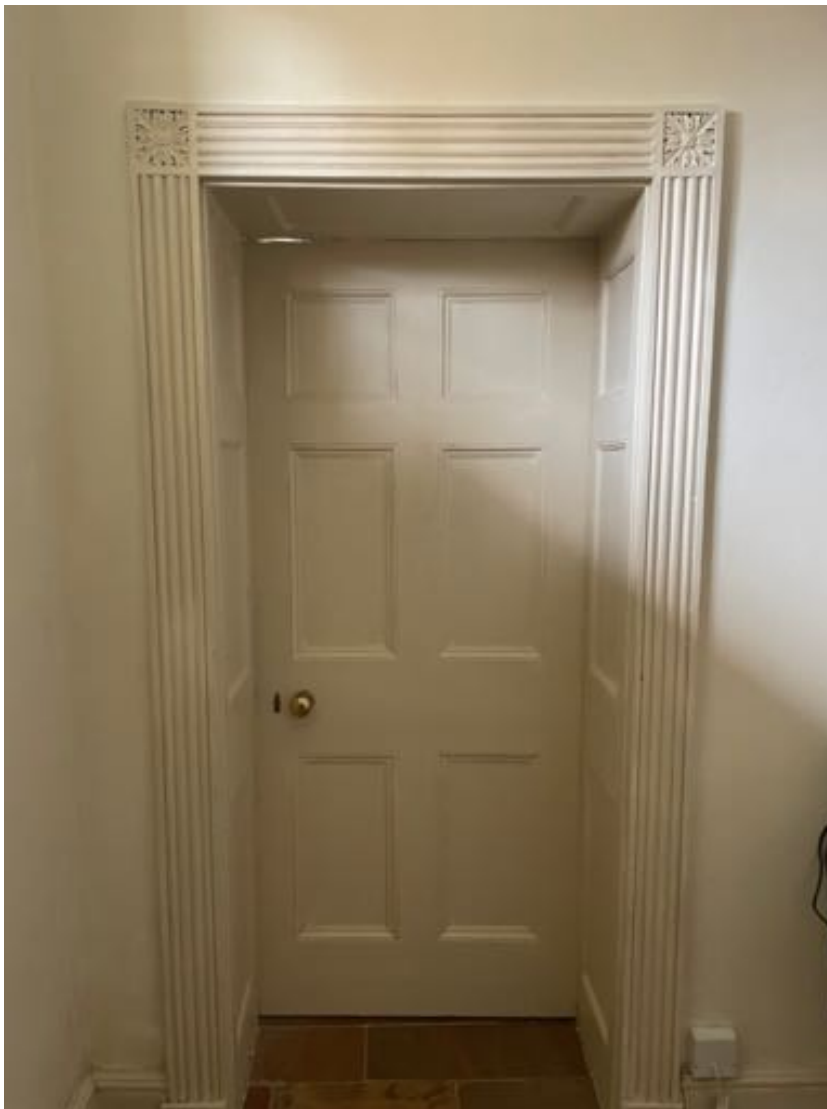
Plate 4. Example of a doorway in the entrance hall with original moulded frame, panelled recess and six-panel door.

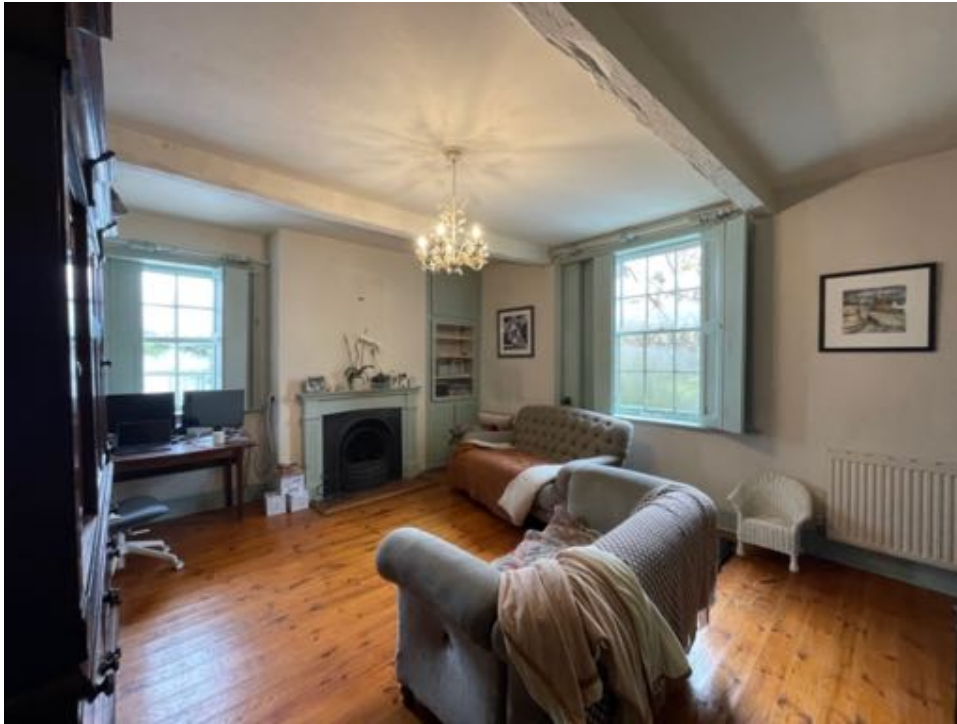
- 3.4.1 Whilst there have been some modern interventions to the interior of the AB, as a whole, Range 1 in particular still retains a high level of original architectural and decorative detailing which signify that it was built as a relatively high-status residence. On the ground floor such features include decorative moulded door and window architraves in the principal rooms (Rooms 1 and 2), a door with panelled reveals into Room 2, along with six-panelled doors, sash windows, and deep skirting and cornicing.
- 3.4.2 Doorways off the central entrance hall into Rooms 1 and 2 are surrounded by fluted frames with foliate blocks to either side of the architrave (Plate 4). Room 1 retains original timber internal shutters to each window as well as exposed chamfered ceiling beams (Plate 5).

Plate 5. Room 1 showing original timber shutters and chamfered ceiling beams. The fire surround is a modern replica.

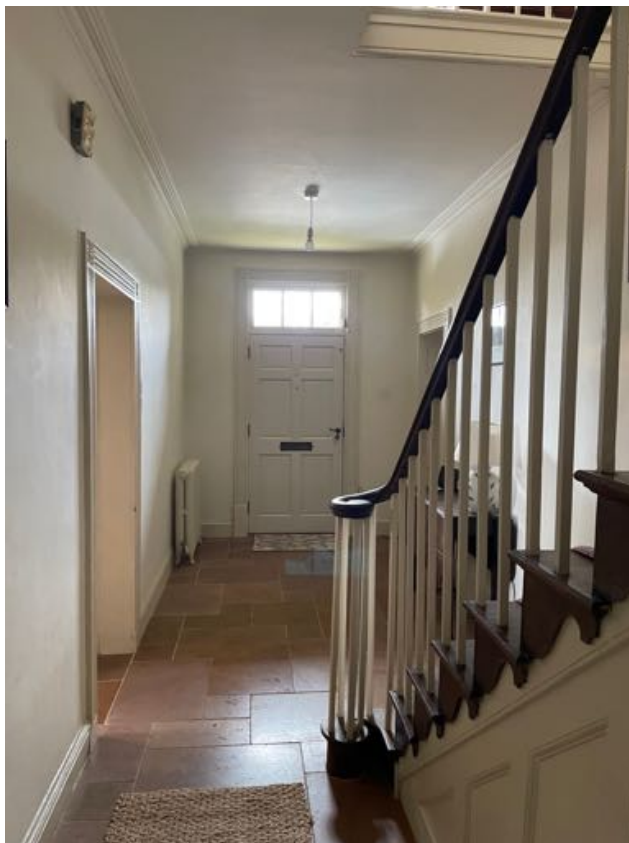
- 3.4.3 The main staircase in the hallway on the ground floor is of simple design with stick balusters, a handrail and bottom newel with a volute (Plate 6). The open string to the staircase is decorated with modillion moulding.

Plate 6. The entrance hall with original staircase.

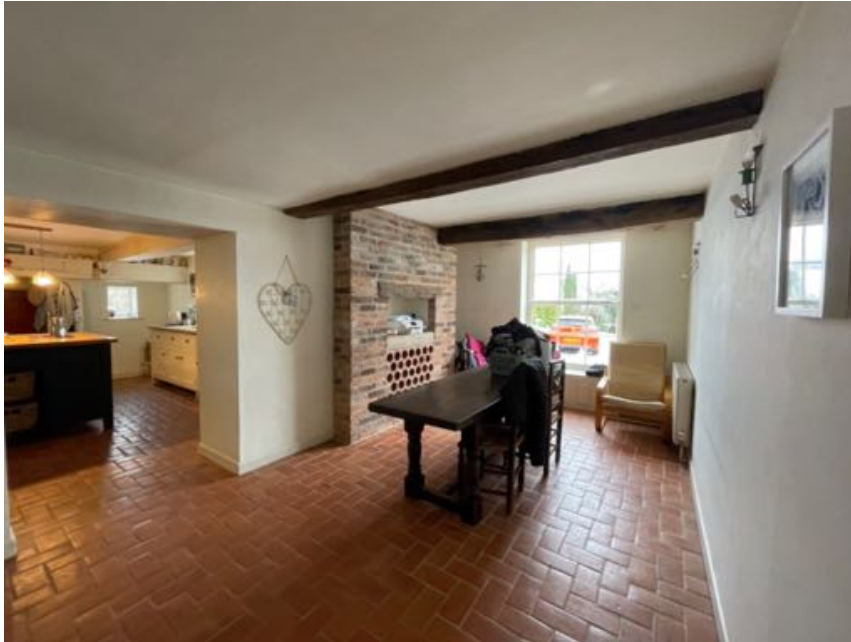
Plate 7. Room 3 in Range 2 with modified original chimney breast and chamfered ceiling beams.

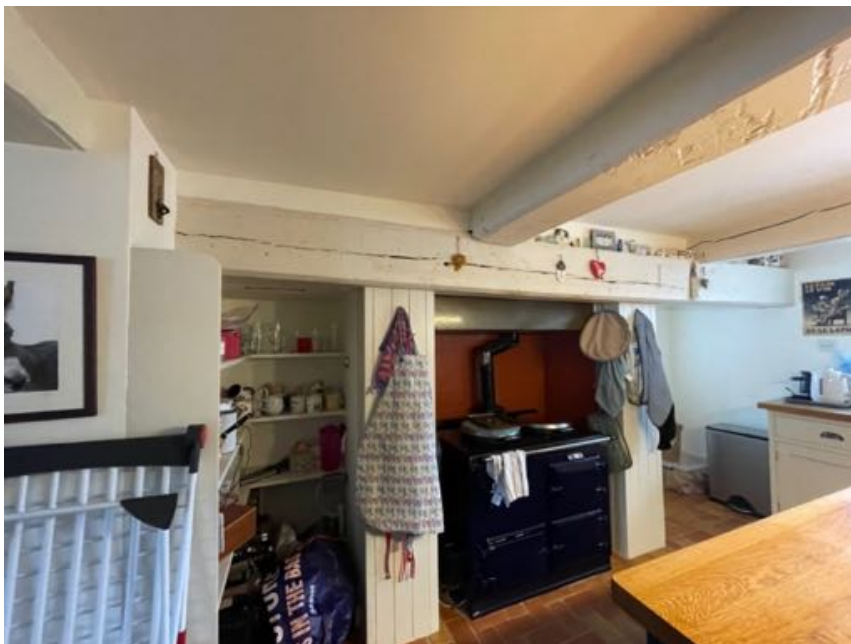
Plate 8. Room 4 in Range 3 showing inglenook with an *in situ* bressummer and chamfered ceiling beams.

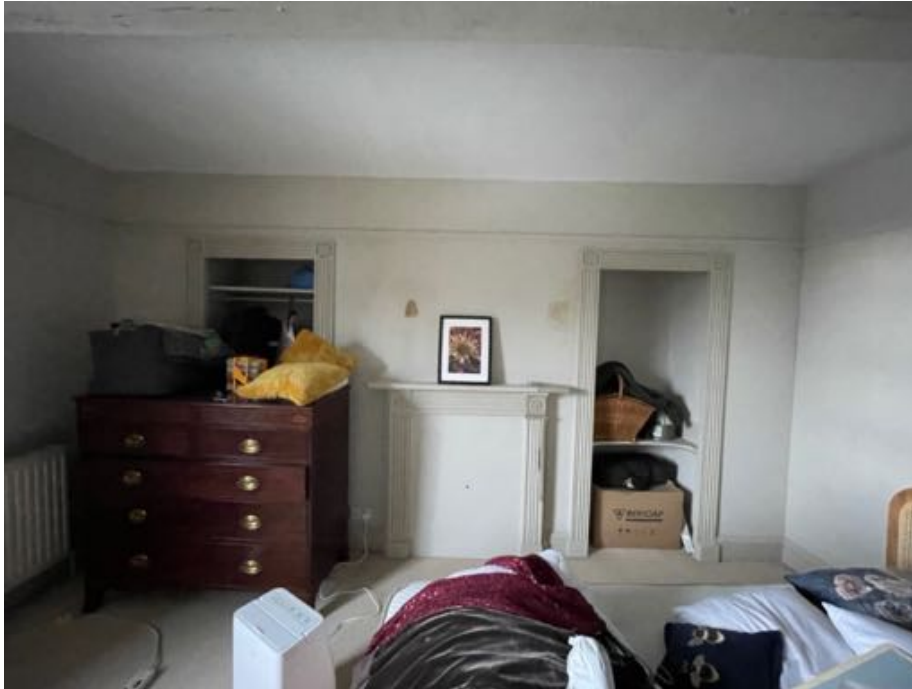
Plate 9. Room 7 in Range 1 showing moulded fire surround and decorative frames to the flanking alcoves.

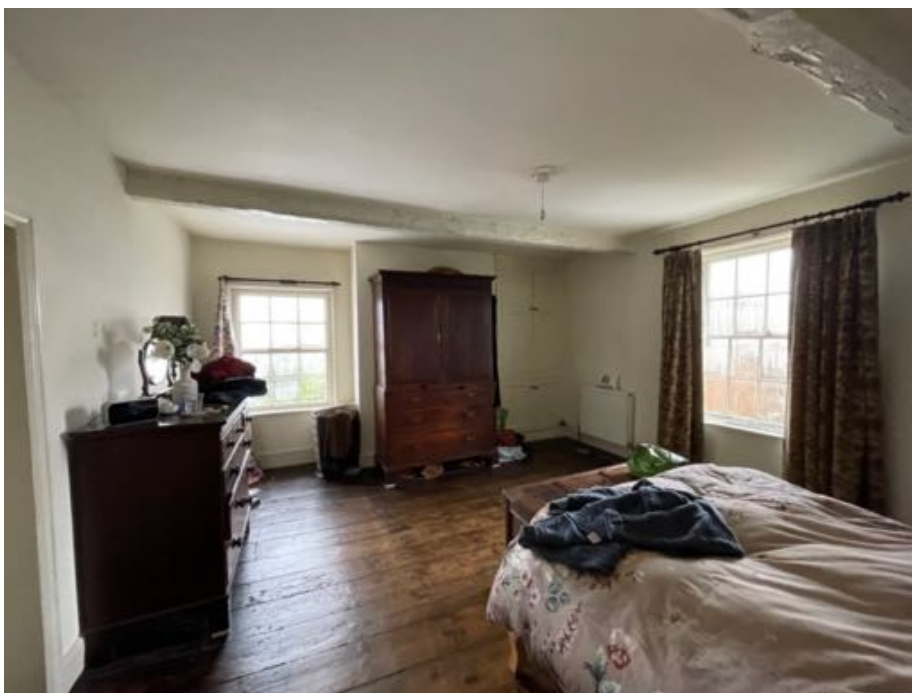
Plate 10. Room 6 in Range 1 showing chamfered ceiling beams, original floorboards and cupboard to the right of the fire breast.

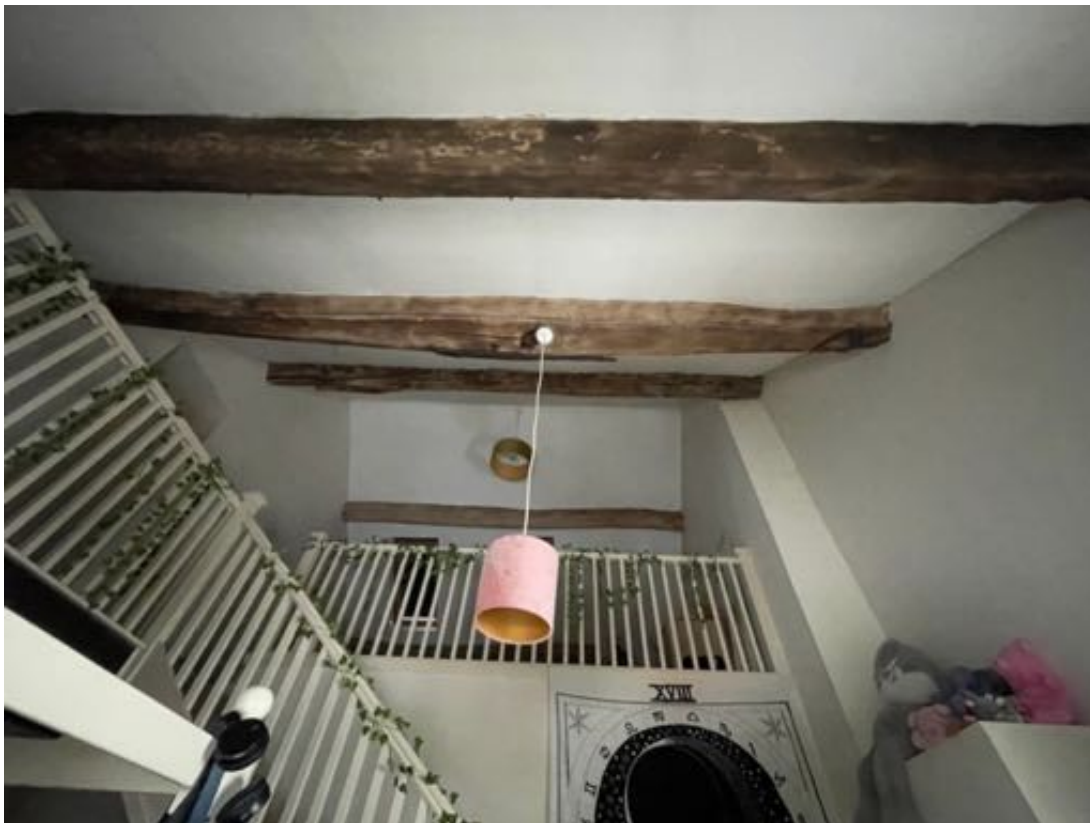
Plate 11. Room 11 in Range 3 with modern staircase to the attic space and exposed original purlins.

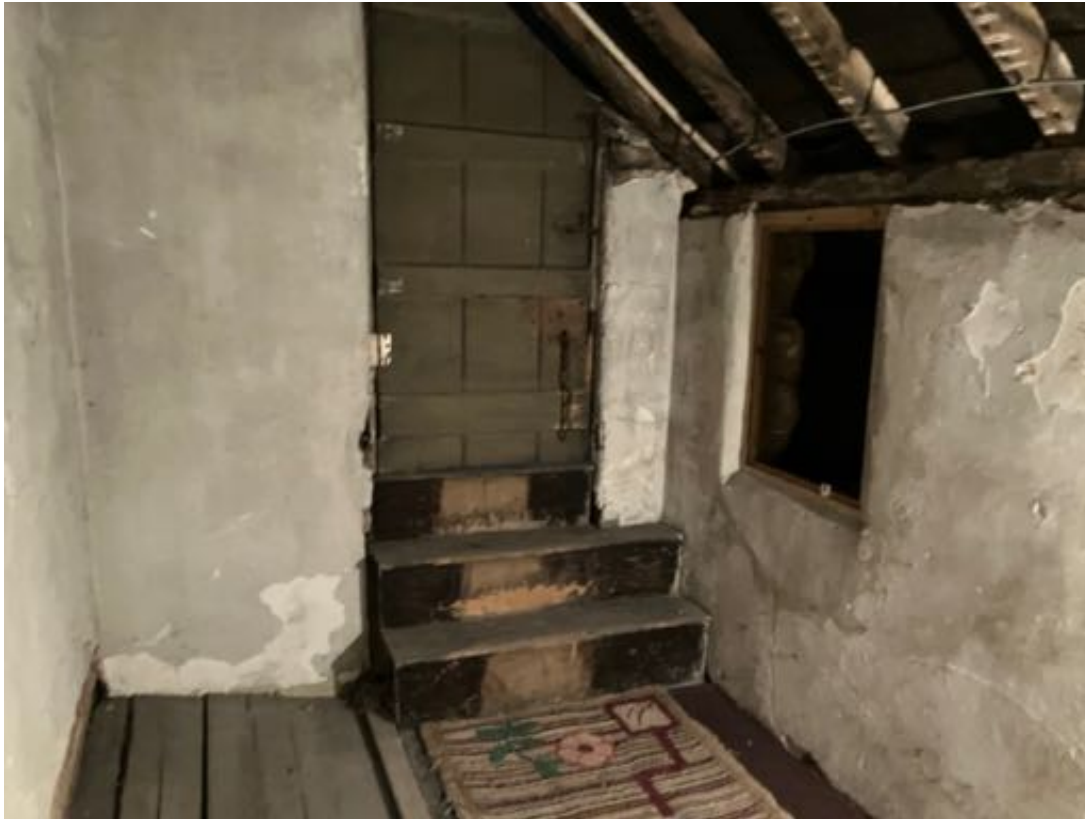
- 3.4.8 The attic comprises a series of spaces occupying the areas over Room 8 on the first floor of Range 2 and then extending along the whole length of Range 1. Room 12, which forms a narrow vestibule providing access to the remainder of the attic space, has plastered walls and original floorboards as well as exposed rafters. However, the floor of Room 12 appears to have been altered at some point as signified by a strip of loose, badly fitting raked floorboards in the eastern side of the vestibule (Plate 12). It is possible that they mark the location of the back staircase from the first floor which was boarded over when it became redundant and was removed.

Plate 12. Room 12, showing plastered walls and loose floorboards to the left of the photograph. The door is original and leads into Room 13.

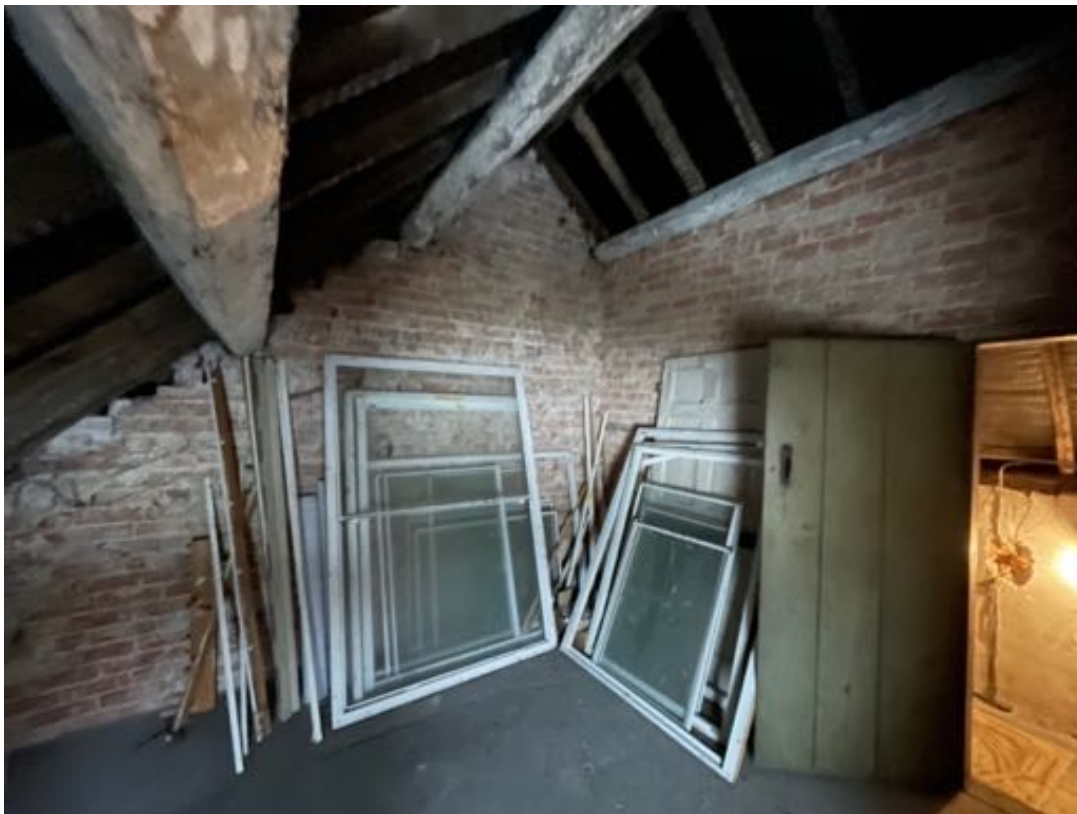
- 3.4.9 The inner walls of Room 13 are constructed of brick which is likely to be early to mid-19<sup>th</sup> century in date and the southern wall supports original purlins and rafters (Plate 13). Next to the doorway from Room 12, is a stepped brick chimney breast to the right of which is a window opening with an original timber lintel, though the window itself is modern (Plate 14). The brick build of the chimney breast and chimney stack suggests that it is a later addition. The floor is plaster and there are original purlins and rafters in place.

Plate 13. Room 13 in Range 2 showing brick walls and original purlins.

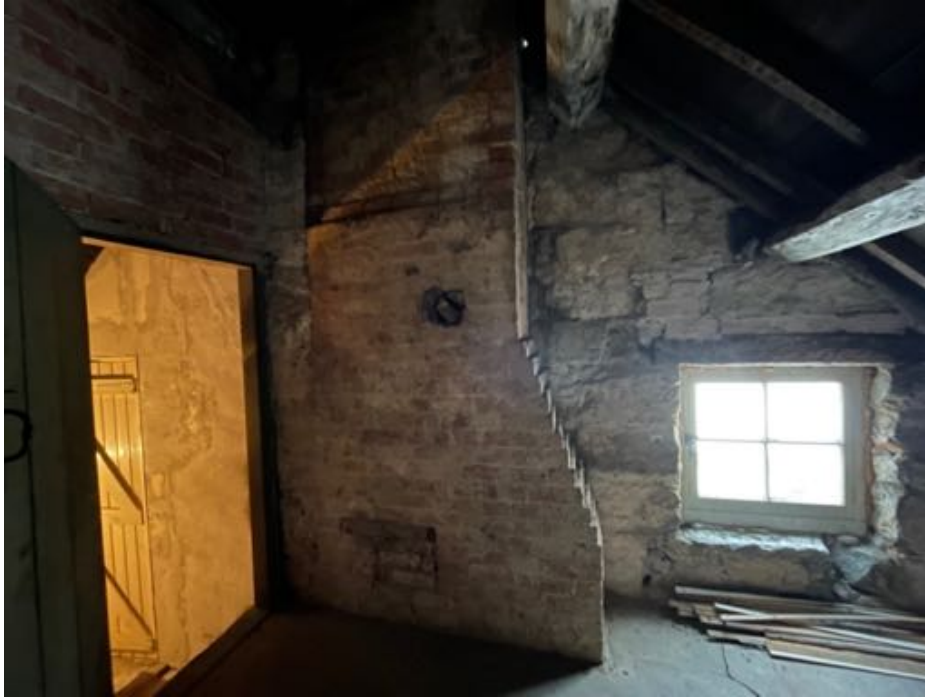
Plate 14. Brick chimney breast in Room 13.

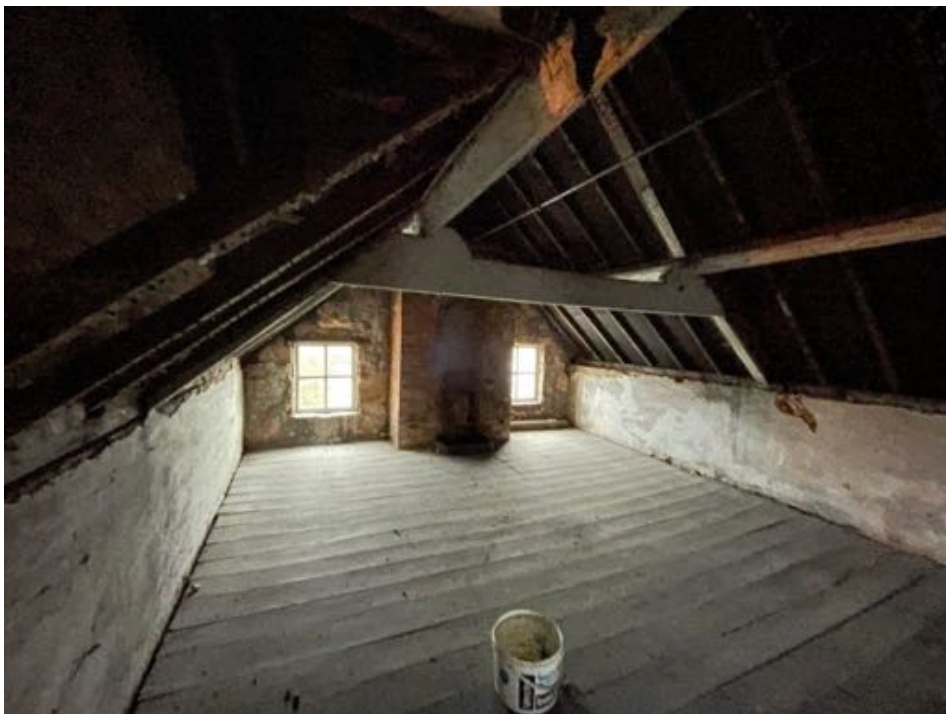
3.4.10 The attic space in Range 1 comprises two large rooms (Rooms 14 and 16) separated by a narrow central space (Room 15). There are openings in the cross walls of Room 15 allowing access through into the other two rooms. Room 16 (Plates 15 and 16) retains original floorboards, and plaster adheres to the walls. There is a brick chimney breast against the western gable wall which may once have housed a fireplace. To either side of the chimney breast are small attic windows with timber lintels but modern windows. The roof retains original purlins and rafters and a central collar. The collar appears to be made from recycled timbers and does not form part of an original truss, perhaps being inserted at a later time to provide additional support to the roof.

Plate 15. Room 16 showing original floorboards, brick chimney breast and recycled truss.

- 4.2.3 The solution presented in the structural reports is to introduce steel frames, tied above purlin height, at the third points of the building, along the length of the attic. This approach will serve to minimise the size of the installed parts of the steel frames, minimising their impact of the character of the attic space. The intention is to install the frames inside the structure wherever possible, avoiding the need to remove the roof, thus minimising impacts on the historic fabric of the building, apart from small fixings. The installations will also be fully reversible if required in the future. In addition, the proposed approach will maximise retention of original timbers in what the structural engineer has described as a flawed design. Using like for like materials to achieve structural stability, instead of the proposed steel frames, within the attic space would result in a completely different design which would impact on the proportions of the attic.

- 4.2.4 Whilst the proposal will entail the loss of the tie beam in Room 16, the feature is considered to be of low heritage value comprising reused timbers and likely a later introduction to the attic rather than being part of a true roof truss. AHL considers that its removal will not compromise the ability to understand and appreciate the key factors which make up the significance of the attic or that of the AB as a whole. Similarly, the removal of localised areas of the plaster floor in Room 14 to enable the upright beams of the frames to be fixed to the timber floor beams, is also considered an acceptable level of removal of historic fabric.

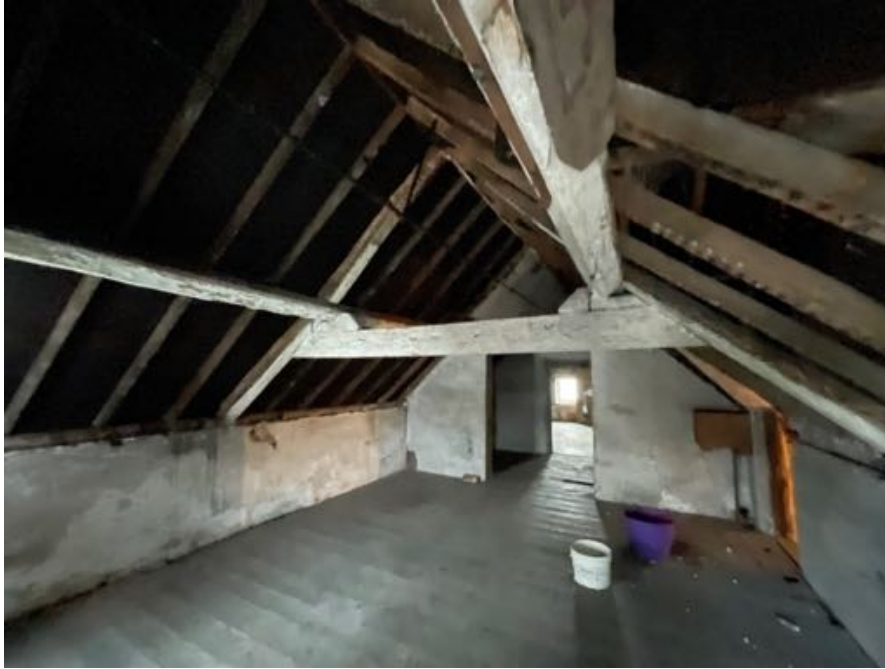
Plate 16. Room 16 looking towards Room 15 and 14.

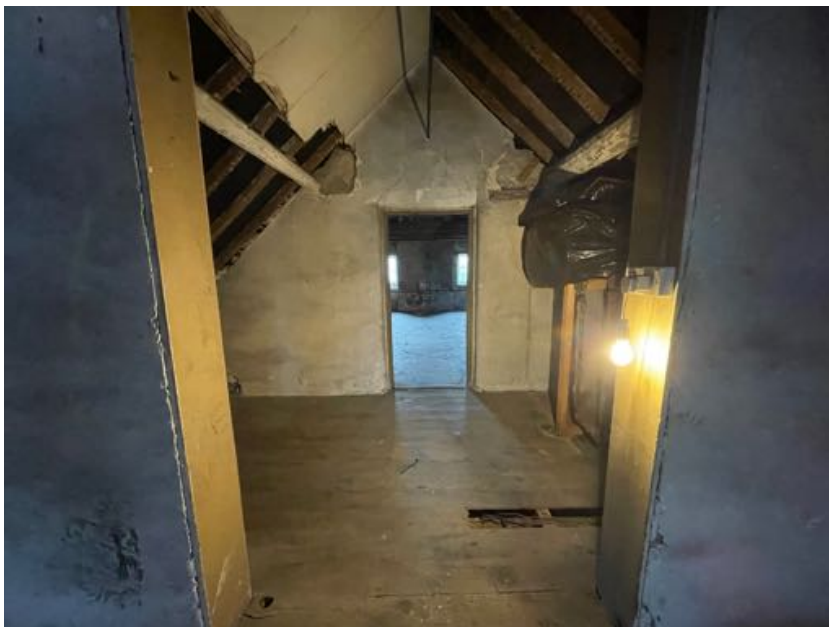
- 3.4.11 Room 15 retains original floorboards and roof timbers, and the walls are plastered throughout (Plate 17). The cross walls of Room 15 are built of stone rather than brick. Room 14 (Plates 18 and 19) has a plaster floor whilst the walls are also plastered. The roof timbers comprising a series of collared rafters, are not original and look relatively recent. A metal tie beam is present at the centre of the room, apparently added to provide additional support to the long walls at this point. There is a brick chimney breast which has been rendered against the eastern gable wall of Room 14 flanked by two small attic window openings which are original though now housing modern windows.
- 3.4.12 Throughout the attic as a whole the roof has sarking felt placed against the rafters suggesting that the AB has been re-roofed in recent times.

Plate 17. Room 15 looking towards Room 14.

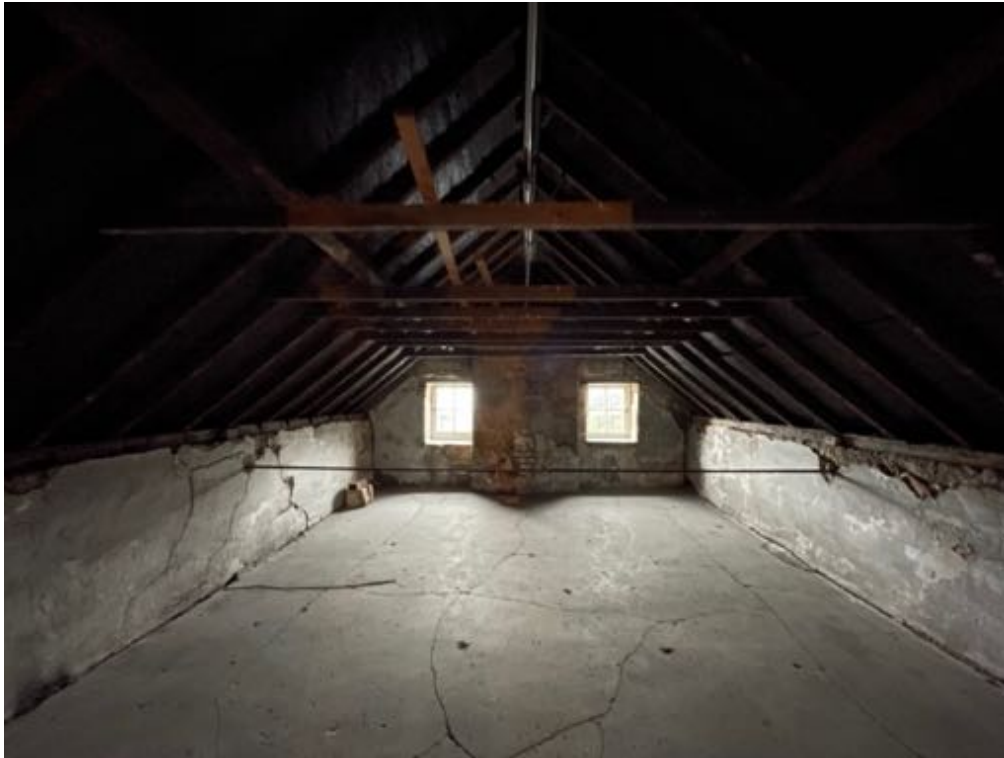
Plate 18. Room 14. Showing plaster floor, brick chimney breast and tie beam across the room.

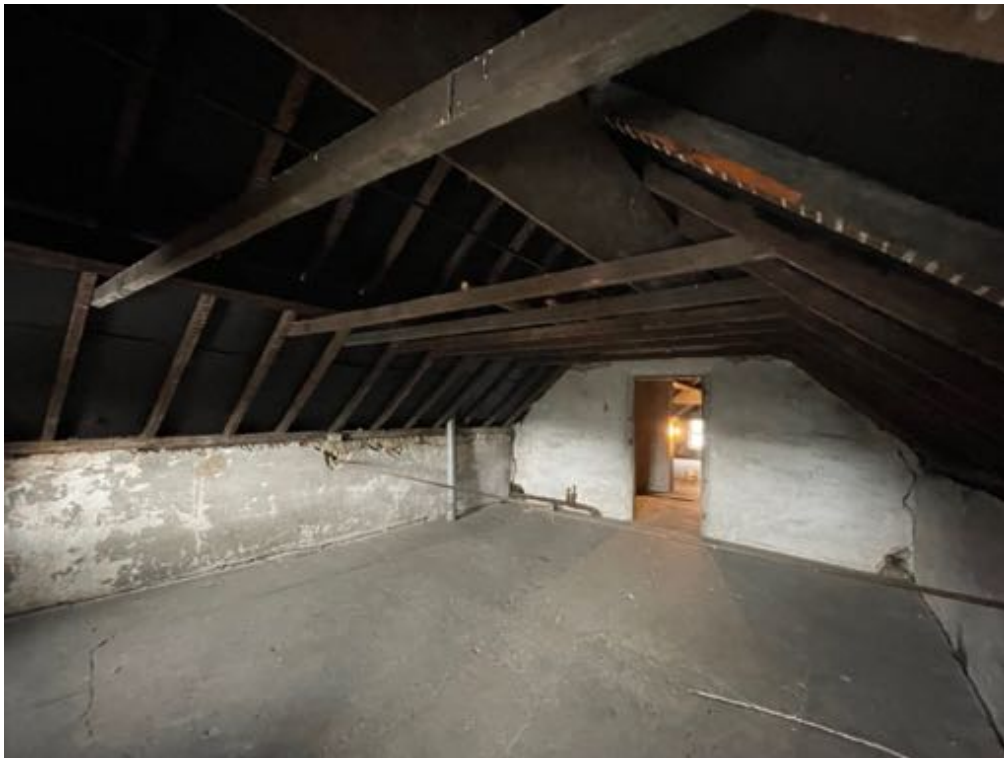
Plate 19. Room 14 showing recent/modern roof beams.

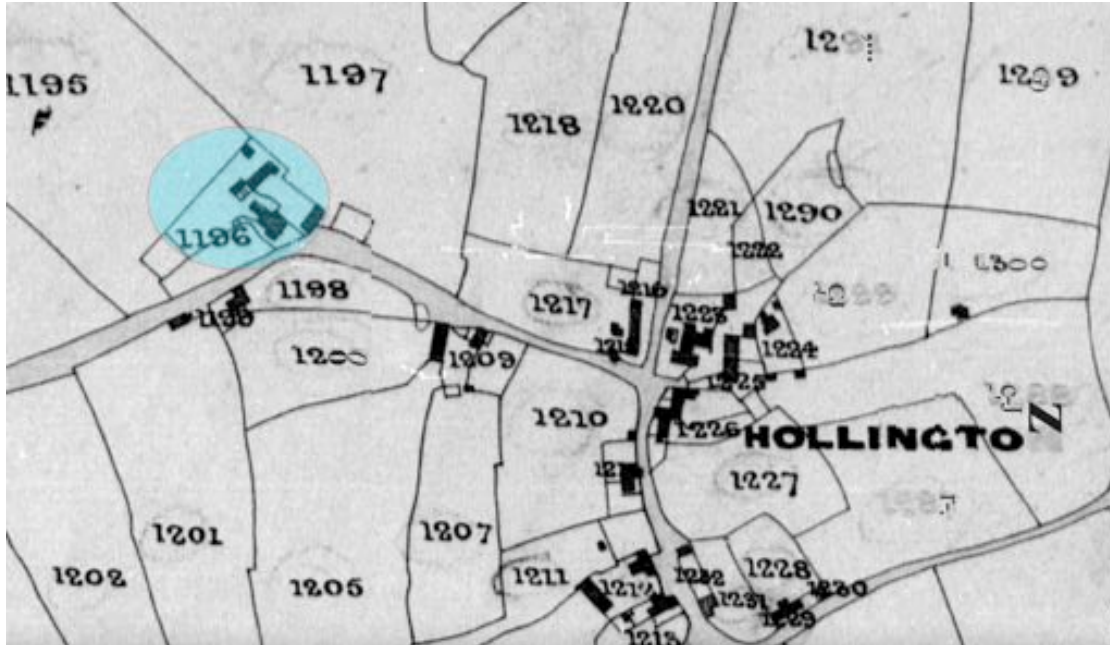
- 3.5.1 The Tithe Map dating to 1841 (Figure 2) depicts the AB along with its outbuildings within an enclosure to the north of Main Road. The building showing in the northeast of the AB is an extant brick barn which has been converted to residential use whilst the outbuilding to the northwest of the AB is still partially in existence, but much altered by modern interventions.

- 3.5.2 Whilst the map suggests that by this time Ranges 1 and 2 of the AB were in existence on their current planforms the extension shown extending from the northwestern elevation of Range 2 does not appear to conform to the planform of today's Range 3.
- 3.5.3 The Tithe Apportionment records that the site was a *homestead* owned and occupied by Thomas Cope, indicating that it was operating farm with farmhouse, enclosures, yards and agricultural buildings.

Figure 2. Tithe Map dated 1841.

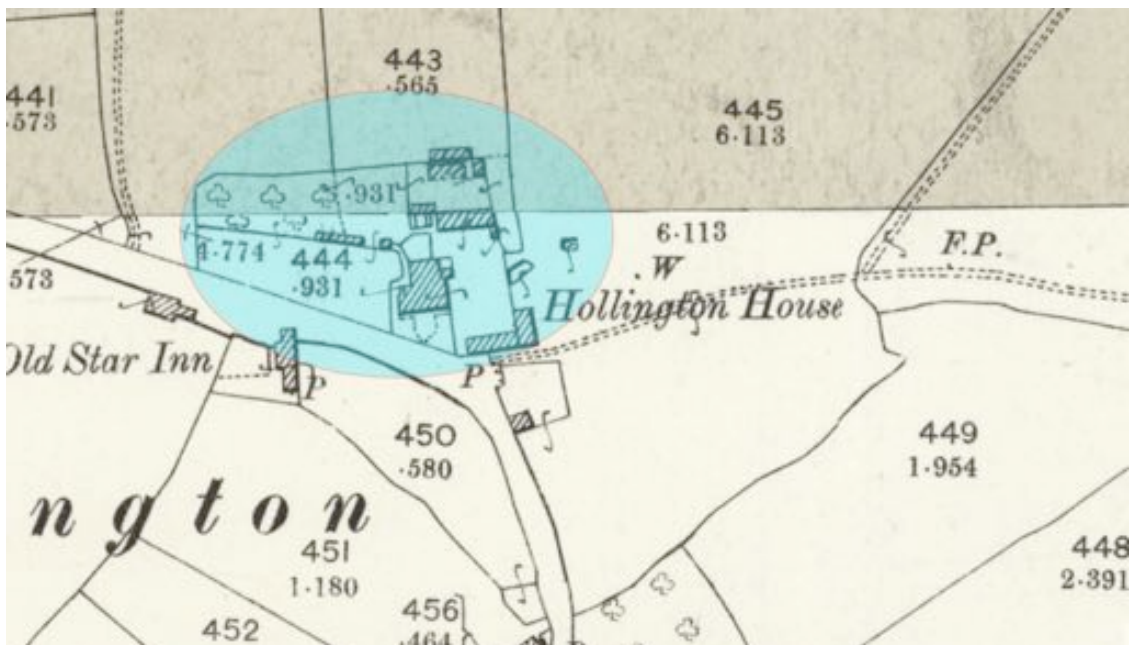
- 3.5.4 The OS Map dating to 1841 provides more detail of the site and the AB and appears to contradict the depiction of the AB on the Tithe Map, by showing that the AB had its current planform by this date (apart from a small extension, now gone, to the northeastern elevation of the AB). It is inferred from this that the three ranges making up the AB were likely to be contemporary, or at least near contemporary.

Figure 3. OS Map dating to 1841.

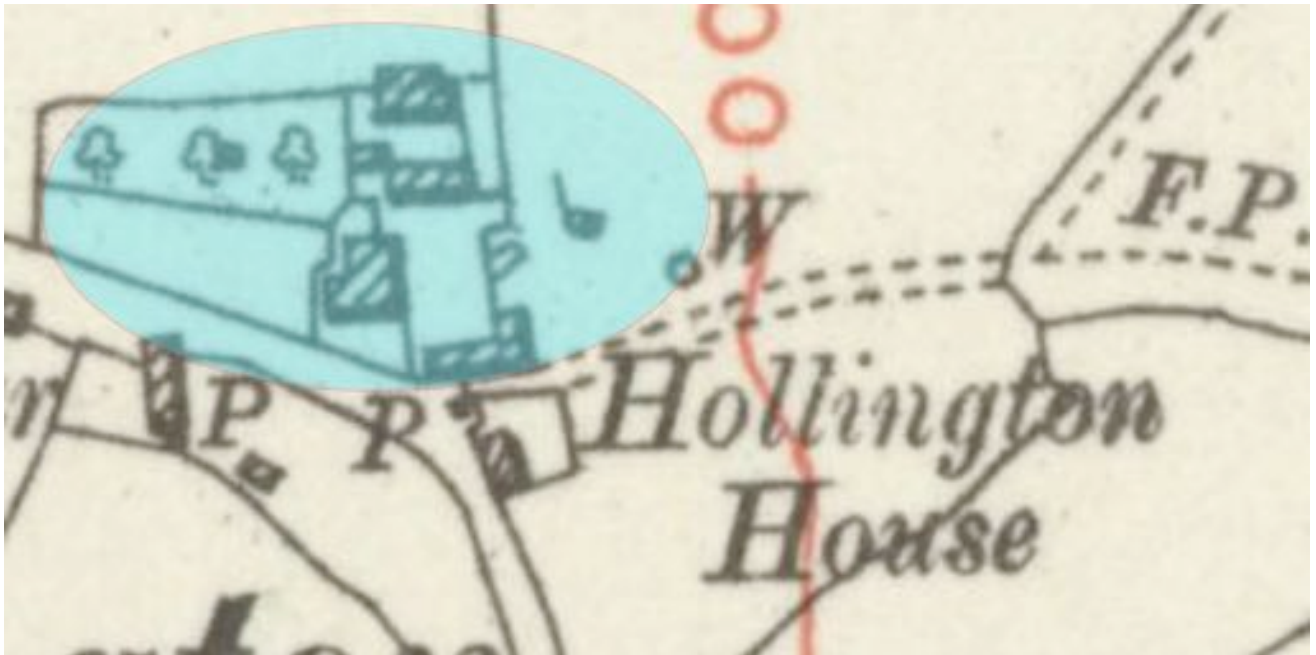
- 3.5.5 Maps dating from the late 19<sup>th</sup> century into the early 20<sup>th</sup> century (Figure 4) indicate little if any change to the planform of the AB or to the layouts of the associated outbuildings.

Figure 4. OS Map dating to 1920 to 1924.
