# FAUNA FOREST

### Preliminary Ecological Appraisal & Bat & Bird Assessment

Prepared for Osprey Property Investment Limited  
Land off Meadowside View, Alton Staffordshire

July 2025

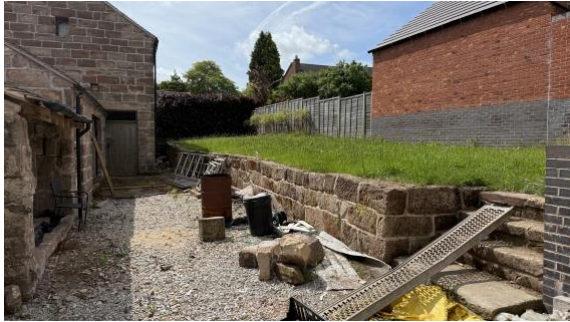
- 3.11 An ornamental copper beech hedge positioned along the southern boundary was approximately 8m in length and 2.5-3m in height, it had been previously manged although at the time of the site visit, it had an unmanaged appearance where the top was uneven.
- 3.12 A 6m laurel hedgerow has been planted along part of the northern boundary between the fence and pavement. It was approximately 1m in height.

Image 1: southerly views towards B1 and the beech hedgerow along the southern boundary

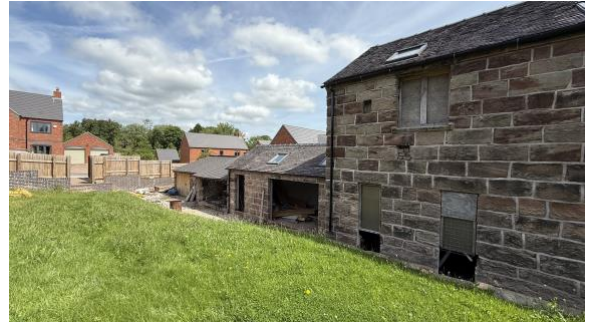
- 108: Frequently mown
  - 612: Fence
  - 828: Vegetated garden
  - 853: Mortared wall
- 3.6 The lawned area was elevated above the ground level of the buildings by approximately 1.2m and was dominated by perennial ryegrass *Lolium perenne*. It covered an approximate area of 149m<sup>2</sup> and appeared to have been mown some weeks before the site visit, although at the time of the assessment the sward was long enough for many of the plants to flower. Based on quadrat assessments of the lawn, species ratios were found to be 10 per m<sup>2</sup>. Aside from perennial ryegrass, other grasses included false oat grass *Arrhenatherum elatius* (R), Yorkshire fog *Holcus lana* (F), cock's-foot *Dactylis glomerata* (R), rough meadowgrass *Poa trivialis* (F), red rescue *Festuca rubra* (F), common couch *Elymus repen* (F) and common bent *Agrostis capillaris* (F).

Image 2: northerly views across the lawn towards the new residential housing estate. B1 is pictured furthest to the right

- 4.1 The wider landscape includes important habitats from an ecological perspective, especially woodland throughout the Churnet Valley, however the site itself is restricted to a garden setting with relatively low value habitat. The lawn provides some interest from a botanical point of view so if feasible, it should be managed to ensure herb ratios are maintained by only cutting the grass after mid-late July to allow seed dispersal. Grass cuttings should be removed from the lawn after 48 hours.

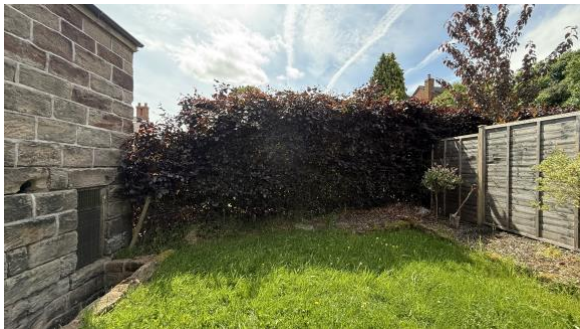
- 3.19 B1: many of the roof tiles, including those along the pitches as well as ridge tiles were gappy and raised in areas, providing suitable roosting opportunity and ingress features for bats, and gaps within the stonework were also considered to offer a suitable environment for bats to roost in.

Image 3: B1 to the left of the image and the beech hedgerow towards the centre

- 4.4 The roof lines of all four buildings were found to provide high bat roosting suitability. No work associated with the roofs is planned, however if the proposals change in such a way that work to the roof lines is required, three nocturnal bat surveys must be carried out following industry guidelines to ascertain if bats roost within the buildings.

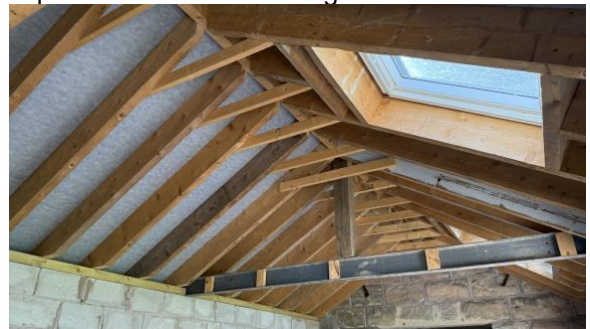
- 3.14 B1 supported a timber-framed pitched roof that was clad with clay tiles and underlined with modern breathable membrane. It featured a single ridge line facing north-south which was covered with overlapping traditional ridge tiles and fitted within each pitch was a series of VELUX-style windows. The eaves were edged by plastic guttering and windows were boarded up on both storeys. Internally, restoration works had been carried out and were ongoing, much of the roof timbers were relatively new and could be seen from ground floor level. Ladders were in place for access to the first floor although it was not assessed due to health and safety concerns.

Image 4: views of the timber roof structure within B1
