## Bat Emergence and Re-Entry Surveys (BERS)

The Morgue, Birchtree Drive, Cheddleton, Staffordshire, ST13 7FE

The proposal is described as: the conversion of the pre-existing morgue into a holiday let.

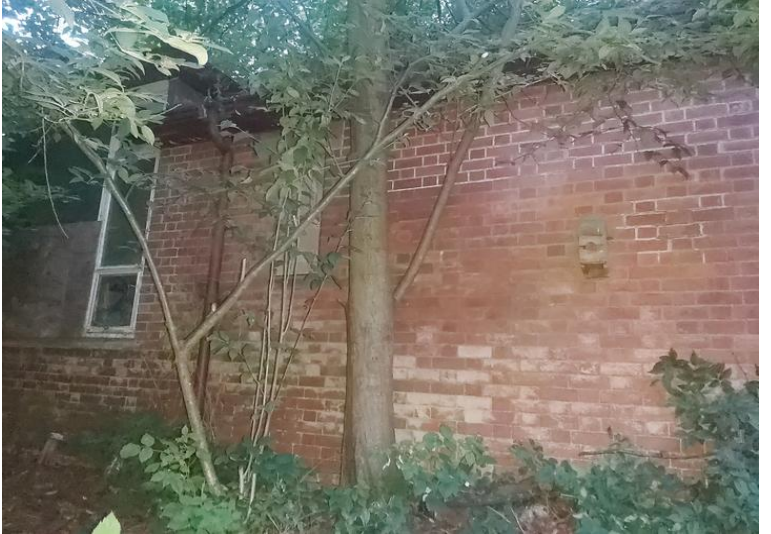
| <i>Surveyor Position 3</i> | <p><b>No emergencies were observed.</b></p> <p>The first bat activity was common pipistrelle that was heard not seen at 21:31. Constant common pipistrelle foraging was heard not seen between 21:33 and 21:47. No further activity was recorded.</p> | A photograph showing a red brick wall of a building. A tree with green leaves is in the foreground, partially obscuring the wall. A window is visible on the left side of the wall. The scene is outdoors with some greenery at the base of the wall. |

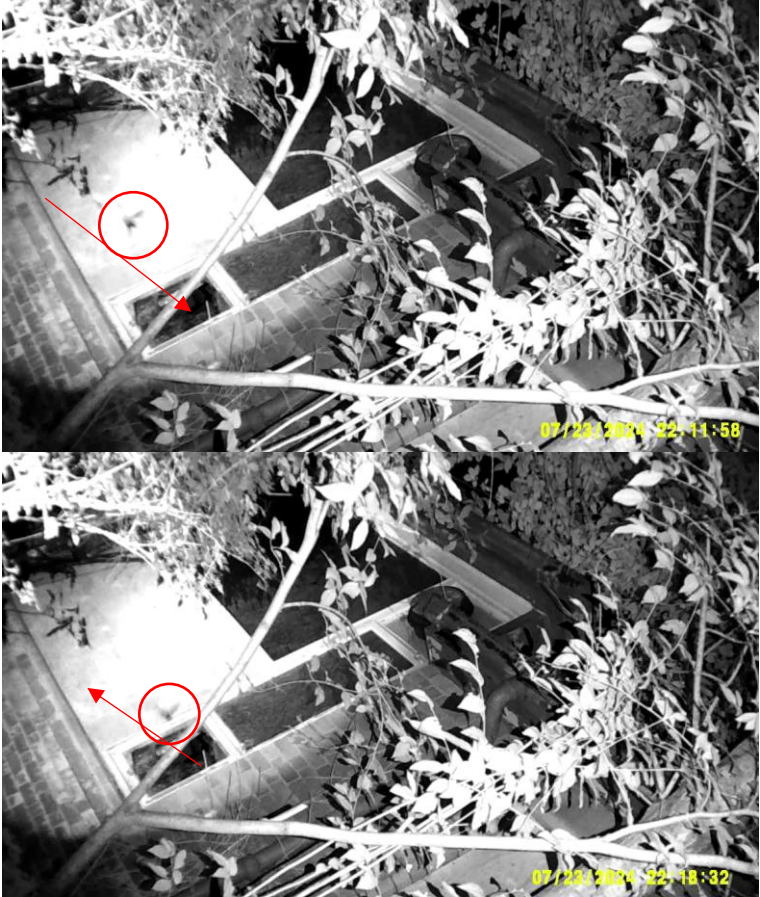
| <i>IR Position 3</i> | <p><b>One brown long-eared bat was recorded entering at 22:11 and emerging at 22:18.</b></p> <p>The bat was recorded entering through the broken window on the northern elevation at 22:11, and emerged at 22:18.</p> <p>The same bat was recorded foraging briefly in front of the elevation at 22:18 and then flew northwest.</p> | <p>The image consists of two infrared photographs stacked vertically. Both show a building's exterior with a broken window. In the top photo, a bat is circled in red with an arrow pointing to it, and a timestamp '07/23/2024 22:11:58' is visible in the bottom right. In the bottom photo, the same bat is circled in red with an arrow, and a timestamp '07/23/2024 22:18:32' is visible in the bottom right. The bat is a brown long-eared bat.</p> |

| Conclusions, Impacts, and Recommendations | |
|---|---|
| <i>Impact Assessment</i> | <p>The proposed development is a conversion of the building into a habitable space, likely to be as a holiday let.</p> <p>This would involve the repair of the window where the brown long-eared bat accessed the interior of B1 and conversion of the internal space. This will destroy the bat roost present.</p> <p>The proposed development will result in the increase of external lighting due to the building being converted into a liveable space. This could spill on to bat foraging or commuting habitat surrounding the site, and deter bats from using these areas.</p> |
| <i>Recommendations</i> | <p><b>A Bat Mitigation Class License (BMCL) application will be required to legally permit the proposed works.</b></p> <p>The BMCL application requires that surveys have been undertaken within the most recent active bat season (optimal May to August, suboptimal September). Planning permission must have been granted, and all relevant wildlife-related conditions</p> |
