## **Preliminary Ecological Appraisal & Nocturnal Bat Survey Report**

Spring Cottage, Greatgate Road  
Winnothdale, Tean  
Staffordshire, ST10 4HB

Prepared for Alistair Whiston

September 2025

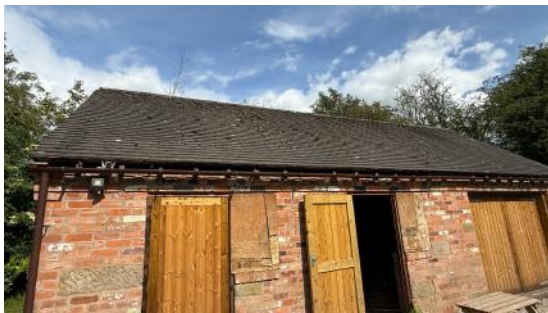
Image 3: western side aspect of the building

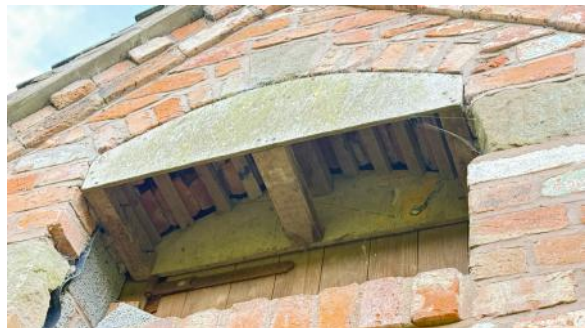
- 4.26 Roof tiles in places were slipped and had become dislodged over time, offering potential access either between the tiles and felt or directly inside the building. Gaps large enough for bats to access the building were also noted above the bricked-up windows between brickwork and small timber sections.

Image 4: potential access points for bats in the gable wall of the building, above the bricked-up window

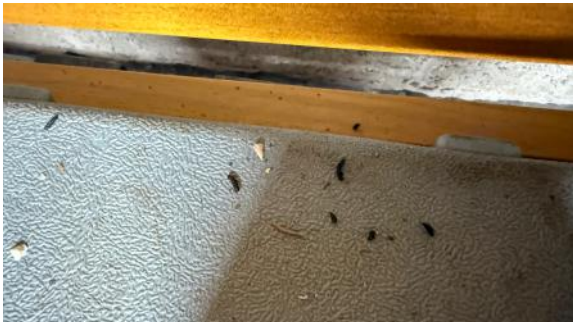
- 4.28 A small concentration of *fairly* fresh bat droppings (~10) was identified inside the building near the north gable wall. No other evidence such as feeding remains, urine strains or bats was found during the survey. Additionally, no evidence relating to nesting birds was found inside the building during the survey.

- 5.6 Results of the PRA in 2025 (Fauna Forest Ecology Limited) reflected those of 2017, although the droppings found in 2025 resembled those of brown long-eared bat rather than pipistrelle. However, the appearance of droppings may be misleading, so they should be sent to a lab for DNA analysis to confirm which species they were deposited by. Consideration was given with respect to placing a static bat detector in the building for a week (or longer), but in many cases bats commuting or foraging above or near buildings like the one onsite are often recorded, which consequently leads to false positive results.

Image 5: small number of bat droppings behind the northern gable wall inside the building

- 5.14 The supervising ecologist will continue the watching brief until the building is declared free of bats. Any bats found during this period will be safely removed by the ecologist and placed in a bat box. If in the unlikely event a bat is discovered after the ecologist is no longer supervising, works should halt immediately and Fauna Forest Ecology Limited should be contacted for advice. If you are not able to reach the ecologist, then contact The Bat Conservation Trust: 0845 1300 228. Never handle bats for legal and Health & Safety purposes.

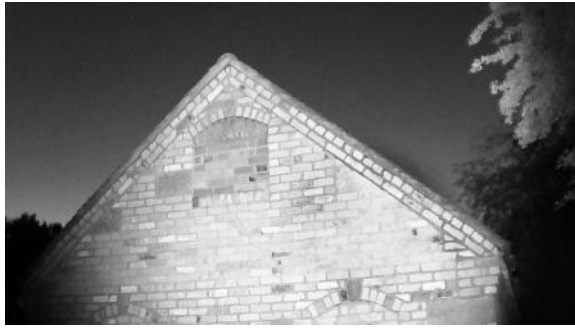
- 5.7 During the nocturnal bat surveys, no evidence of bats emerging from or entering the building was observed. Whilst views across the eastern roof pitch were restricted to some degree, confidence is given bats did not emerge from it during the surveys based on flight paths and general activity patterns. Based on the presence of low numbers of bat droppings and lack of discarded feeding remains (such as wings of moths and butterflies), it is clear the roost is an infrequently used day roost.

Image 7: infrared still image of southern gable wall taken at the darkest part of the survey on 14th June 2025. Note that views across the easterly roof pitch are somewhat restricted due to the hedgerow (right-hand side of the frame)

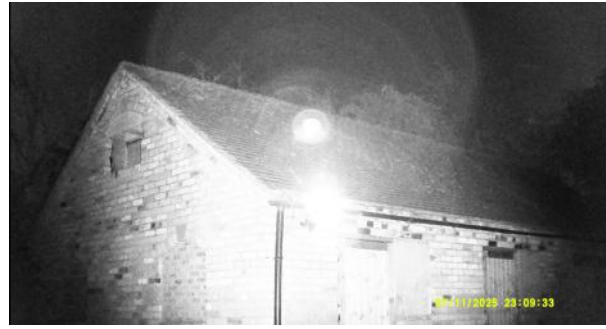
Image 8: infrared still image of the northwest corner of the building taken at the darkest part of the survey on 11<sup>th</sup> July 2025. The bright light towards the centre of the roof pitch is a consequence of the infrared security camera, so it could not be avoided
