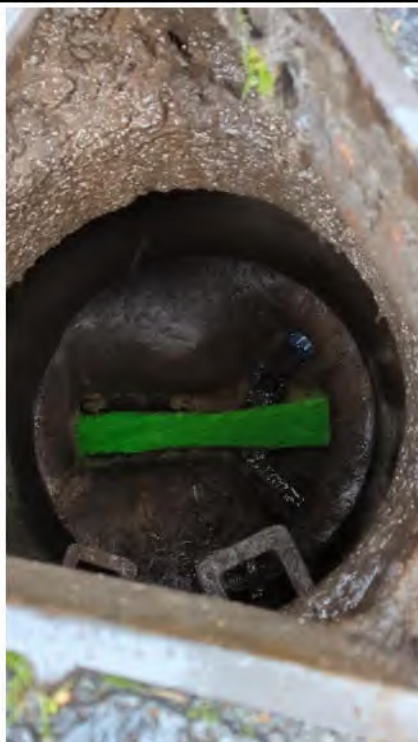
Photo No.10

Drainage dye present in public surface water sewer manhole 5201 (proved connectivity to upstream central chamber).
