# HERITAGE STATEMENT & IMPACT ASSESSMENT LONDON MILL, ASHBOURNE ROAD, LEEK

Alfa Mohuha Ltd  
13th March 2023

## Mel Morris Conservation

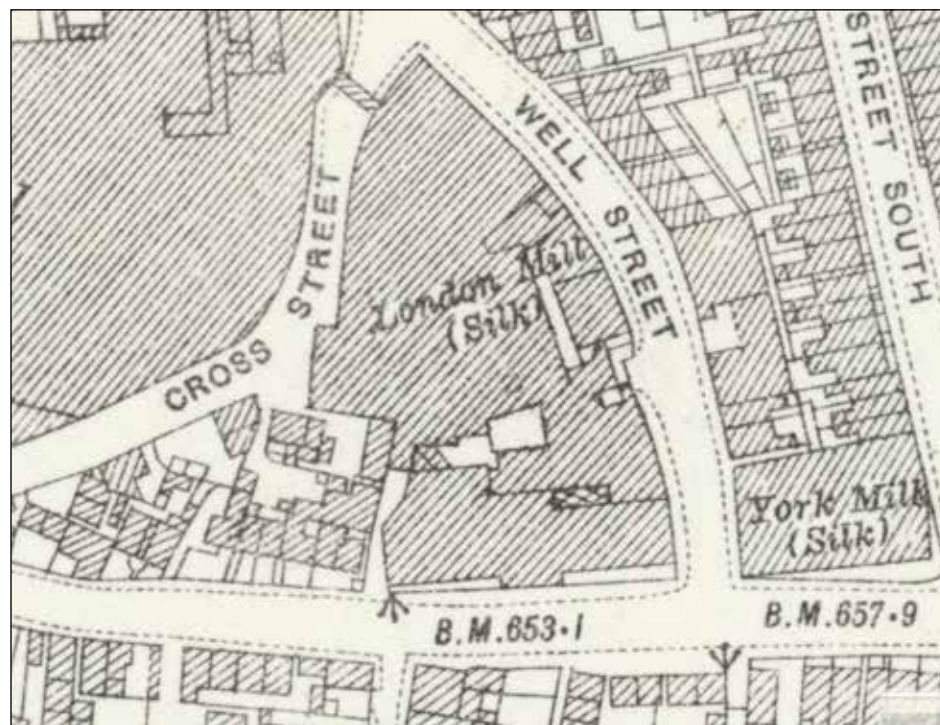
2. 1925 Ordnance Survey map of the 'London Mill Site' at 1:2500 scale. This clearly shows how over time the small gaps between the buildings were in-filled with various structures.

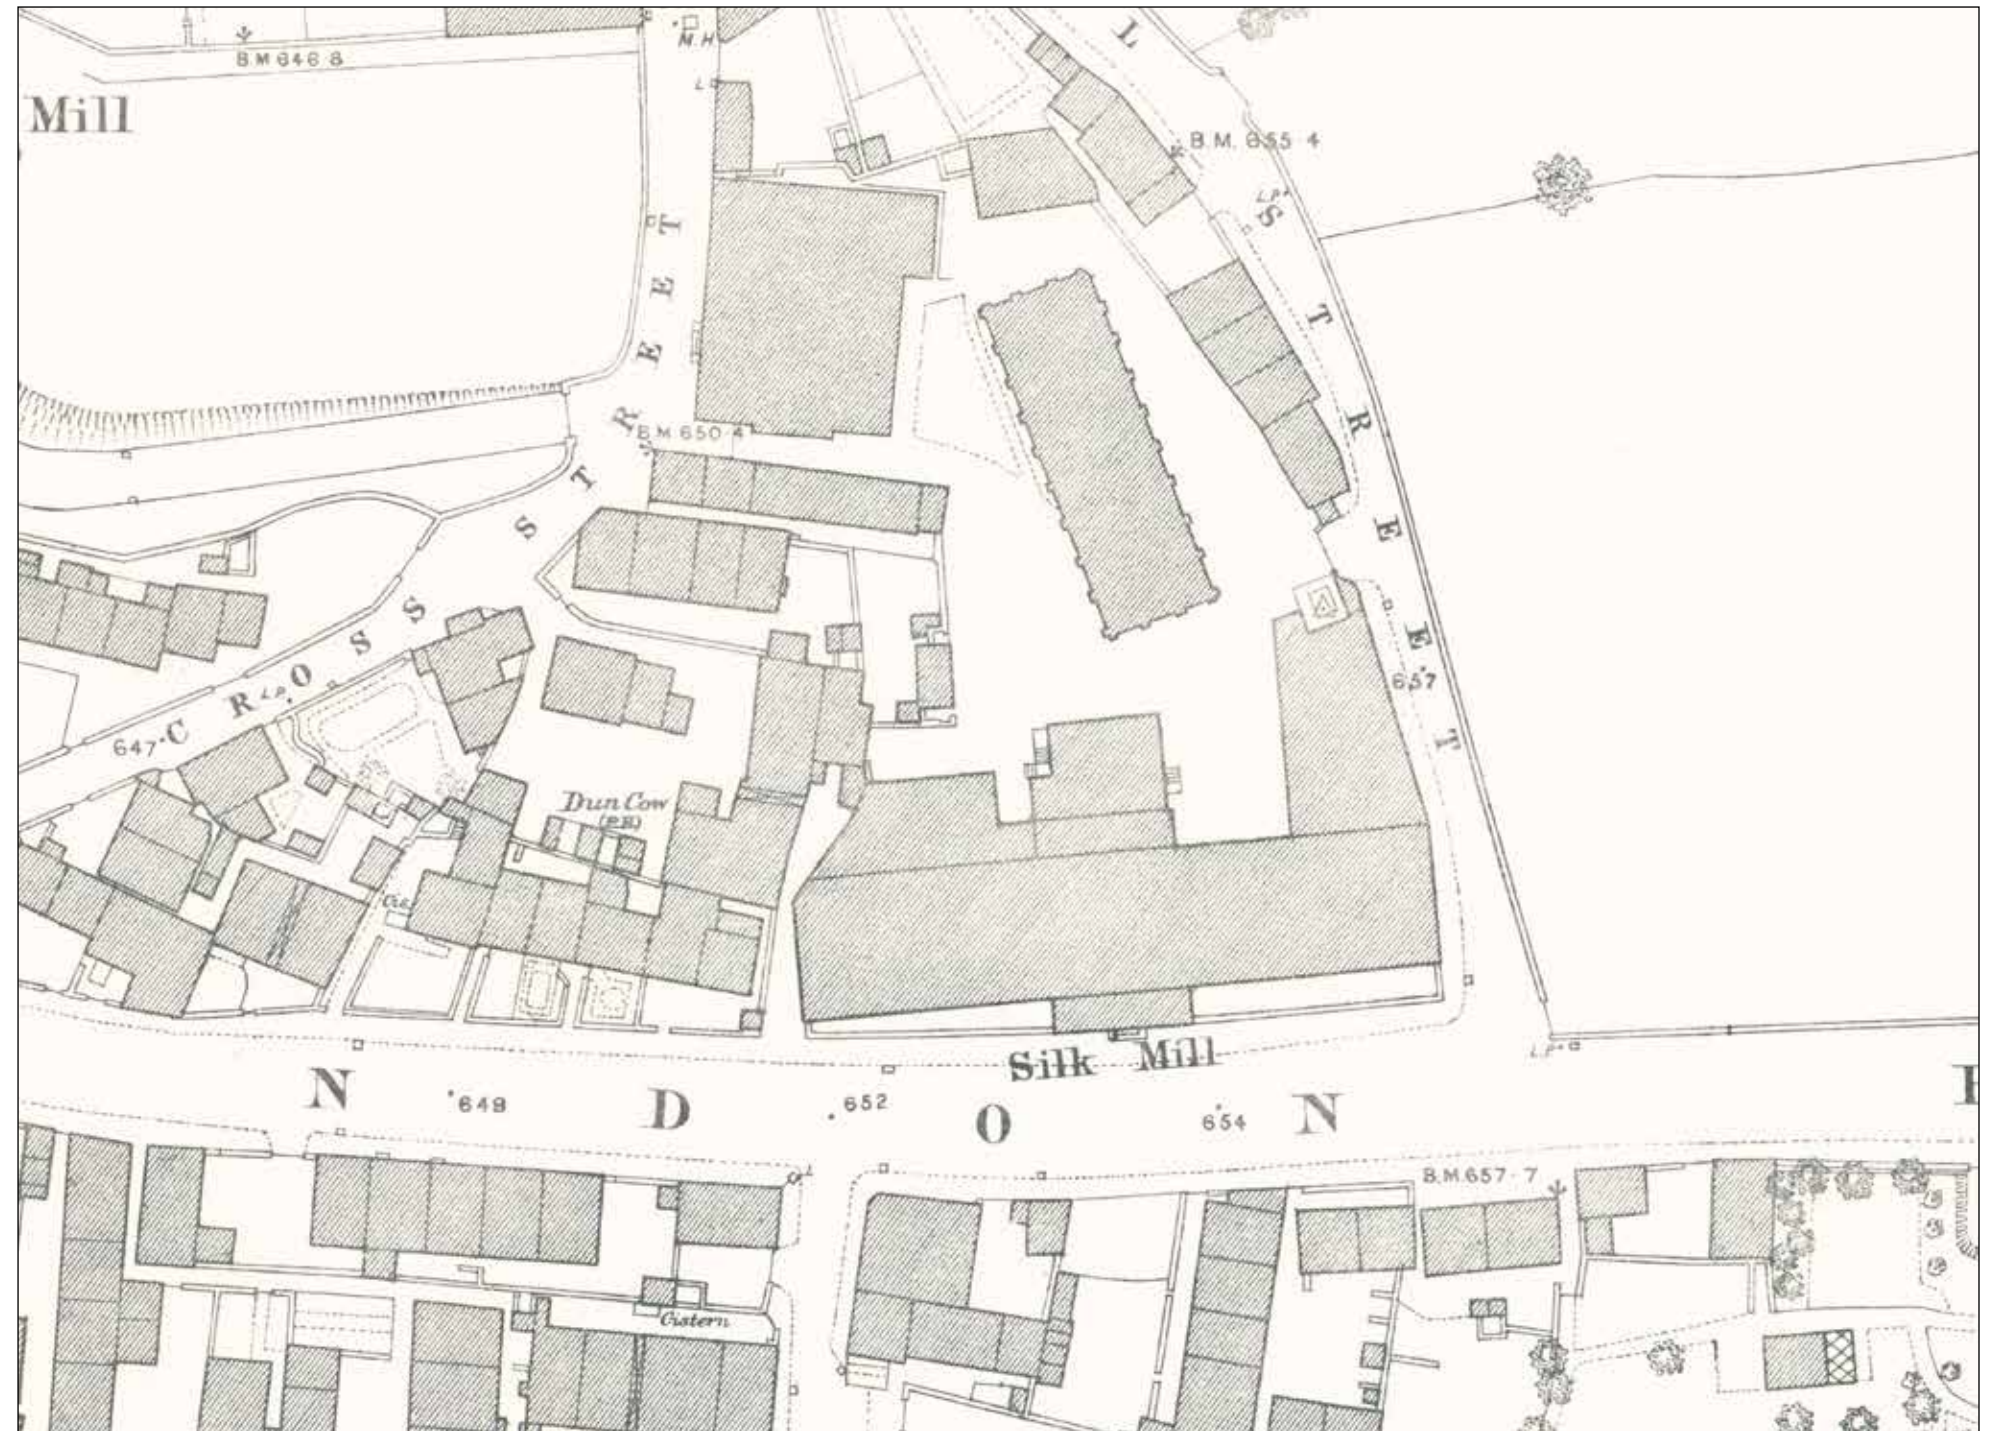
3. Town Plan at a scale of 1:500 (Ordnance Survey - first edition 1879). The town plan clearly shows how the building is angled at the north-west corner, and the alignment continues in the attached single-storey structure, in order to provide access to the properties to the rear of London Road. The significant changes in level were accommodated at that date by external staircases to the north of the building. The location of the octagonal chimney stack and the Boiler House is clear running along Well Street. By comparing this plan with the current layout (top left - fig. 1) we can see that the land ownership has been truncated but not in a particularly logical way, as there is no access between the east and west sides of the building.

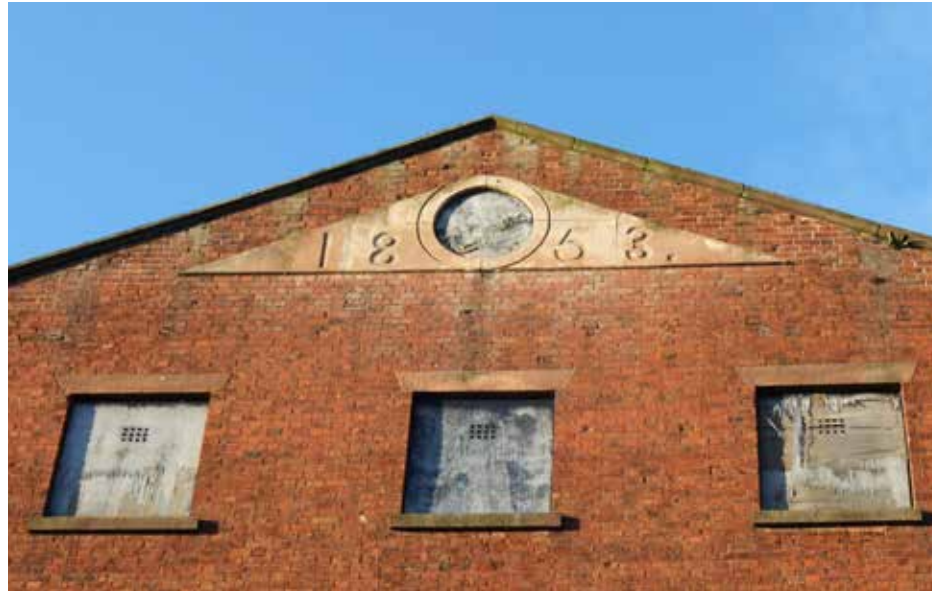
**6. Central pediment with carved datestone in pink gritstone and roundel for a former clock face.**

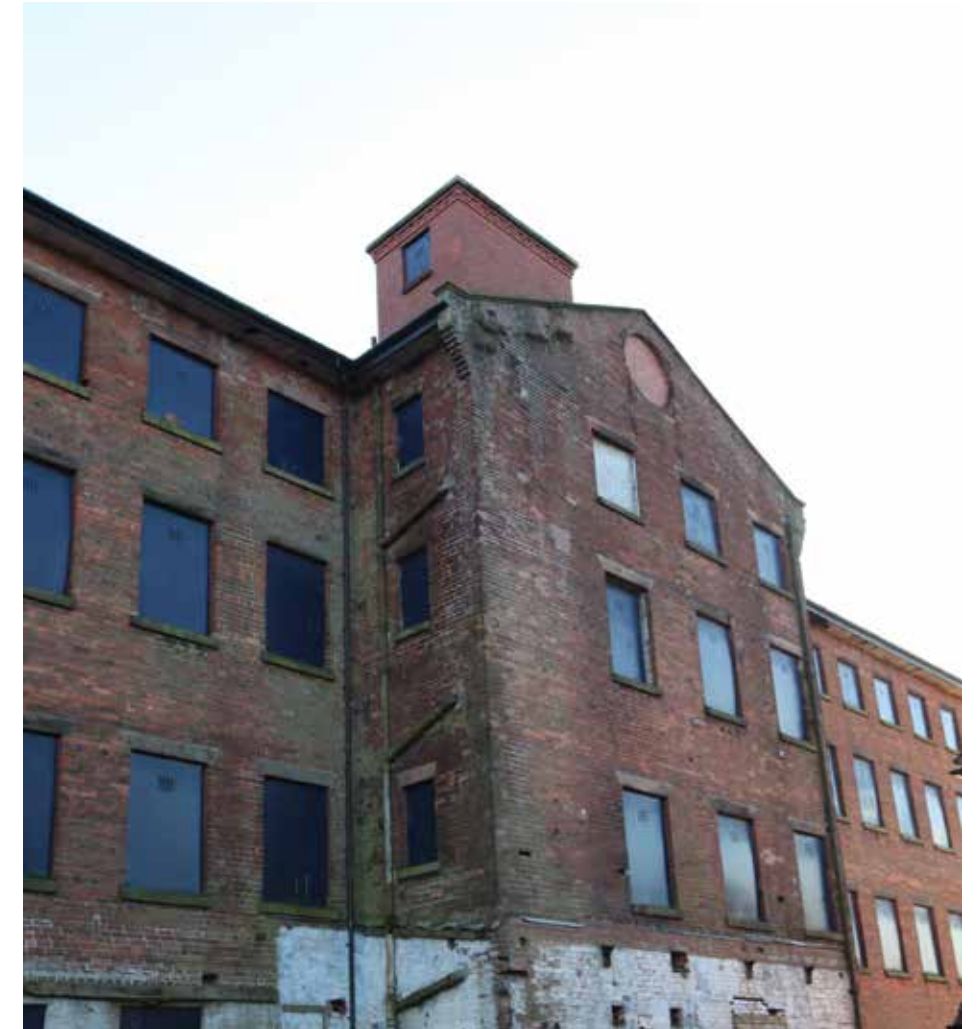
**7. Rear transept with former clock face (bricked up) and smaller windows for water closets. Lower down the elevation is the painted face of the former internal wall to the engine room. The modern brick, goods lift over-run is relatively modern (post 1934).**

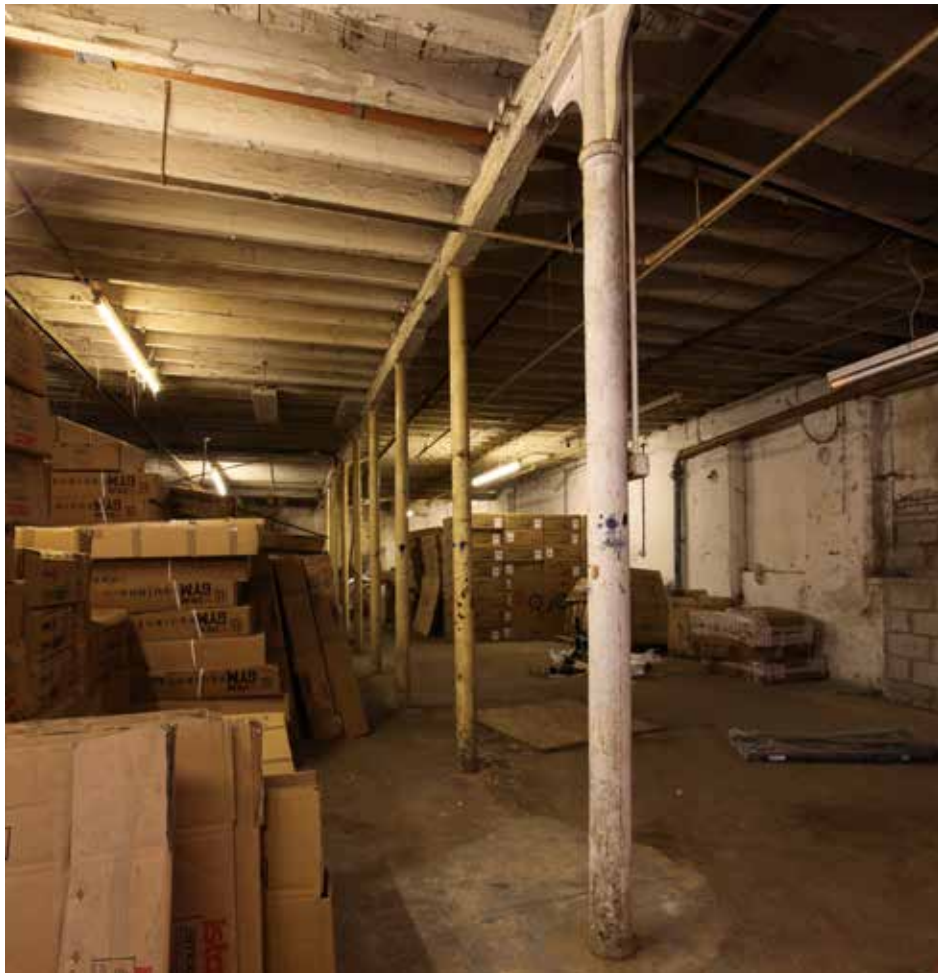
The cast-iron posts run like a forest and at ground floor level there are almost twice the number than the floors above. They roughly, but not entirely, alternate between plain cast-iron posts and those with flanges, which are bolted to the axial beam. There is one post with much larger flanges, which was probably inserted when the ceiling was modified.

8. Ground floor - cast-iron columns looking west

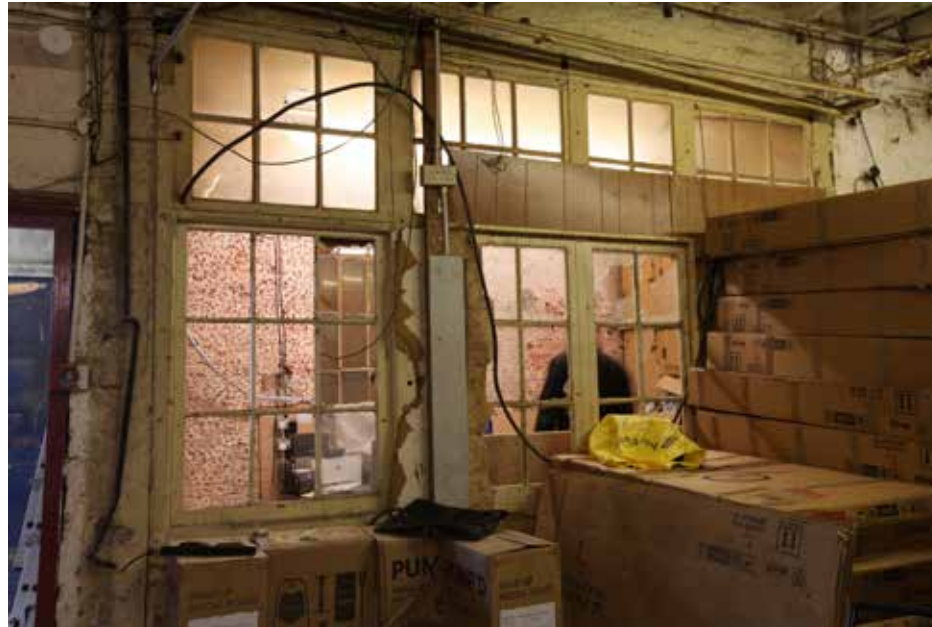
9. Internal screen at ground floor level - this has been modified but may be the remnants of the Counting House.

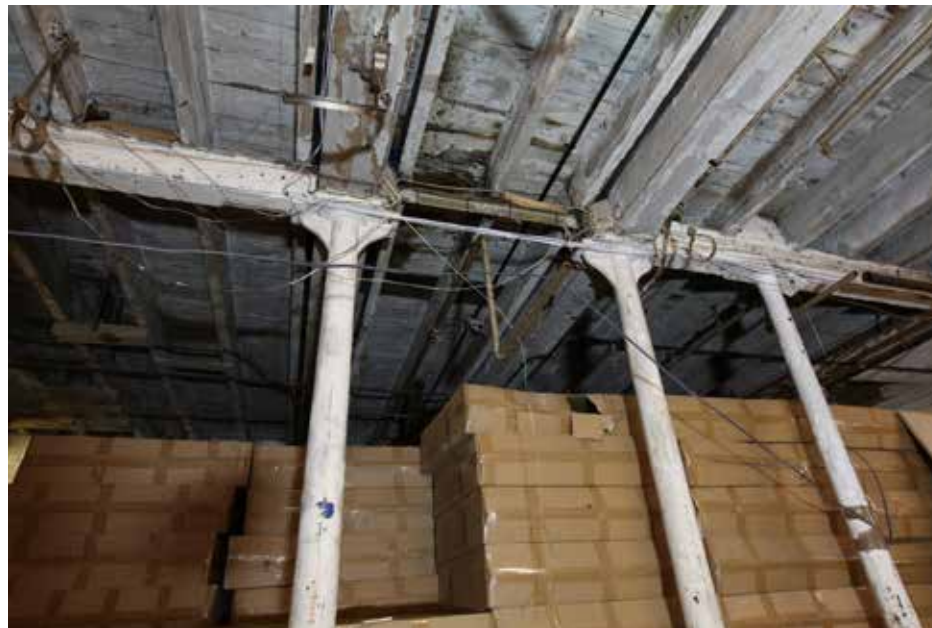
10. Pitch pine transverse beams with replacement flanged cast-iron columns to ground floor ceiling.

The purpose of the additional transverse pitch pine beams is unclear, but they may have been added to support an additional specific weight from localised heavy machinery. At this point one of the cast-iron posts has been re-located in order to create a cast-iron shoe to support the central axial beam and attach it to the transverse beam. Box-section cast-iron castings have also been added to connect these two transverse beams and there is an intermediate box-section casting. There are two additional cast-iron flanges hanging beneath, one with a 'hook' and one without, but with drilled square sockets, both of which may have supported line shafting.

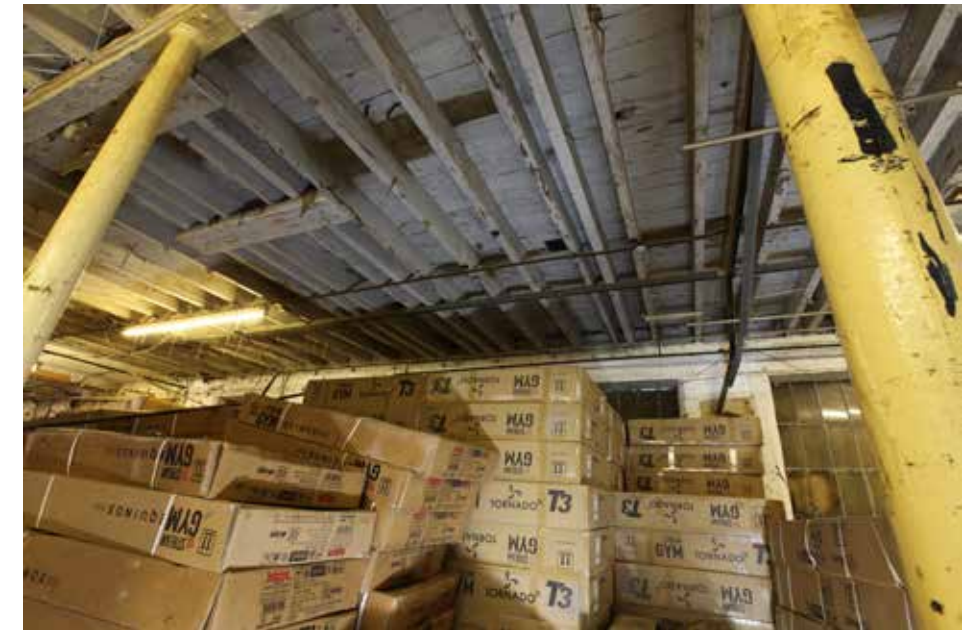
11. Section of ground floor ceiling with supplementary timber joists.

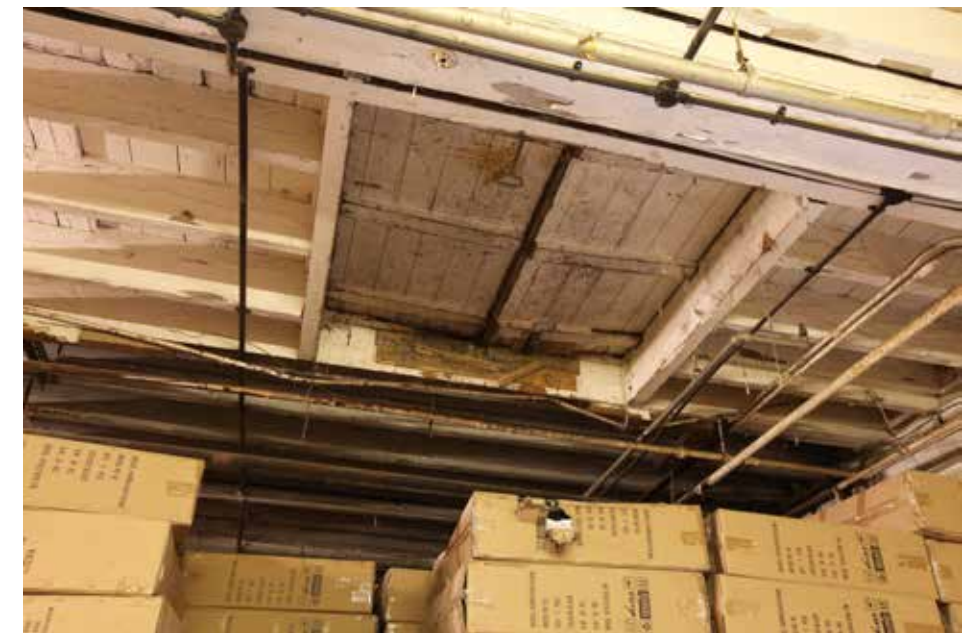
12. Trap doors to former internal hoist.

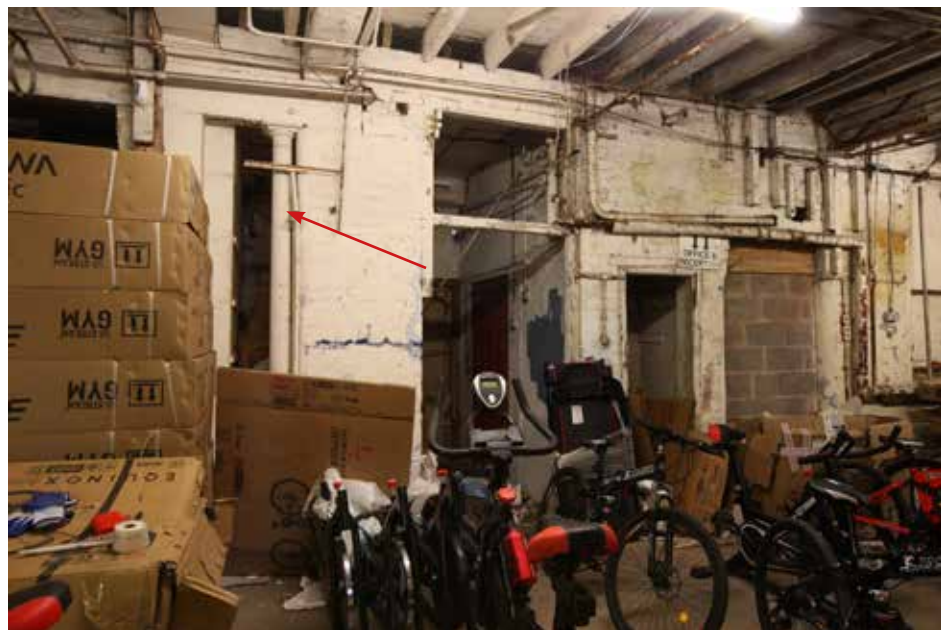
14. The north transept is partially infilled at ground floor level. The cast-iron column (arrowed) may have been added when the transverse beams were inserted, as it appears to be providing additional support to the load from the beam above.

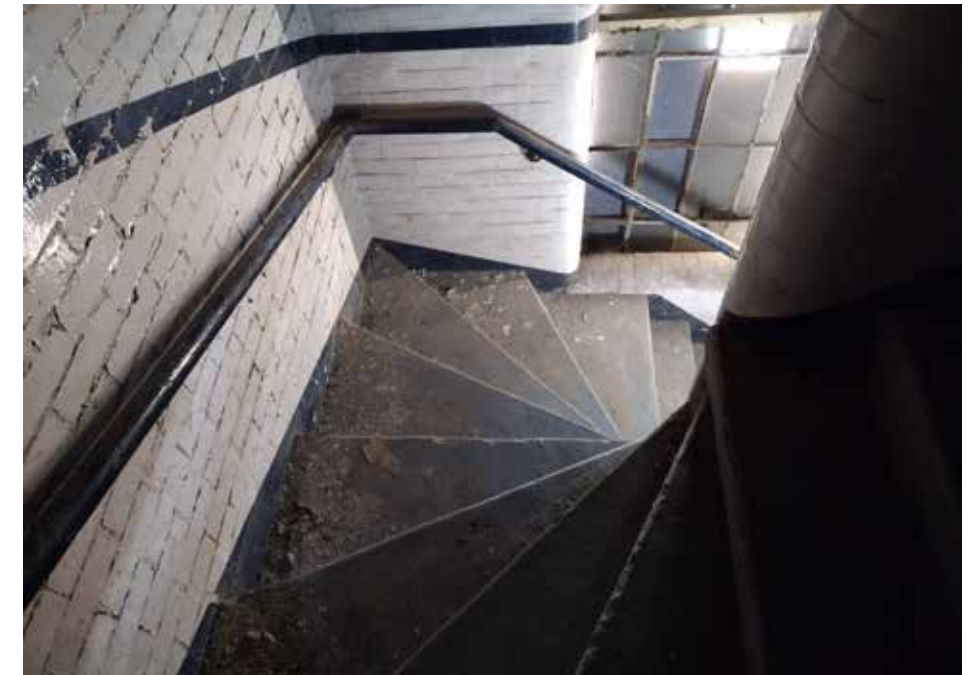
Within the southern 'transept' there is the principal staircase, which is a winder, with stone steps, very worn and made up in concrete, and a timber glazed screen separates a small room from the main mill floor. It is likely that this was the 'Counting House' which is mentioned in 1861.

16. Detail of stone winder staircase, with later concrete repair.

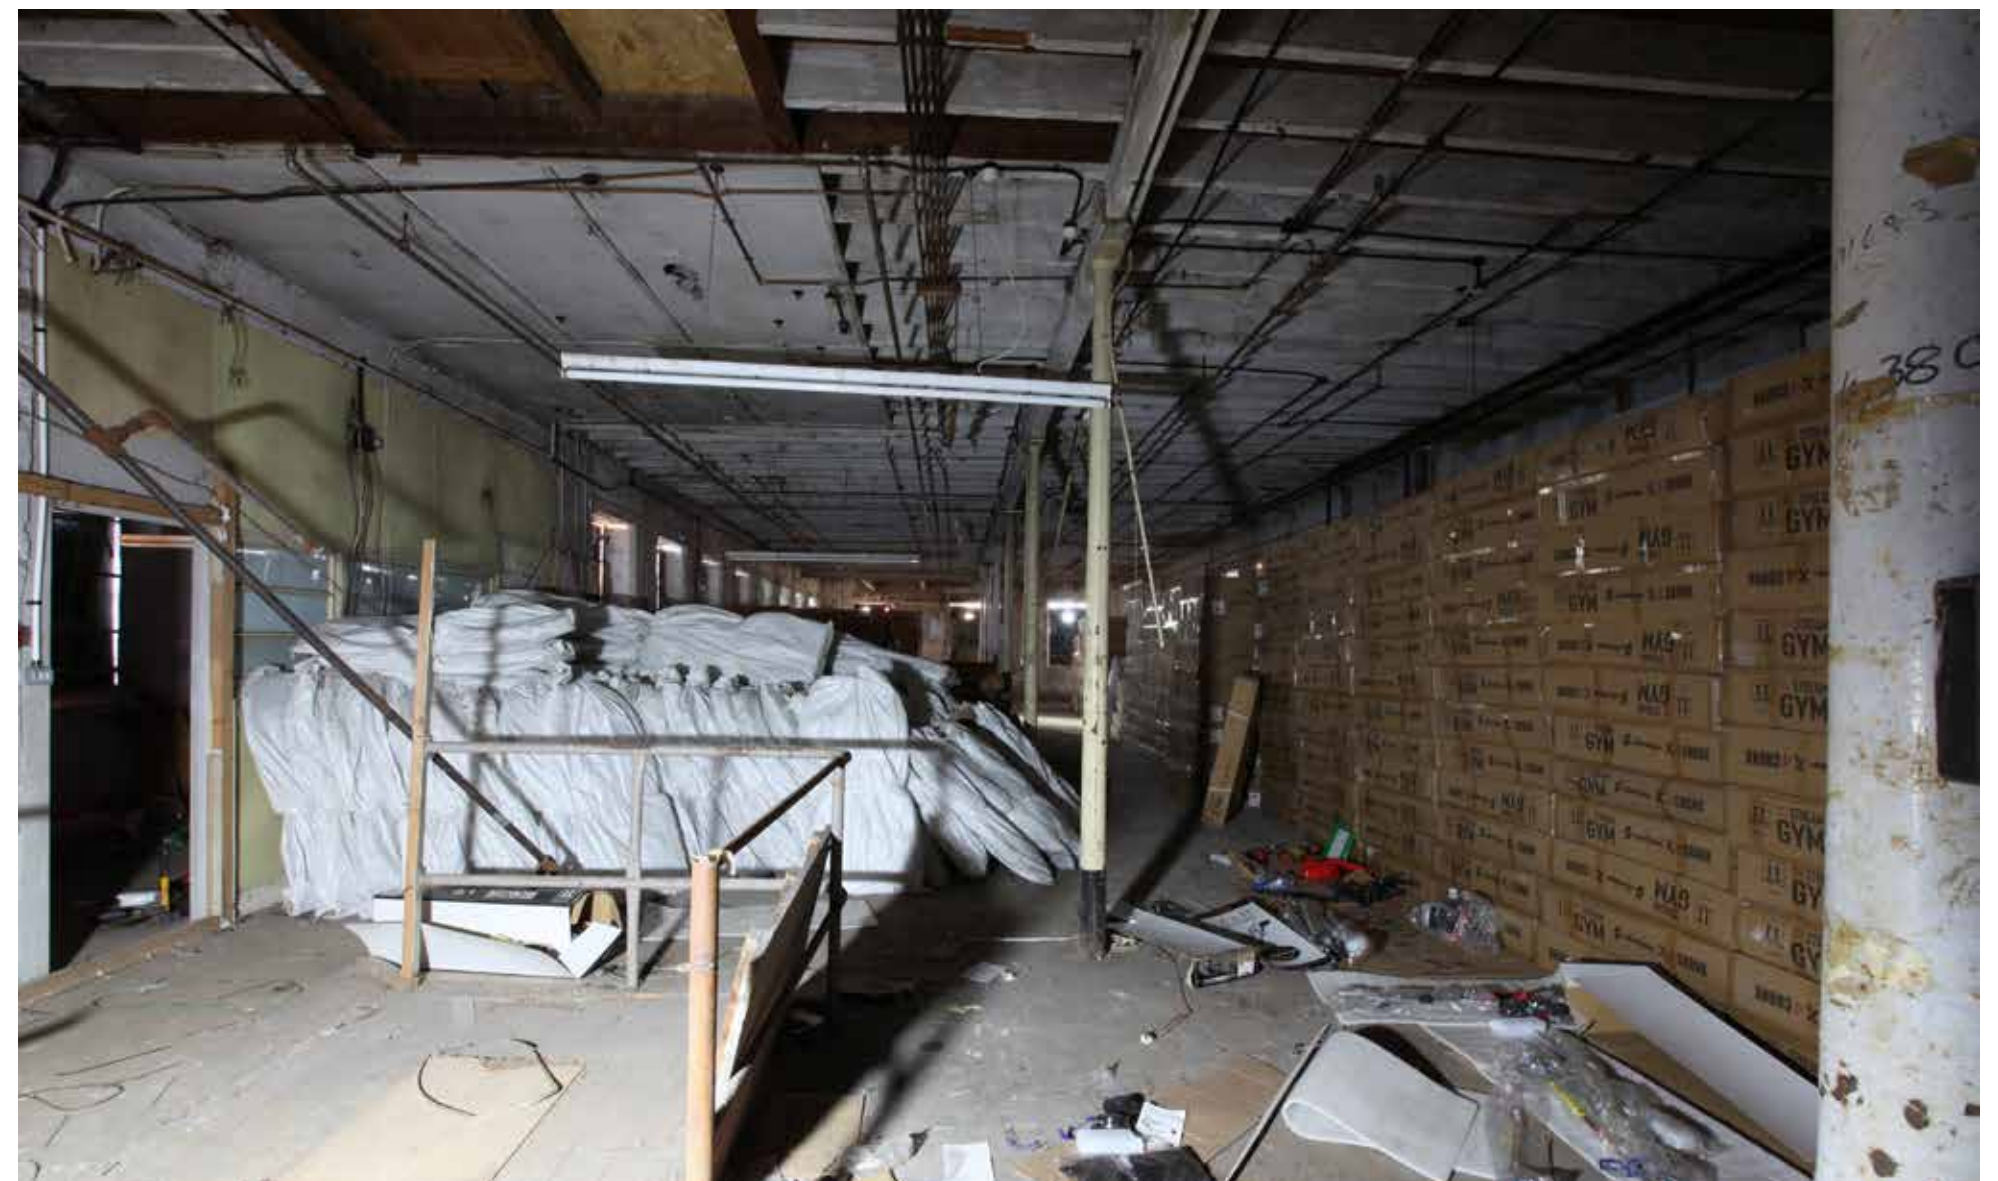
The first floor has much taller floor to ceiling heights, at about 12 feet. It has been suggested that this height was purpose-designed to accommodate the taller Jacquard looms. Jacquard looms required a clearance of 11 to 12 feet (up to 3.6m). A series of plain cast-iron posts support the central axial scarfed beam. This in turn supports timber joists jointed along the line of the spine beam. The top of each cast iron posts has a simple neck casting and has a timber trimmer underneath the spine beam, which may indicate additional pads where the beam has been jointed at each scarfed section. There are a few repairs at the western end, where an RSJ has been inserted.

15. Below - first floor with 12 feet floor-to-ceiling height and slender cast-iron columns

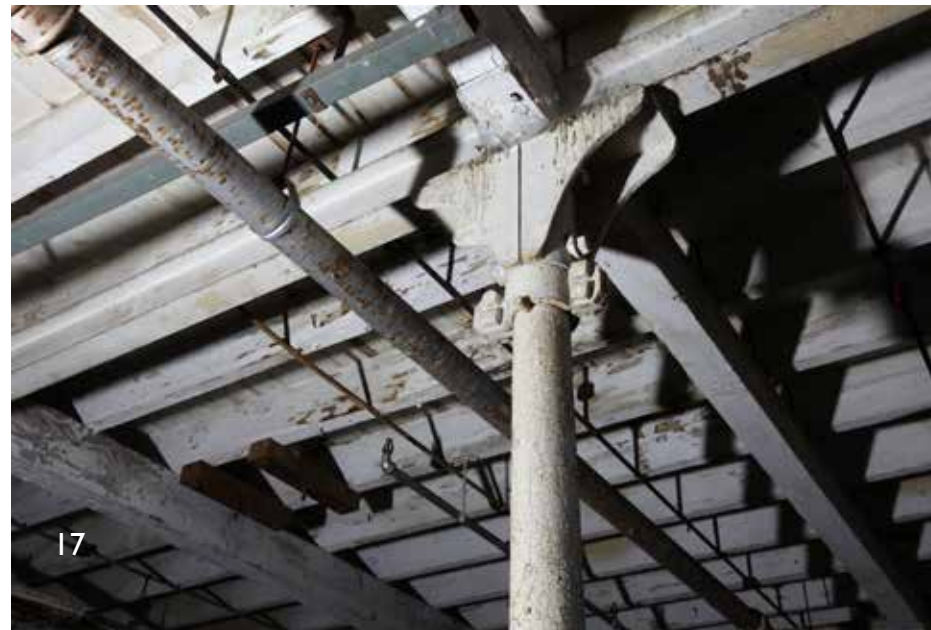
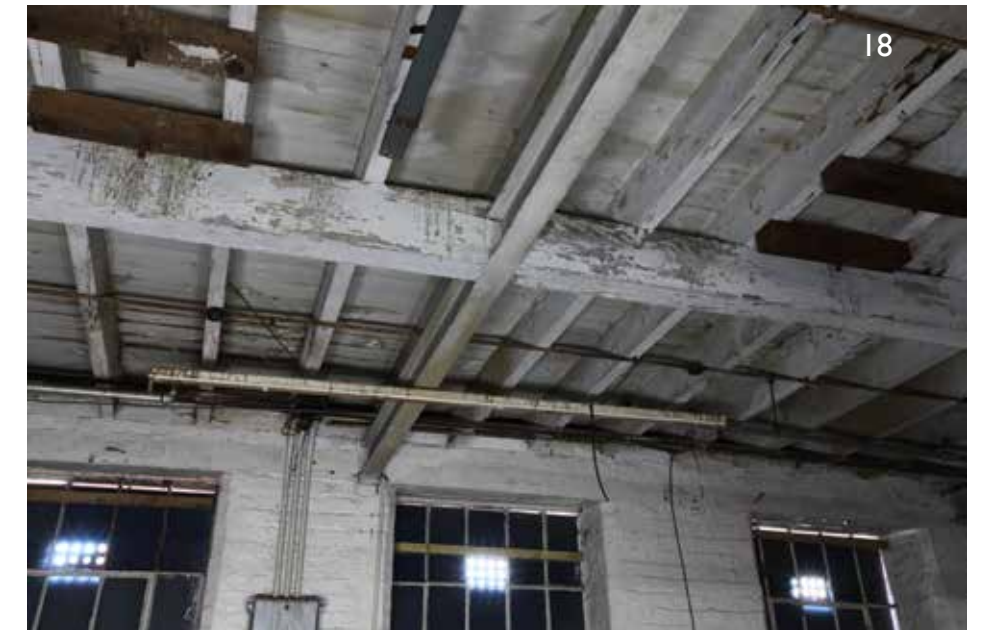
### 17-19. Second Floor details

The second floor is open throughout and the ceiling supporting the third / attic floor has been reinforced throughout by attaching flanged plates to each cast-iron column, which support RSJs. The RSJs in turn support additional longitudinal timber beams. The cast-iron posts from the original mill of 1853 still survive, with their plain square bases, and these still support the original axial scarfed spine beam and the original floor joists. All of the overhead beams, both original and later, have been limewashed and / or painted white.

Original cast-iron columns are supplemented with metal 'shoes', drilled and tapped into the columns, which carry secondary RSJs. These, in turn, support secondary timber beams.

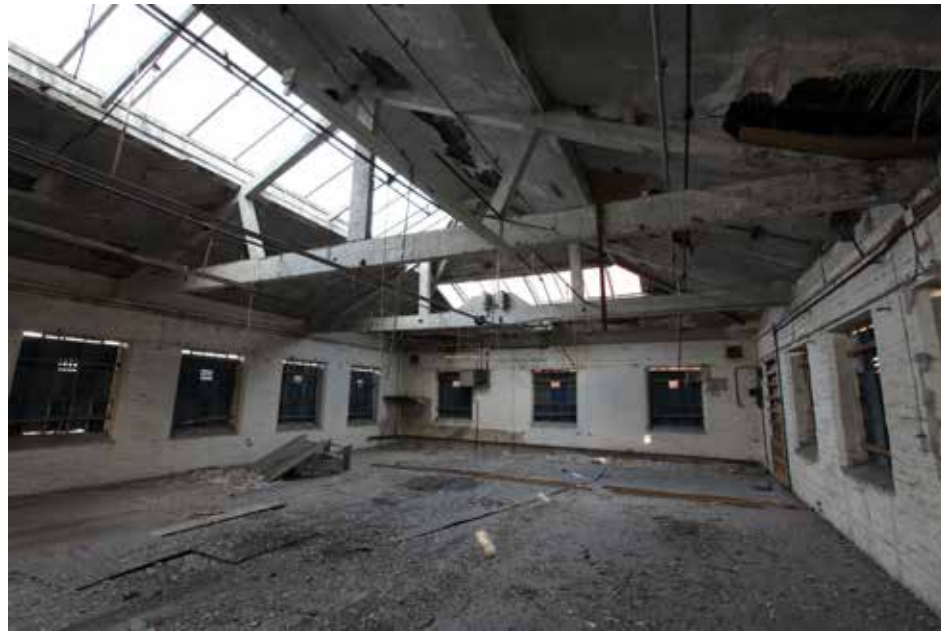
The third floor is windowed throughout and also has north-light glazing and secondary glazing to the east and west roof slopes. There are a series of I I King post trusses, with struts and each principal rafter supports a single purlin. In addition, there are pairs of longitudinal boxed beams spanning the trusses, spanning most of the trusses. The purpose of these additional beams is unknown. All of the soffit of the raked ceilings was finished in lathe-and-plaster, so that the finishing of processing was clean and tidy. The north and south transepts of this top floors have evidence, in the form of a timber staircase and an enclosed timber partition at high level, of the access to the former clock faces. There is also a riveted iron water tank which has been inserted over the main staircase and was probably inserted in 1924, if not earlier, in association with the sprinkler system.

20. Northlights and King post trusses

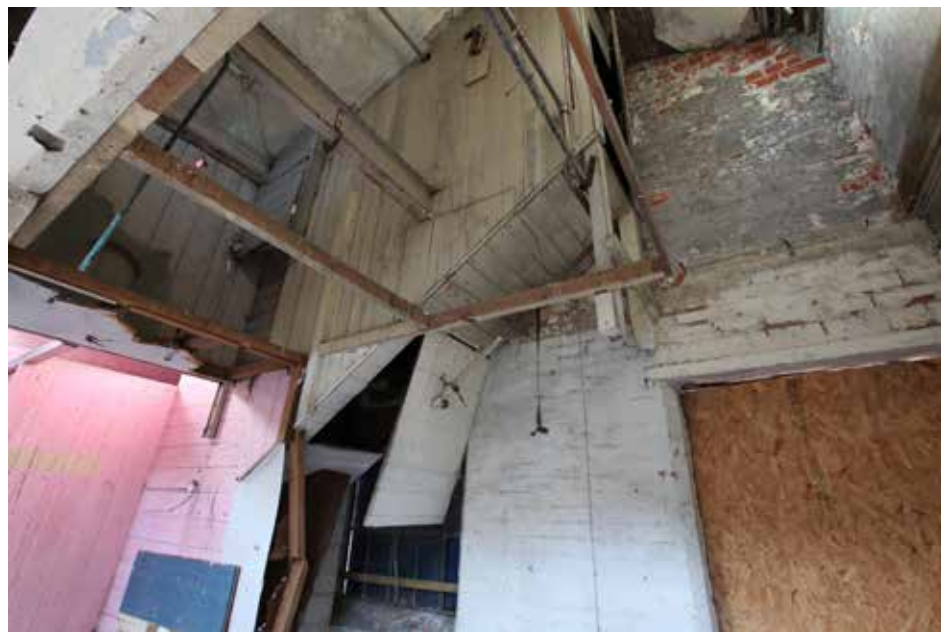
21. Possible remains of access to former clock - north transept

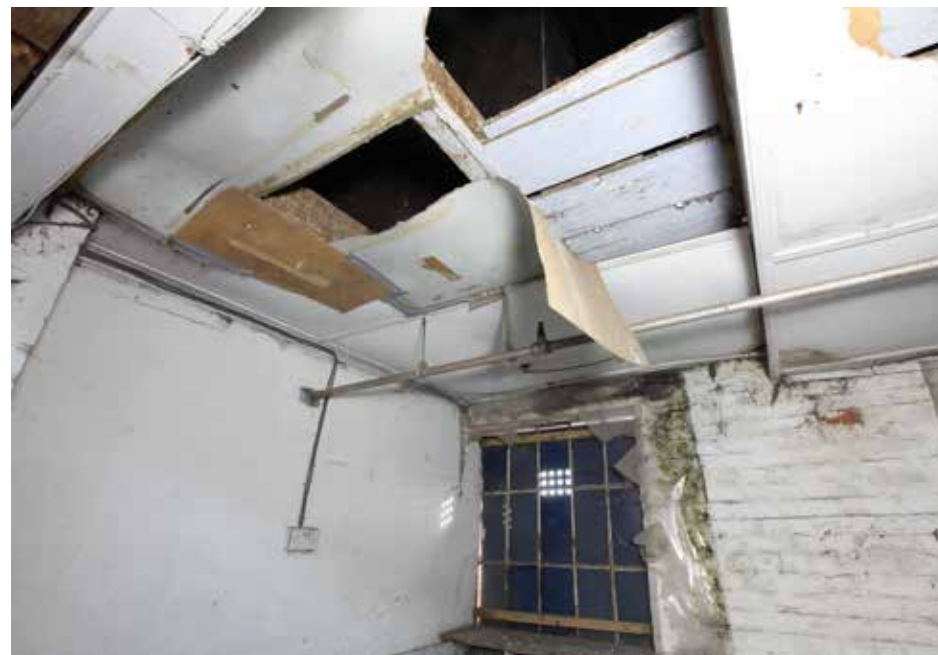
23. Possible remains of access to former clock - south transept

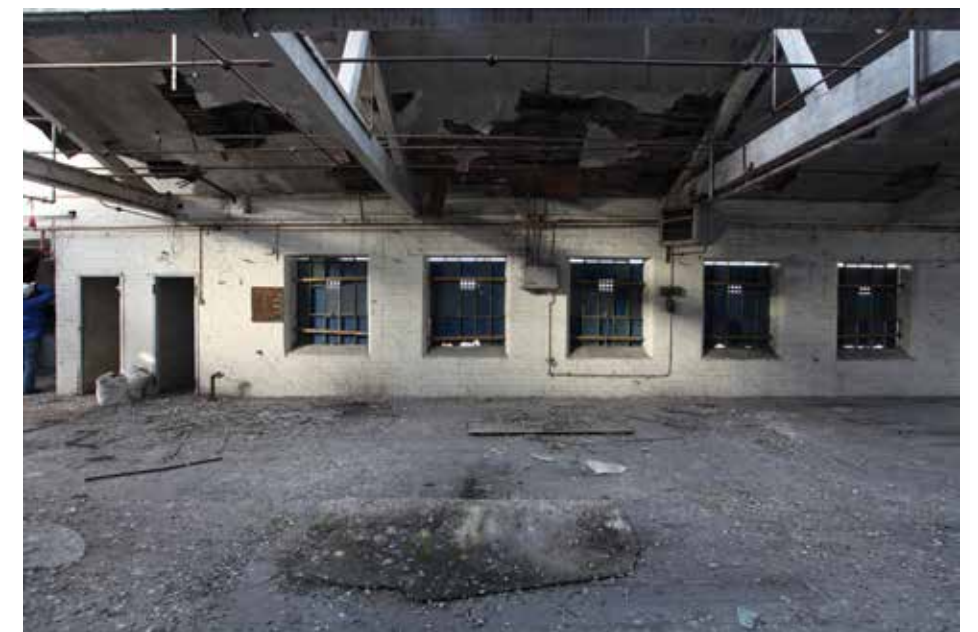
24. Surviving cast-iron windows to rear elevation

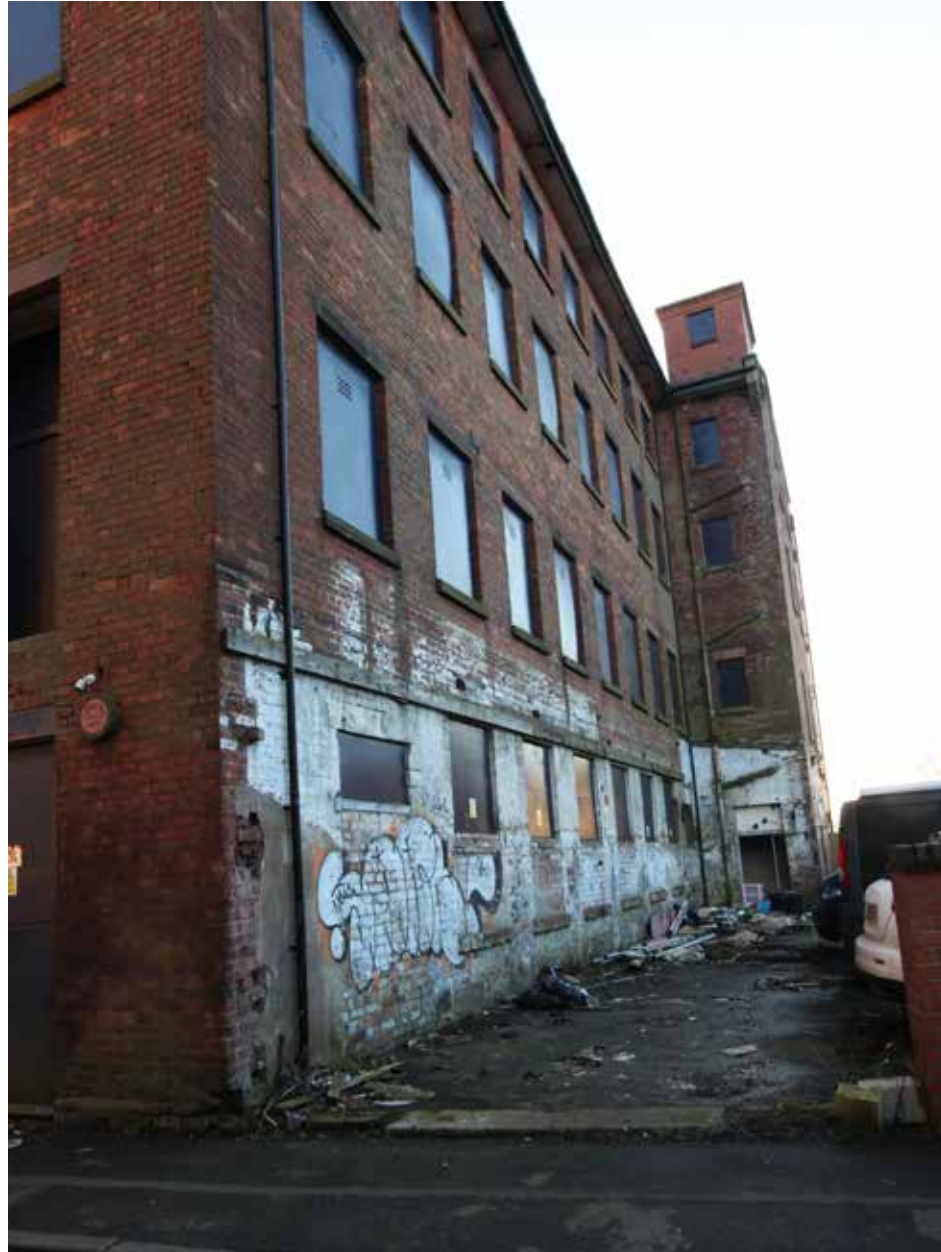
25. View of the rear elevation and yard to Well Street. Removal of the Boiler House and Engine House has left some visible scars which will need to be addressed through sensitive cleaning and repair.

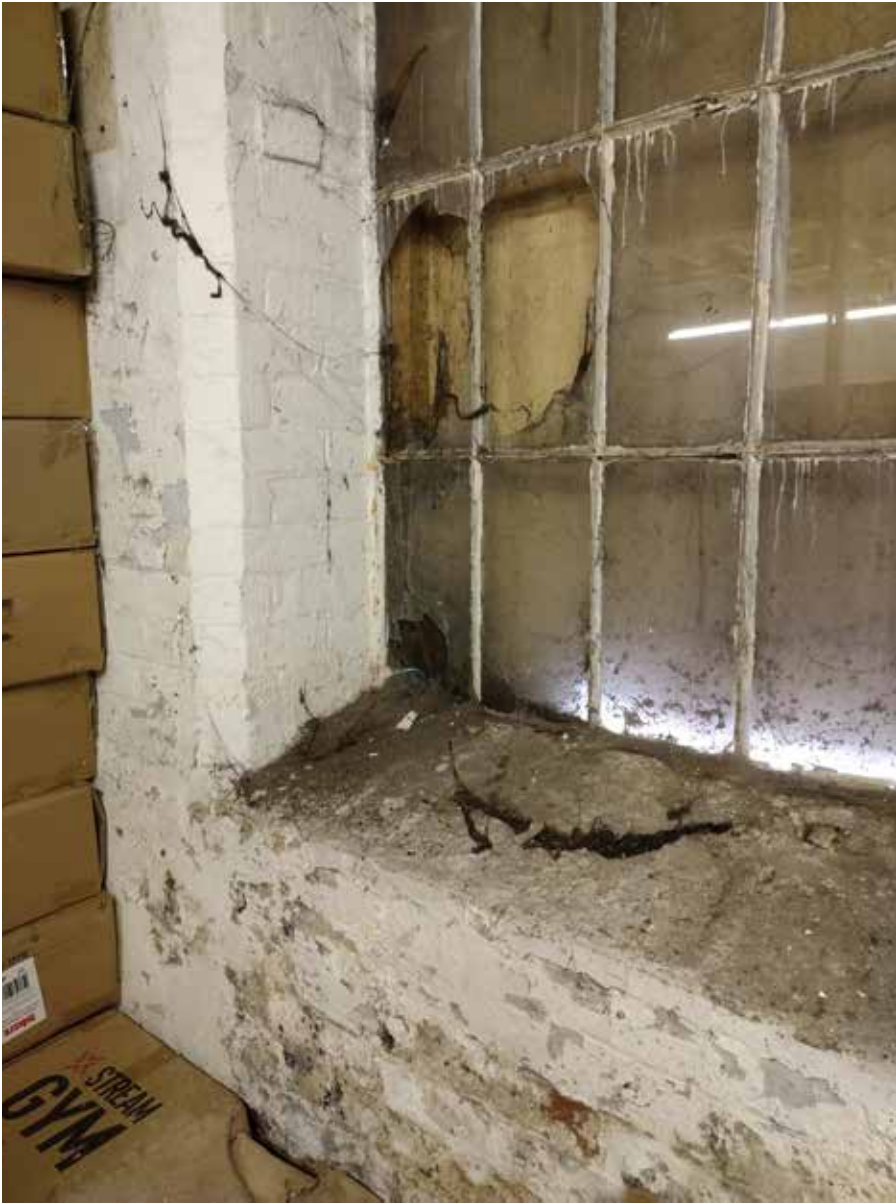
30. Detail of cast-iron window with very fine section glazing bars, putty finish, and 3-4mm glass. Windows were actually glazed internally so that it was easier to replace broken panes.

All windows will need to be removed for refurbishment as it is unlikely that they can be retained and refurbished in-situ. Once putty is removed, the cast-iron is cleaned and all rusting metal is properly treated and the windows are re-glazed and painted with a factory-applied paint, they will be reinstated.

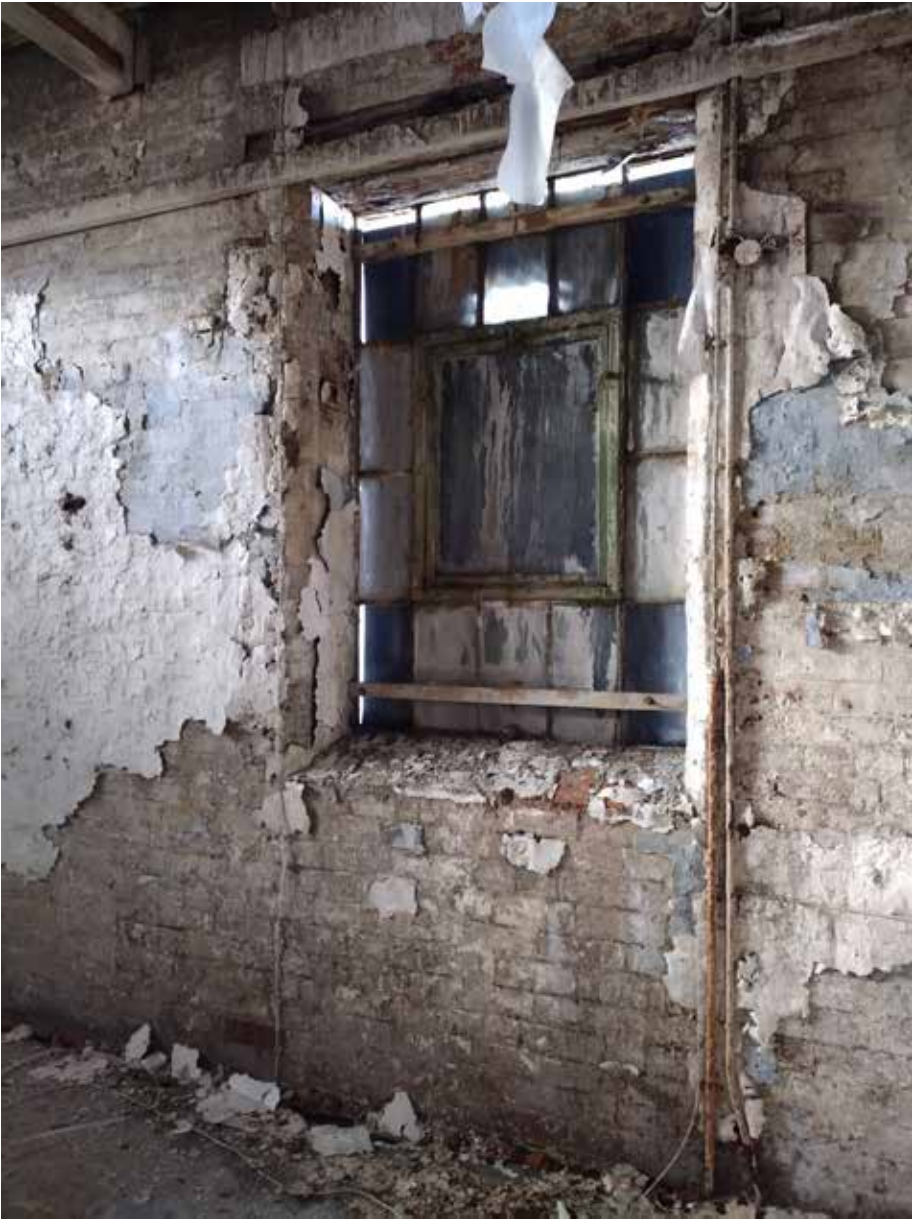
31. Typical example of the condition of the internal wall face - with mutiple layers of paint over lime-wash and trunking.

Option B:Timber stud wall insulation system using 'breathable' wood-fibre boards.This provides enhanced thermal performance and involves installing an appropriate breather membrane against the wall, which extends up between ceiling joists.An appropriate vapour control tape is used at any gaps or junctions

in the membrane including around ceiling joists etc. Timber studs 75mm x 50mm are fixed against the wall and 75mm thick wool insulation slab such as ThermaFleece Cosy Wool slab is inserted between the studs. An appropriate vapour control and air tightness layer is installed over the insulation and timber studs, extending between ceiling joists etc. All gaps, junctions and joints are properly sealed using appropriate tapes and sealants. Finally, 40mm thick wood fibre insulation boards are fixed to the timber studwork using appropriate fixings (perhaps using Steico Internal tongue & groove wood fibre boards). A lime plaster is applied to the boards. An alternative option is to use non-natural insulation and a plain thistle-plastered finish. This will be assessed on a cost basis but will materially make no difference to the finished internal appearance of the walls. It is, therefore, considered that this element need not be conditioned.

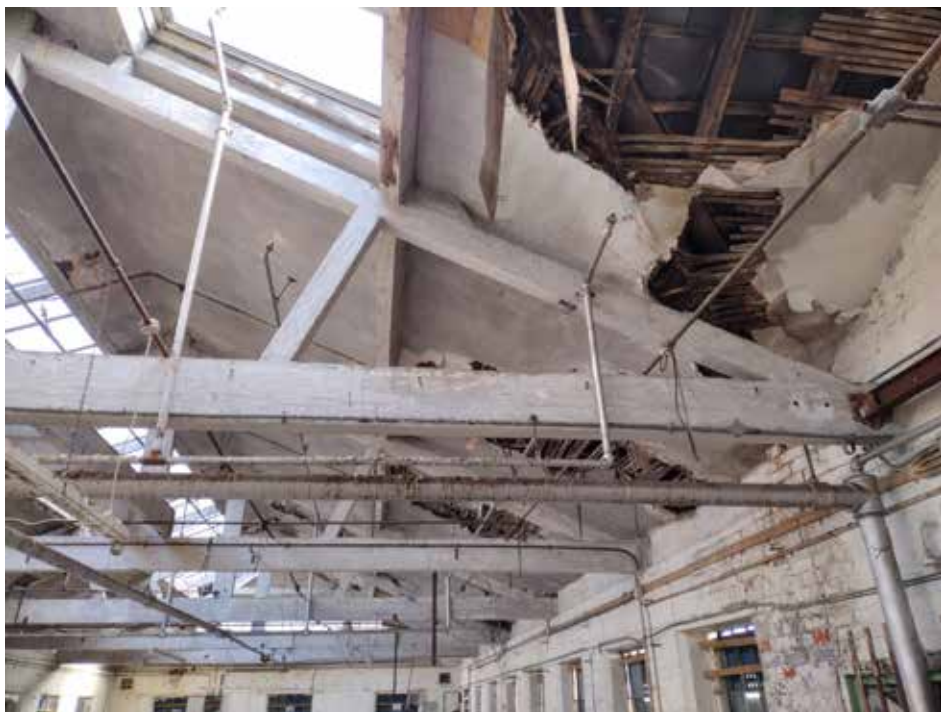
In order to comply with Building Regulations for the change of use to residential, the internal face of the lath-and-plaster roof will have to be upgraded with a more thermally efficient insulated system. The lathe-and-plaster is heavily degraded, and plaster has become detached in certain areas, although it is largely complete. Options are to clean down and retain plaster in-situ, and to thermally upgrade from beneath the existing plaster line, or to remove the lathe-and-plaster and thermally upgrade the roof and then re-plaster using either further lath-and-plaster or plasterboard. There is no option to ‘do nothing’. The acoustic report also recommends upgrading the ceilings to the roof slopes. On balance, it is considered that retention of lath-and-plaster in-situ in its current degraded state is not viable and that the loss of the historic lathe-and-plaster will have to be considered as a slightly harmful impact. It would seem perverse to upgrade the roof, provide new insulation between and below the rafters and then to apply at a new and lower level an expensive lath-and-plaster finish, as this is not the authentic location and will significantly increase the costs of the project. It is suggested, therefore, that the loss of the historic lathe-and-plaster finish be accepted as a consequence of the proposed scheme, and this has been included in the balancing exercise in the conclusions of this report.

32. Example of the variable condition of the internal roof slope, with missing and damaged sections of lathe-and-plaster.
