# HERITAGE STATEMENT & IMPACT ASSESSMENT LONDON MILL, ASHBOURNE ROAD, LEEK

Alfa Mohuha Ltd  
13th March 2023

## Mel Morris Conservation

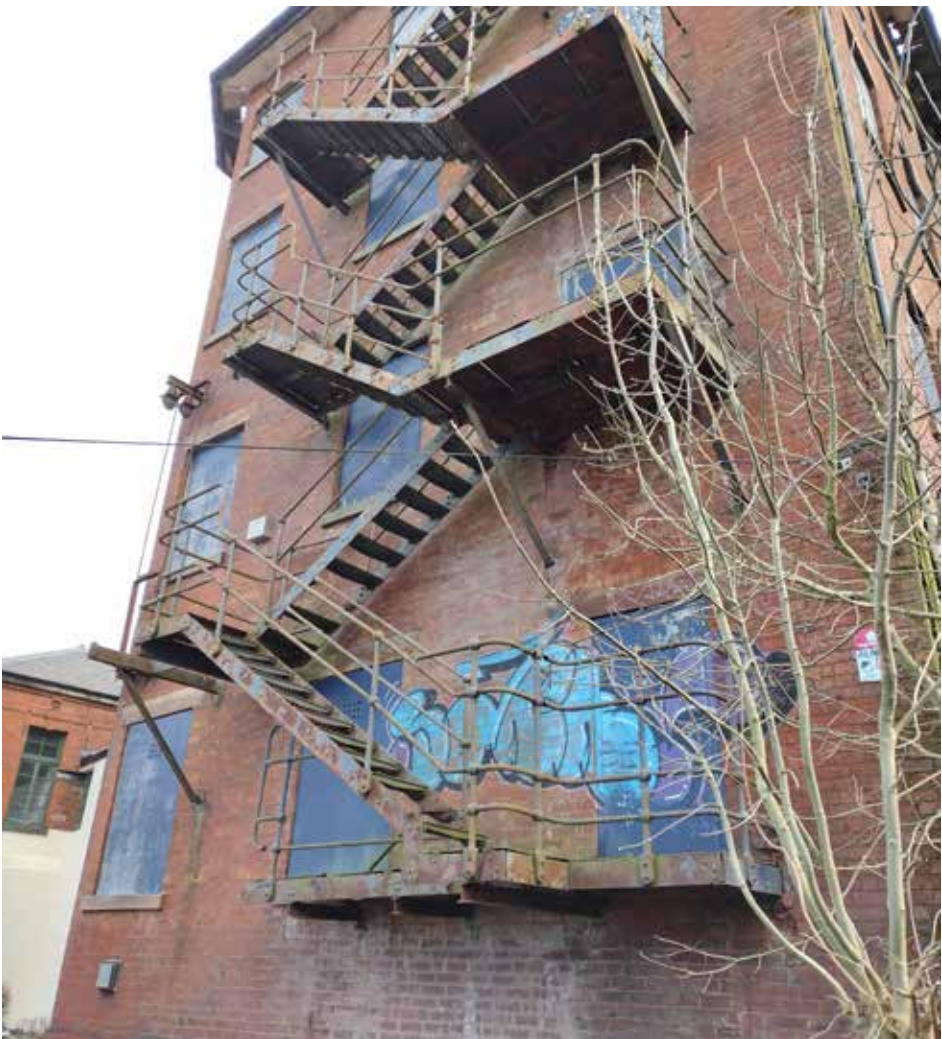
The second fire escape staircase was added in the mid 20th century, probably in the 1950s. The circumstances of this staircase are quite different, as the staircase actually overhangs the building line. The land to the immediate west of the staircase belongs to another property and is in separate ownership. So, not only is the staircase inaccessible from the bottom, it is not possible to repair the staircase or redecorate it without getting a special permission from the adjacent landowner, which involves partial closure of the car park. The steel which is embedded in the masonry is causing cracks and deterioration of the brickwork. Maintenance and re-decoration will be an ongoing liability. It is the recommendation of Mel Morris Conservation that in view of the low value of this fire escape stair, that it be removed and that the elevation be restored, and windows restored to their former symmetrical appearance.

33. The western fire escape staircase is heavily rusted and suspended in mid air, with the bottom flight removed

**Impact** – the loss of the fire escape staircase to the west elevation is negligible negative. This is balanced against the restoration of the symmetrical pattern of the window openings and reinstatement of stone cills to this elevation.

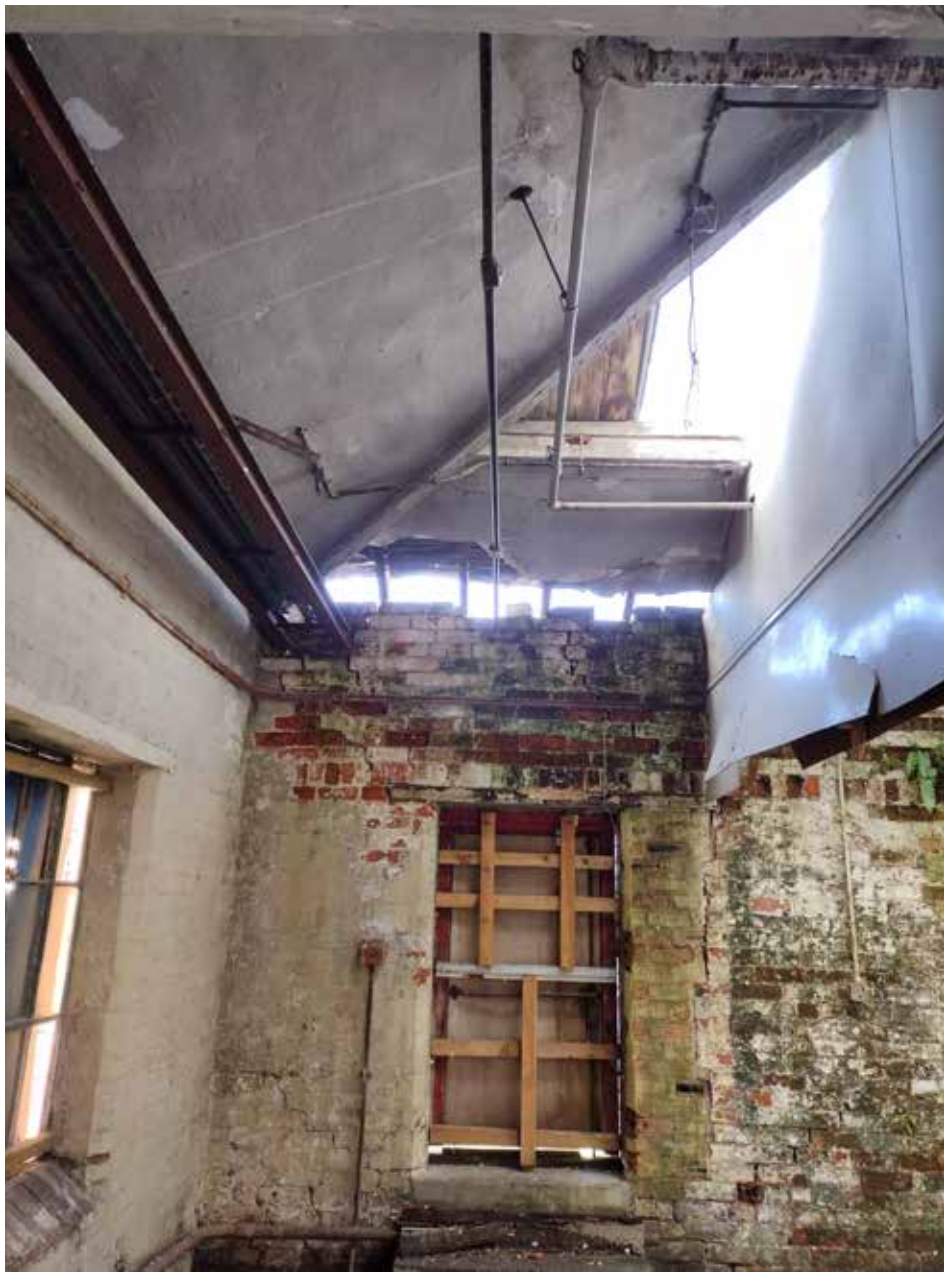
**36. The building is not wind and watertight and there are gaps at eaves level over the western elevation, and the eaves masonry is in a degraded condition. This section of the roof is open to the elements, with missing sections of slate and battens, and no sign of a gutter.**

The condition of the building is, therefore, a material consideration. The building is 'at risk' and the issue of the roof is an economic one. The repair of the roof will require a full structural scaffold, with access across the neighbouring owners land and isolation of a section of the car park, in order to re-roof the building. There is no short-term fix and the whole question of re-roofing the building has to be considered as one of viability and finding an economic use.

due to the geometry of the splayed corner formed by thermal movement of the masonry. The steel staircase is also corroding within the masonry, the expansive force of the corrosion is causing numerous cracks propagating from the elements. ....The roof finishes are completely missing to sections of the west end and some rotten timber rafters are inevitable."

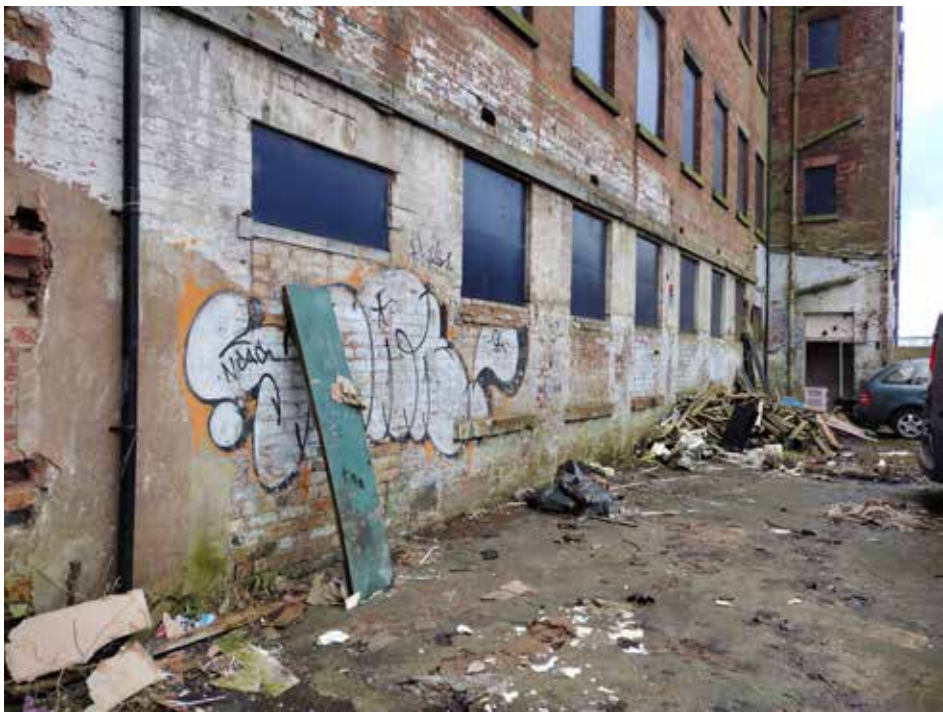
**37. The north elevation has suffered from some graffiti and the removal of the rear Boiler House has exposed the former internal wall.**

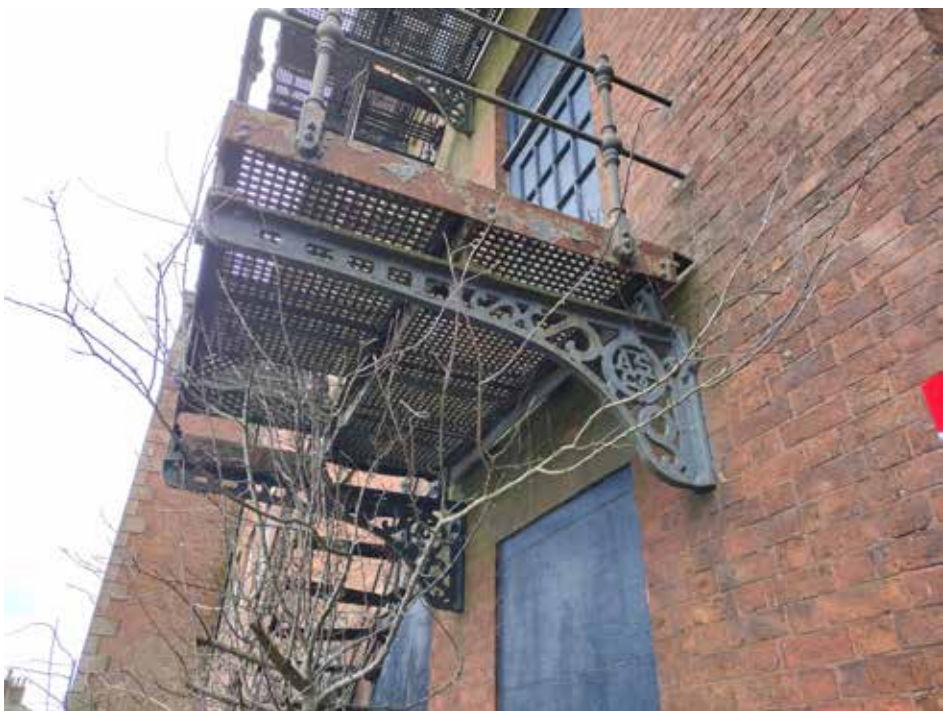
**38. The more important cast-iron fire escape staircase is in poor condition, rusting, and needs fully blast cleaning and re-decorating.**

There are two fire escape staircases. That to the Ashbourne Road is much earlier and a very distinctive feature of the building in moving through the Ashbourne Road. It is proposed to retain this in-situ, repair the metalwork and re-decorate the staircase.
