**NORTH LODGE (TO HEATH HOUSE),  
WINNOTHDALE,  
STAFFORDSHIRE**

**BAT SURVEY REPORT**

**January 2024**

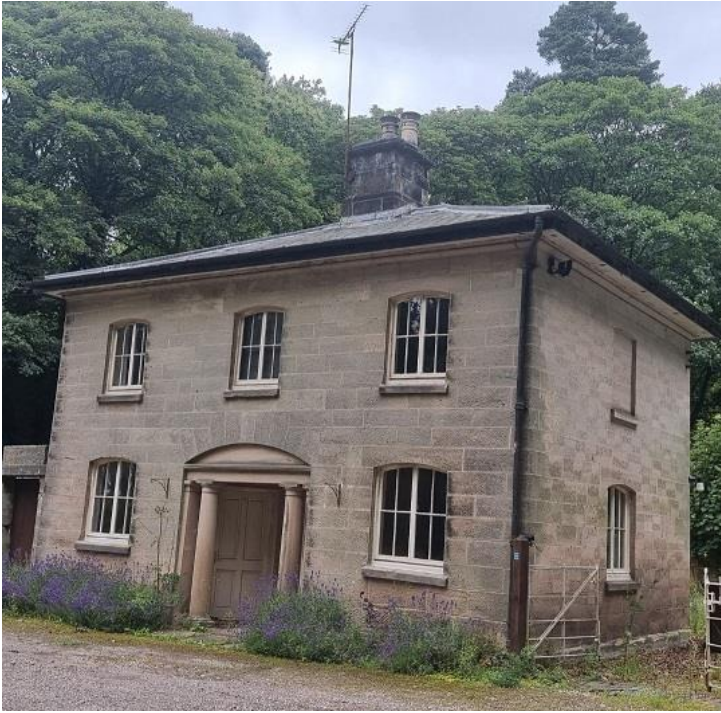
**1. North Lodge – southern and western elevations**

- 3.6 The building is detached and two-storey. It is built from dressed sandstone and has a large central chimney. The roof is hipped and clad in slates. The ridge and hips are formed from lead flashing. Gaps are present associated with the ridge, hips and under lead flashing at the chimney base where it meets the roof tiles. The stone walls are well sealed. The soffits are wooden with meshed vents and appear well sealed.

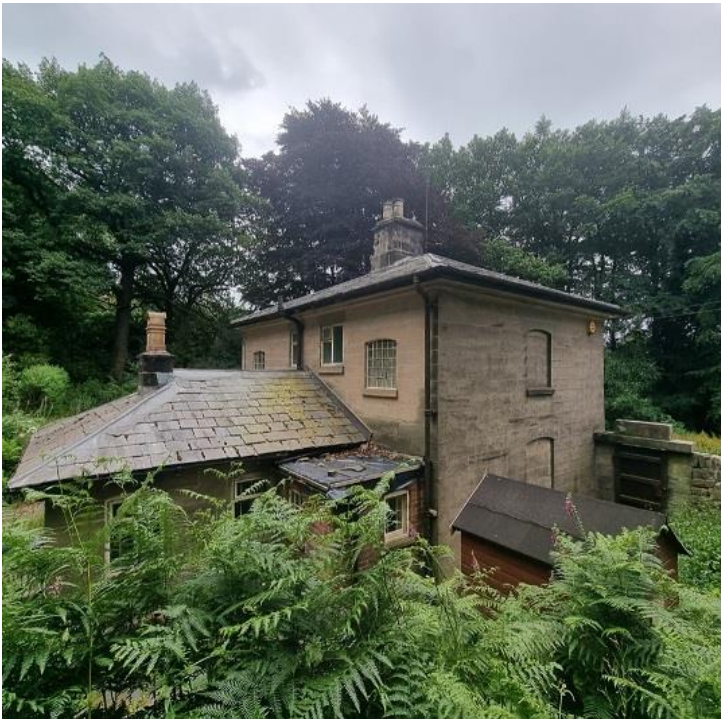
**2. North Lodge – northern and eastern elevations including rear extension**

- 3.7 At the rear (northeastern elevation) is a single-storey extension. This is also built from stone and has a part-hipped roof clad in slates. The ridge and hips are formed from lead flashing. A small chimney is present. Occasional gaps are present associated with the ridge.

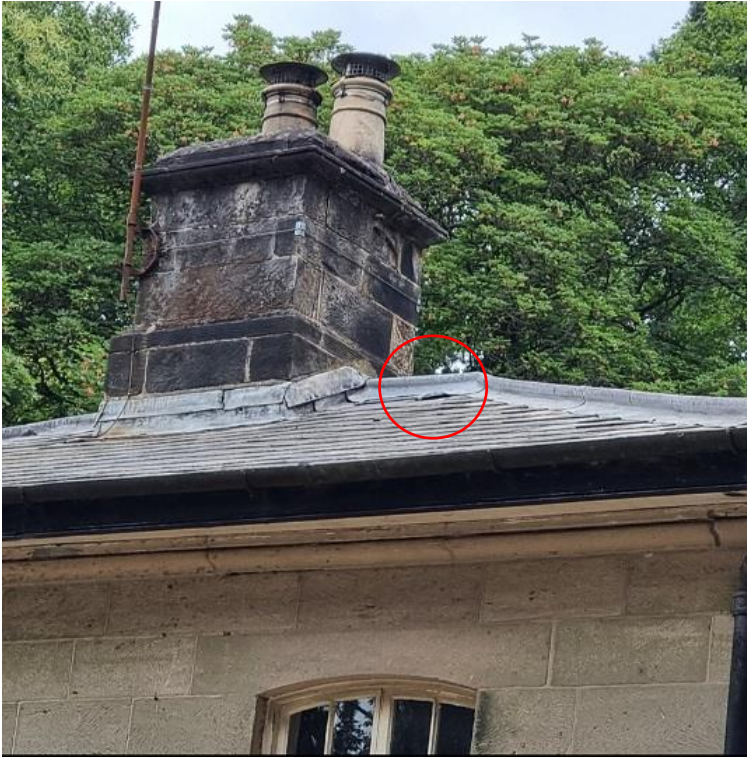
**3. One of roost access points – southwest of building**

| Date | Findings |
|---|---|
| 31 <sup>st</sup> July 2023 | Six brown long-eared bats emerged during the survey. The first five bats emerged between 21:14 and 21:38 from a gap below the lead flashing of the ridge adjacent to the chimney (southeast side of chimney). All the bats flew directly westwards towards the adjacent trees. A brown long-eared emerged at 21:42 from below the ridge close to where it meets the hip on the southwest side of the building. |

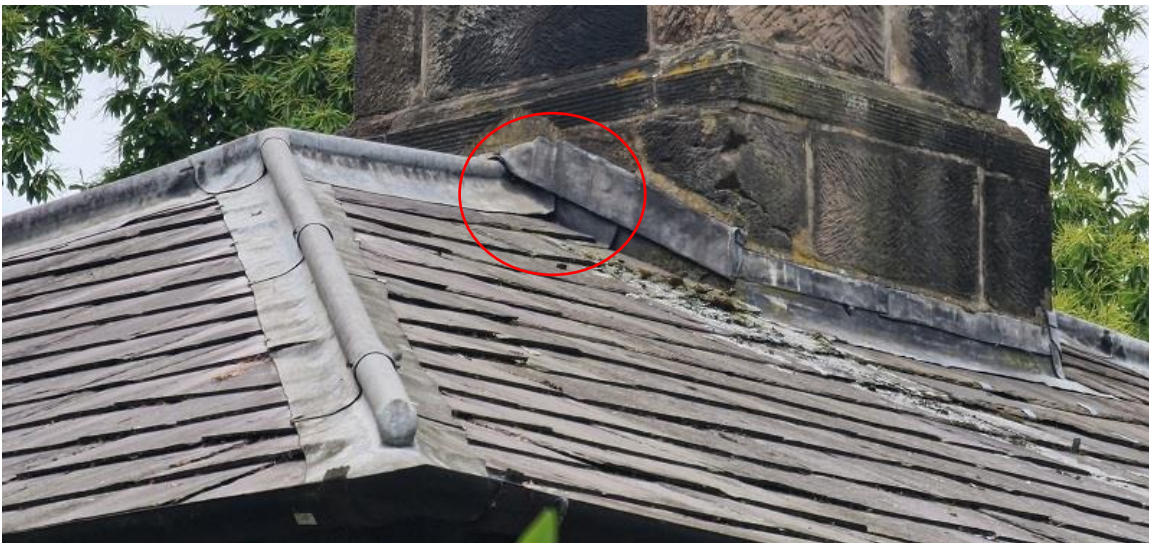
**4. Main access point for bats below the ridge, to southeast of chimney**

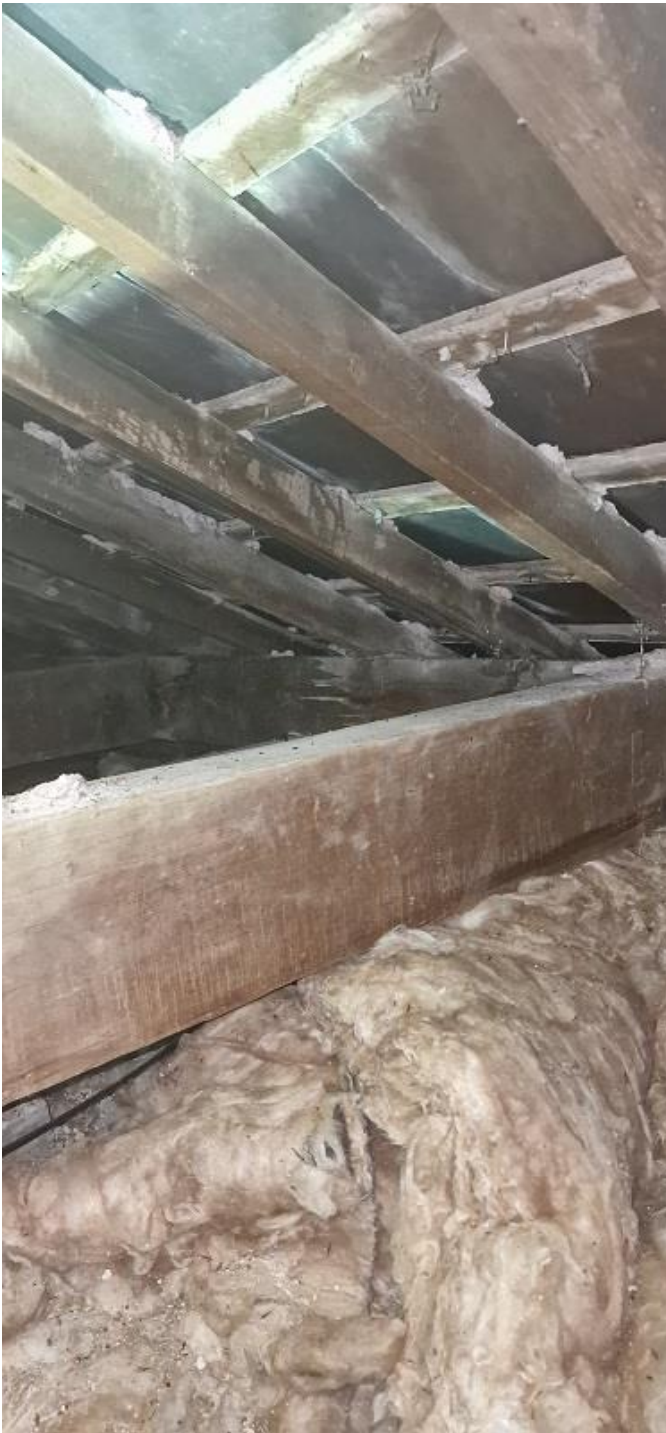
- 3.8 The roof void is approximately 1.25m in height. It is separated in two by a large centrally placed chimney breast. Gaps either side of the chimney breast provide open flight access for bats between the two halves of the roof void. The roof void floor is lined with rockwool insulation.

- 3.9 The roof is supported by purlins and cross beams. The ridge and hip beams are wooden and clean and free from cobwebs. The roof slates are unlined and the undersides visible. In several places, daylight is visible, such as at the ridge, at the eaves and by the chimney.

- 3.10 Thousands of bat droppings, characteristic of brown long-eared, are present throughout the roof void. The droppings are spread across the floor of the void, with a concentration of c. 2000-3000 droppings located below a joint between the hip and ridge beams in the north-west half of the void. Droppings were also found stuck to the walls of the chimney breast, with small clusters on the floor below. The droppings ranged in age from old to very fresh. Wet urine stains were also present.

**5. Main roof void (northwestern half)**

- 4.6 Changes to the development design have also been made to ensure the re-roofing and re-insulation are compatible for use of the roof voids by brown long-eared bats. The roof voids should provide attractive roosting opportunities for the nursery cluster given the inclusion of traditional bitumastic (1F) underfelt and roof voids that will be sealed and draught-free resulting in secure and warm (in summer) roosting environments. In addition:
